Water Compliance Inspection Report

NPDES
Inspection Report

Mensonides Dairy, LLC
(NPDES Permit #: Unpermitted)

Inspection Date: April 27, 2017

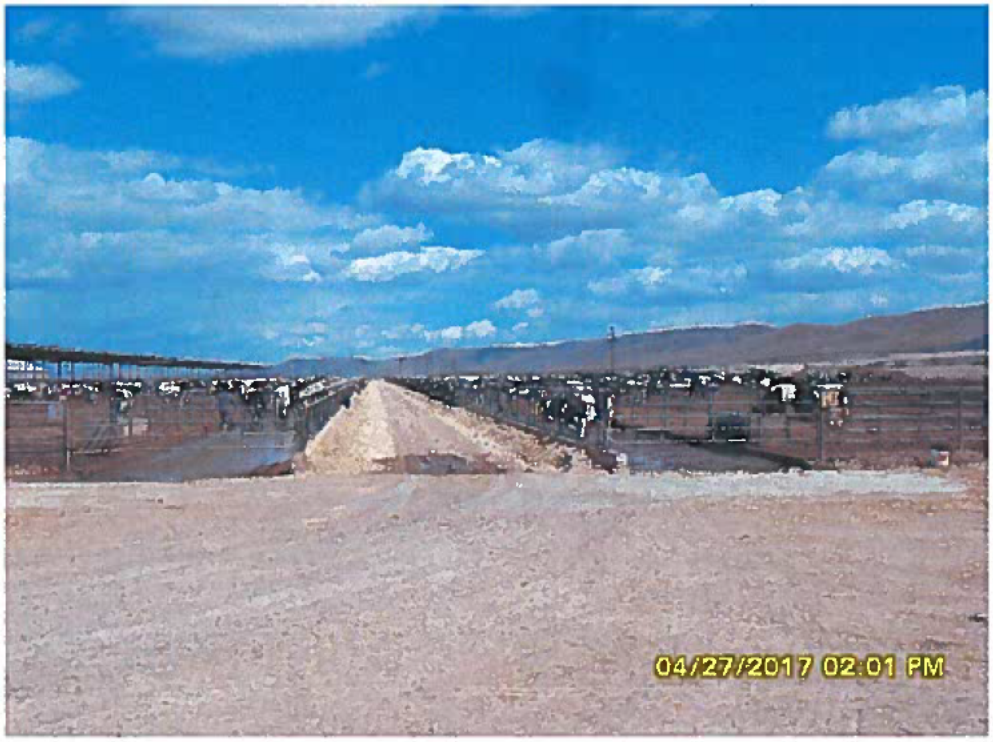
Photo #4: Easterly view showing one of the open lot confinement areas. Camera photograph #SAM 2793.
