Log Book: Chemical Recovery Systems Inc; Black River Samples

TDD: R05-8512-06

2-5-86 ITINERARY

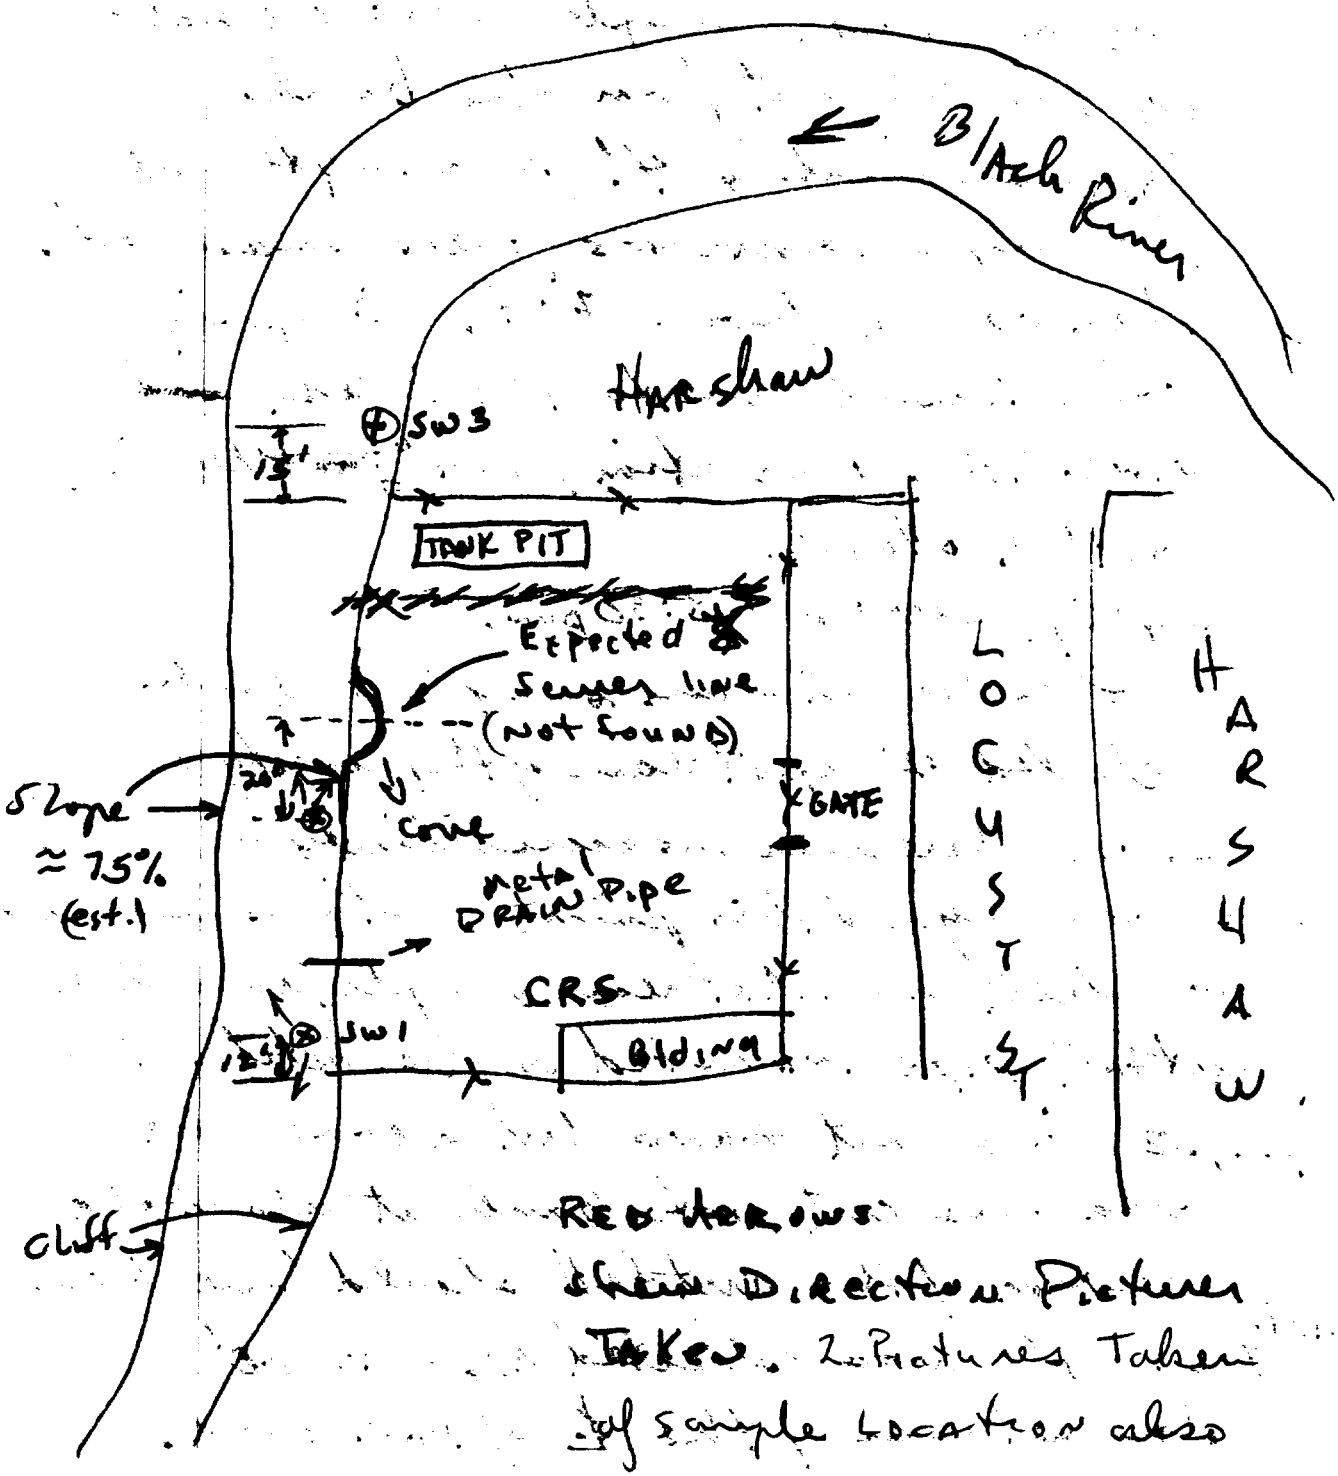
SITE SKetch
w/ Photo Locations + SAMPLING LOCATIONS

RED ARROWS show Direction Pictures Taken. 2 Pictures Taken of sample Location also

the sample location and terrain experienced. Samples were collected by reaching out from the bank approximately 4'. River depths at the sample locations were measured. They varied from 2'-4'. Sampling was slowed due to the trees, ~~and~~ vine like vegatation, and ~~[illegible]~~ debris, on the slope.

The downstream sample had to be collected 12' upstream of the property boundry since there was no accessibility to river bank beyond this point. It was intended to collect a midstream sample from the outfall pipe located on the sketch. The pipe was not found but a cone like area was cut into bank at about the location of the outfall should have been located. The sample was collected approx. 20' downstream of the ℄ of this cone.
