FINAL
SITE INSPECTION PRIORITIZATION REPORT
COMMERCIAL ENVELOPE MFG. CO., INC.
DEER PARK, NEW YORK

CERCLIS ID No.: NYD981184138

ENGINEERING INVESTIGATIONS AT INACTIVE HAZARDOUS WASTE SITES IN THE STATE OF NEW YORK PHASE I INVESTIGATIONS

COMMERCIAL ENVELOPE MFG. CO., INC.
TOWN OF BABYLON, SUFFOLK COUNTY
NEW YORK I.D. NO. 152103

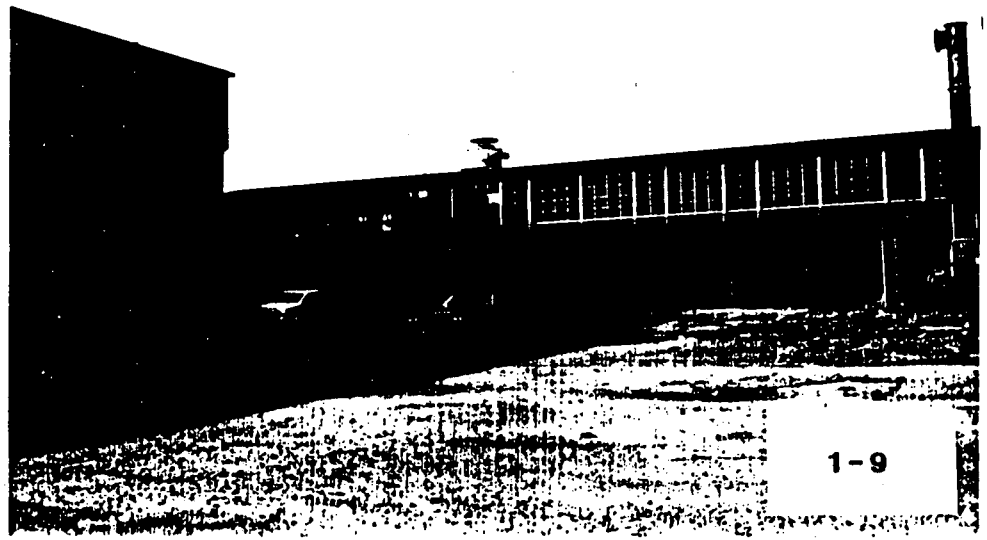
1-8	Southwesterly view into the northeastern parking lot where the leach pools, underground storage tanks, incinerator, and dumpster/compactor (center of photo's right edge) are located.
1-9 and 1-10	Westerly view of the northern portion of the eastern wall of CEM's main building (note the incinerator chimney near the center of the field of view). Also, note the dug up area (light colored sand and gravel) near the right side of Photo 1-10 which includes the two leach pools, the underground "cache" and the underground ink waste storage tanks (in order from the lower right area of the photo to the rollup door). Refer to Figure 1-2.
1-11	Detail of a portion of the area shown on Photos 1-9 and 1-10, including the incinerator (left portion of Photo 1-11), and the general vicinity surface area of the underground waste ink storage tanks (central portion of the photo in front of the rollup door).
1-12	Closeup view of the eastern leach pool shown on Photo 1-10 and Figure 1-2 (inset).

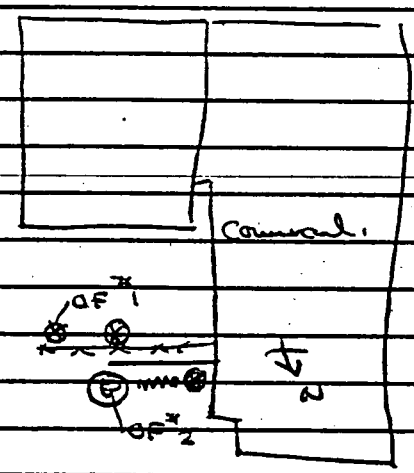
④ Loading dock storm drain over flow pool cement cap has been removed + pool widened + exposed. There are two 4-6" ~~[illegible]~~ white piped eastern pool, side by side from the direction (West) of the visible loading dock storm drain.
There is sludge at the bottom of the pool which will be removed.
The are no other apparent overflow pipes from the excavated overflow pool. The pool is a typical leaching pool, approx. 20-25 ft. deep.
