4-19-85

From: Bob Holtz

TANK AND DRUM LOCATION
BRIDGEPORT RENTAL & OIL SERVICES, LOGAN TWP., NJ

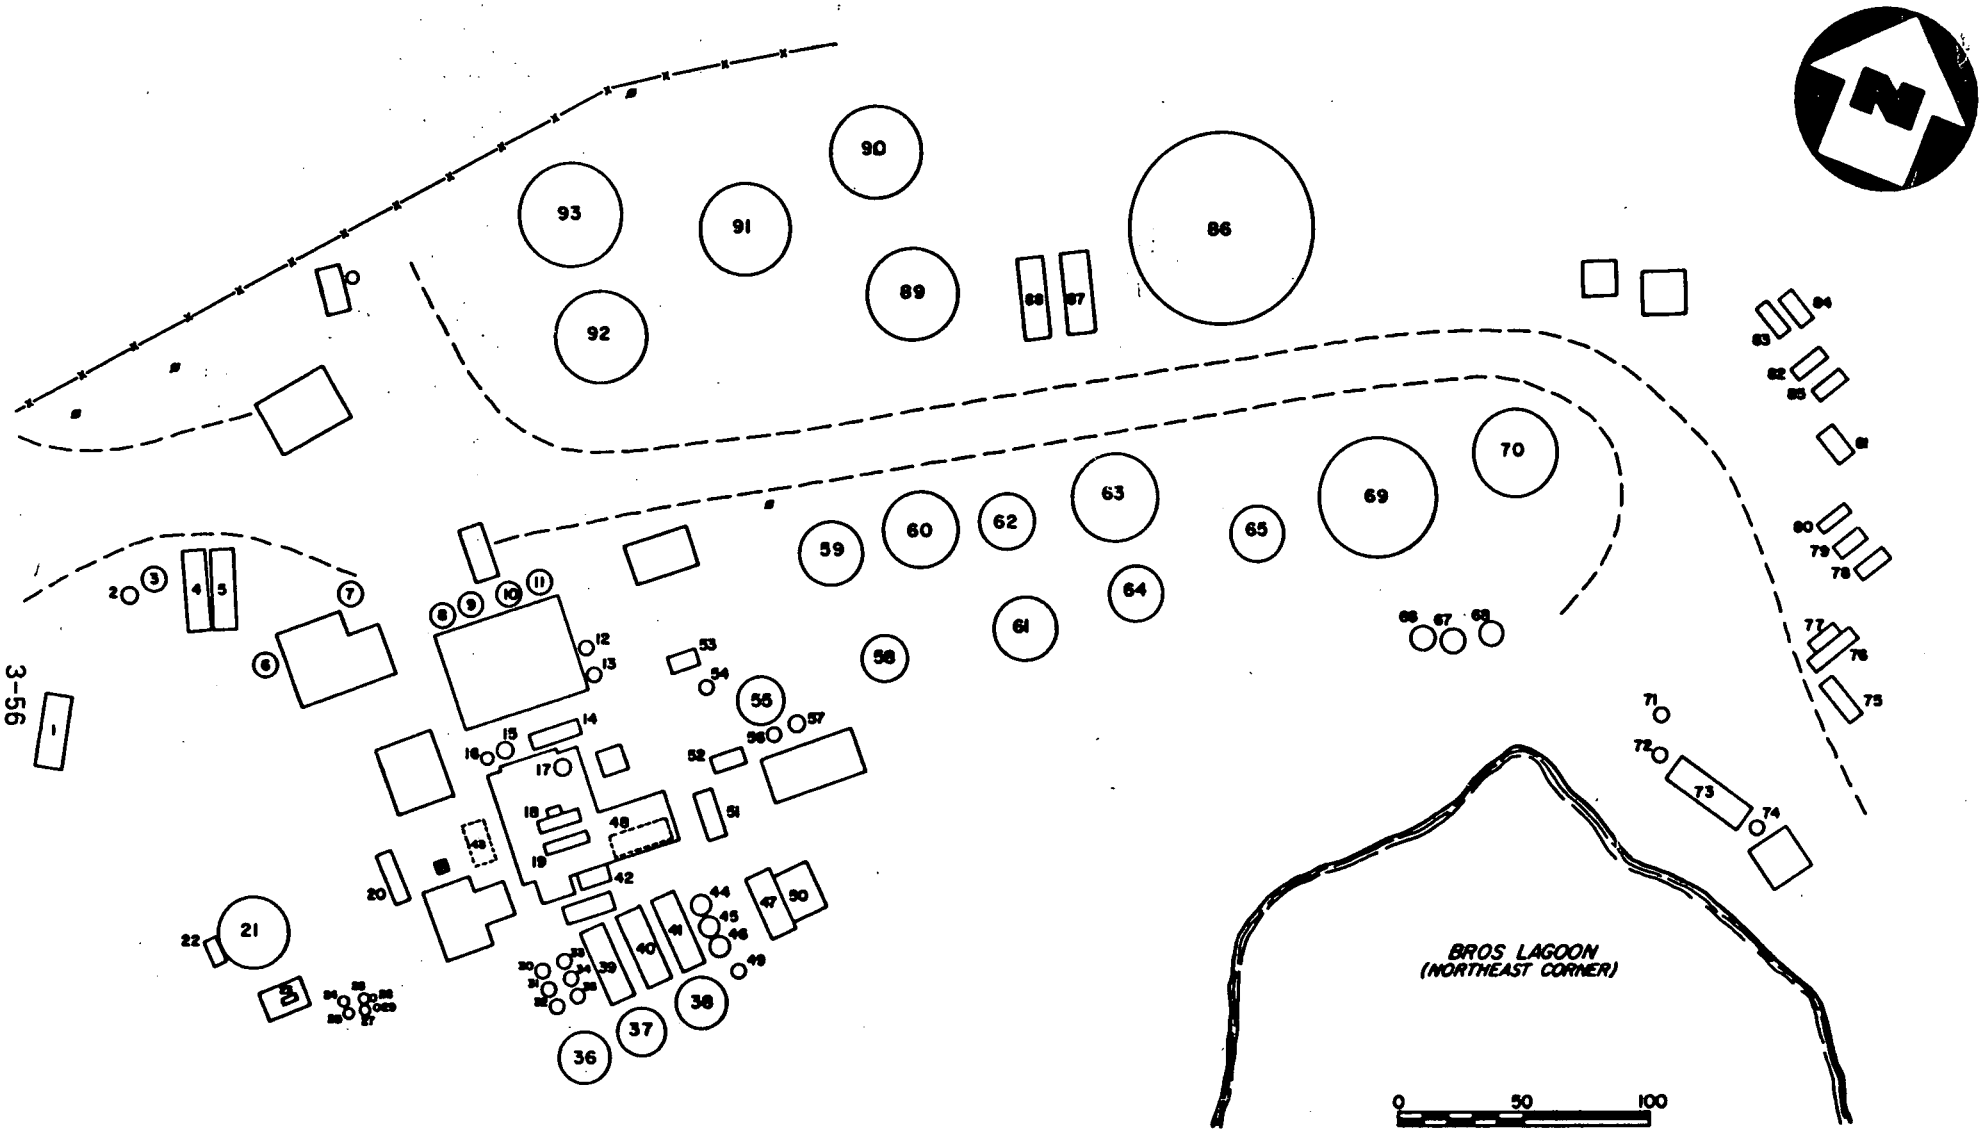
FIGURE 3-24

An inspection of the BROS site on 4-19-85 revealed that Tank #69 had a small oil leak from a standpipe that extends from the pontoon at the N W corner. The leak stopped, however, about 4 hours after it was initially spotted. ERB was notified of the situation. This tank should be carefully inspected.
