ENGINEERING INVESTIGATIONS AT INACTIVE HAZARDOUS WASTE SITES

PRELIMINARY SITE ASSESSMENT

R. SCHLEIDER C & D SITE
KINGS PARK (T)

SITE NO. 152089
SUFFOLK (C)

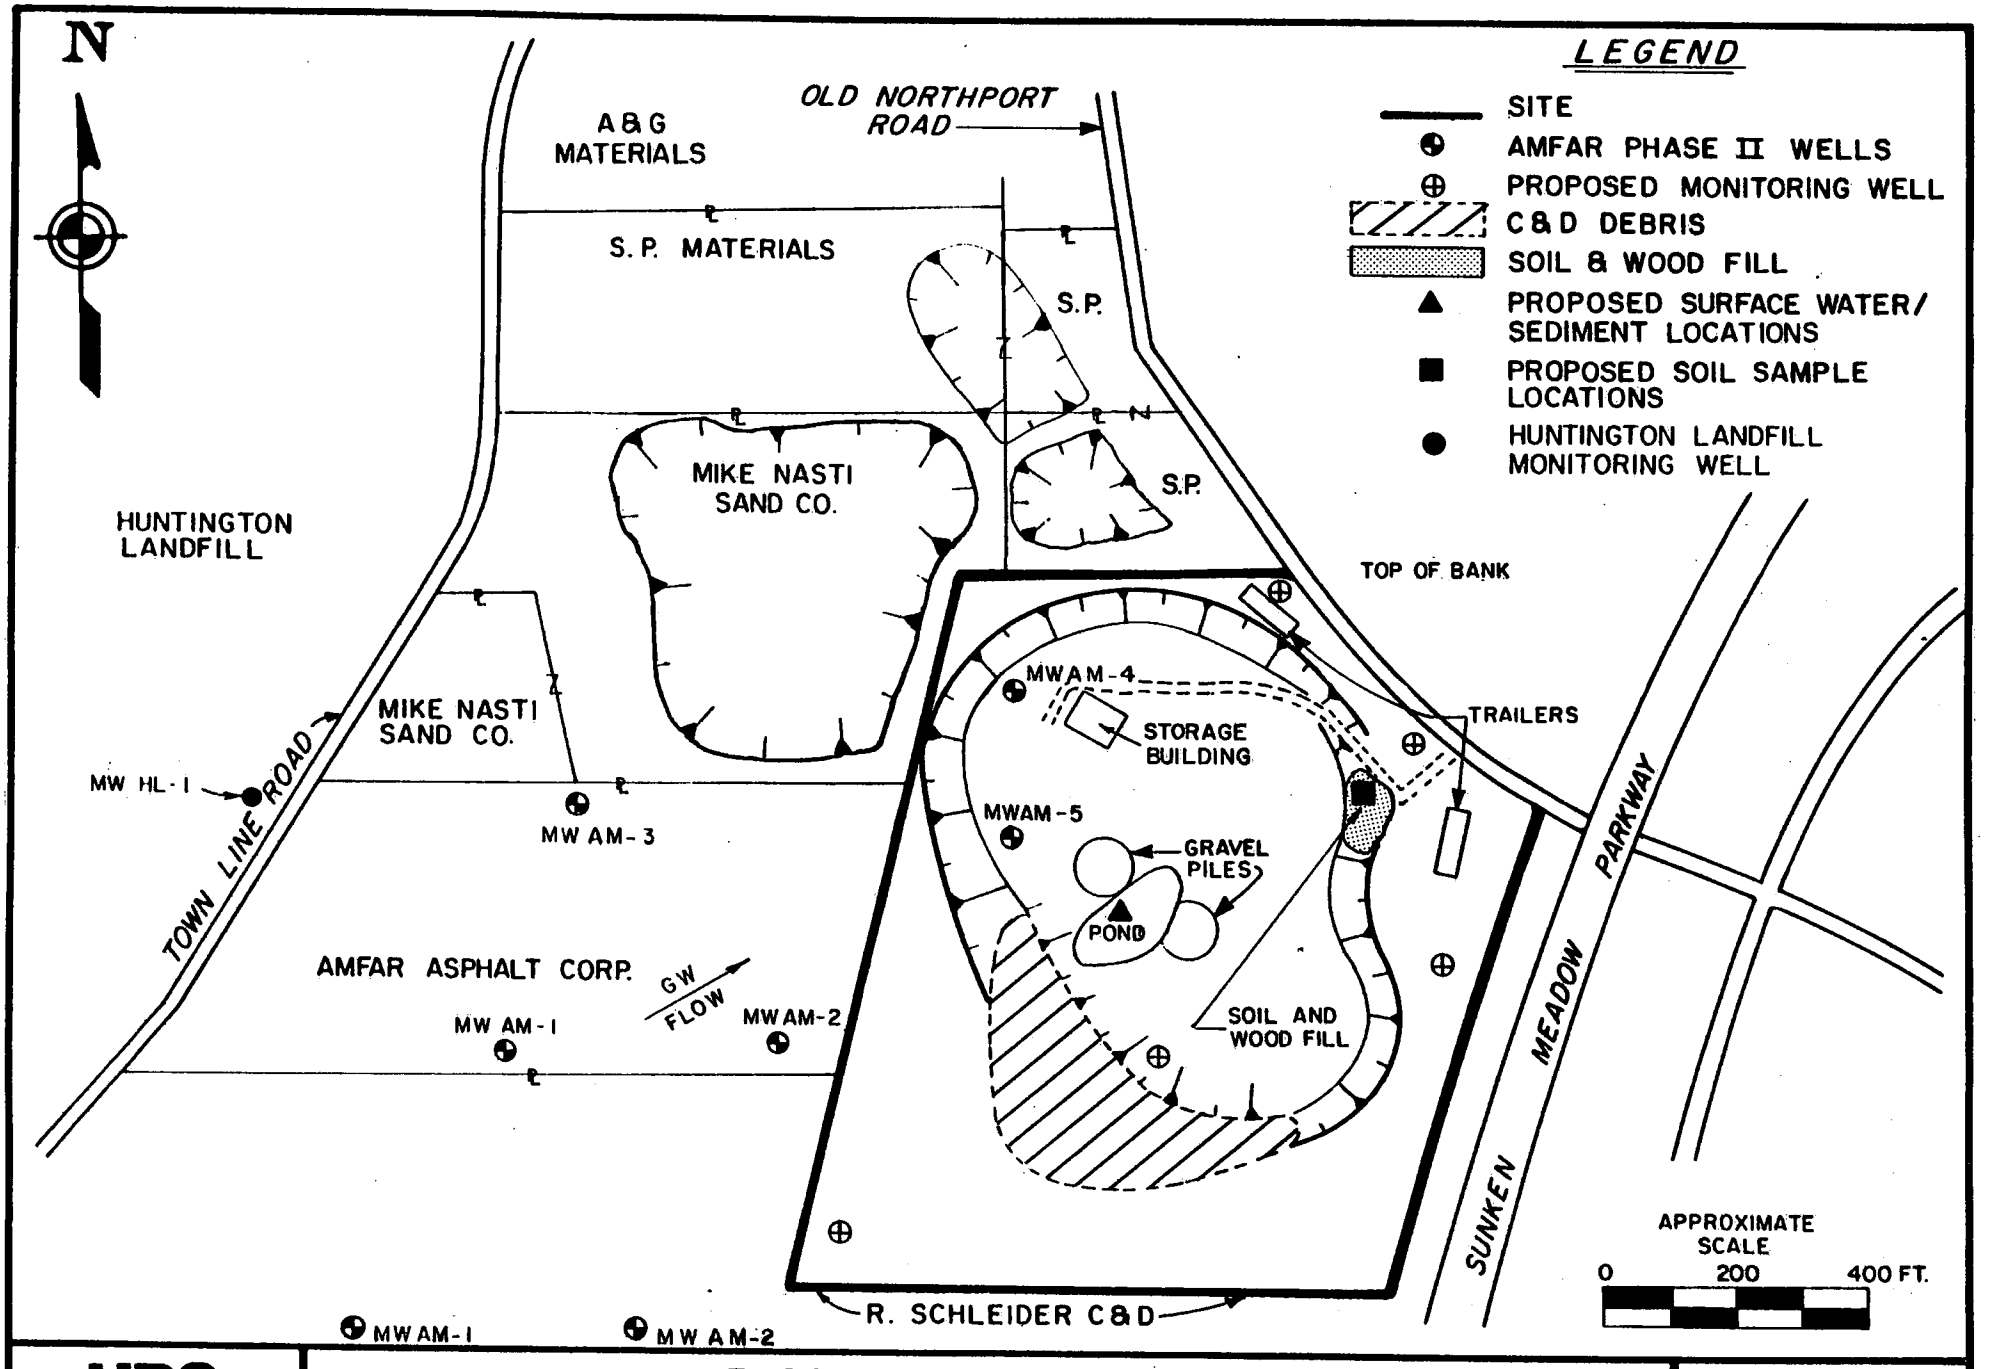
FIGURE 2

During the one hour site inspection, no readings above background levels were recorded on either instrument. The facility consists of a sand mining operation with some C&D material present (Figure 2). During the visit, two fill areas were observed. An embankment of the sand pit along the southwestern side of the site had C&D fill placed along it. Additional fill, consisting of chipped wood and soil, was located in the northeastern portion of the site. No signs of leachate seeps were observed in the vicinity of either of these fill areas.

the embankment. The wells were several feet below grade within the protective pipes. Surface features, areas of fill, monitoring well locations, and building locations are shown in figure 2. A USEPA Site Inspection Report (EPA Form 2070-13) and the NYSDEC " Additions/Changes to the Registry of Inactive Hazardous Waste Disposal Sites" were completed following the site inspection.

There is no documentation of hazardous waste deposition at the R. Schleider C&D site. The majority of the waste accepted at the site was C&D debris including concrete, tree stumps and road bed material. In addition to accepting C&D debris, file information indicates that the site also accepted industrial waste, and incinerator ash (Ref. 12). The file information was unclear as to the composition of the industrial waste (Ref. 2). The site files also indicated that the site was allegedly used to dispose of drummed waste (Ref. 8). The areas of the site used to dispose of waste are shown on Figure 2.
