REFERENCE 85
Page 1

Facility: Gary Development Company

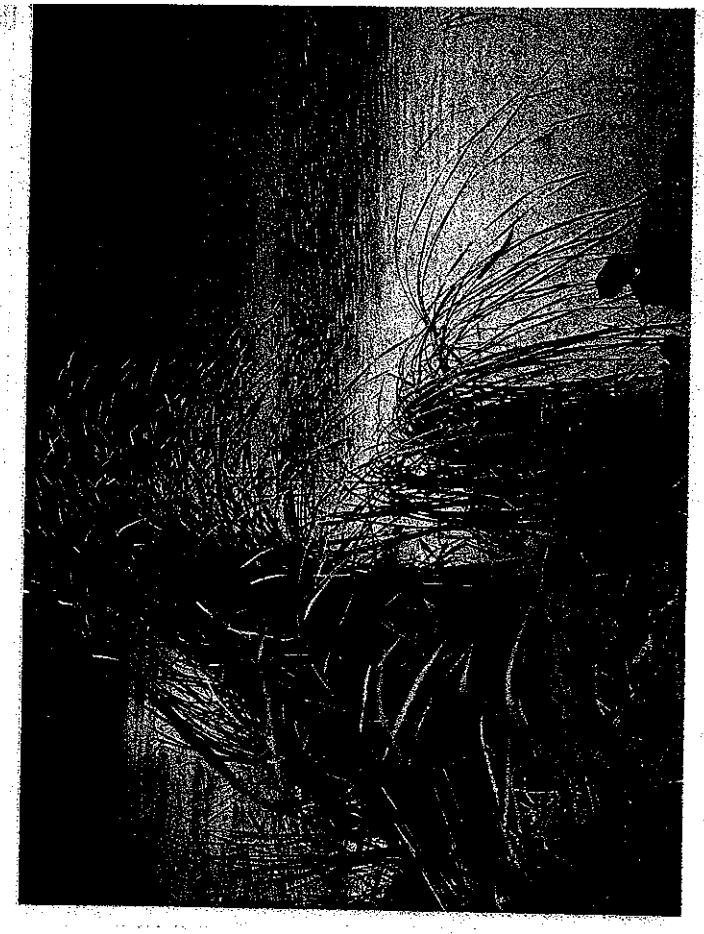
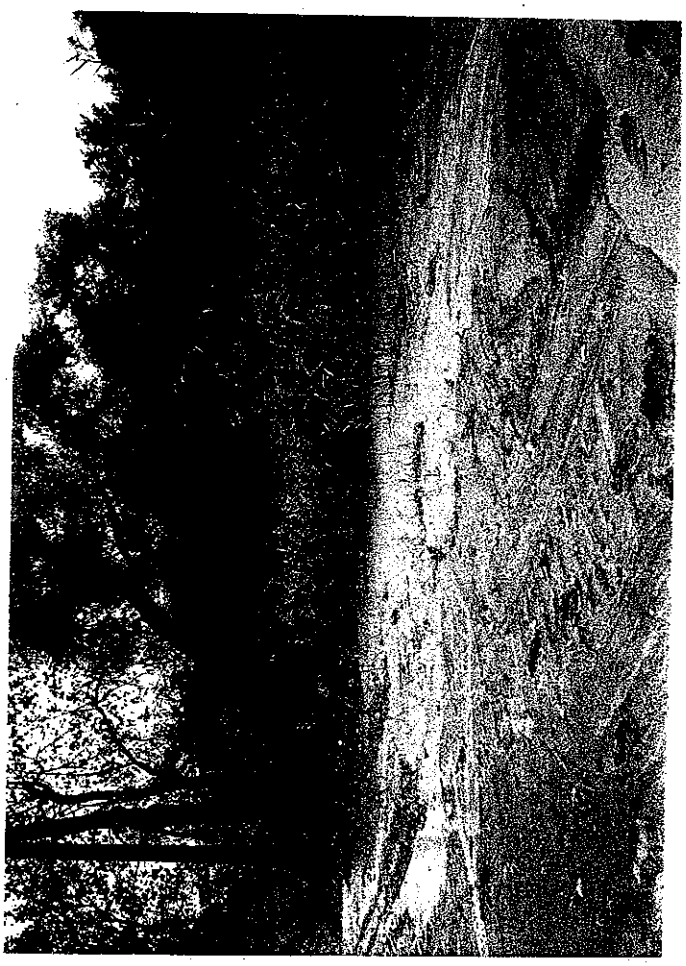
Location: looking up at South Slope ~ 50' from admin buildings

Subject (movement): Runoff, gullies

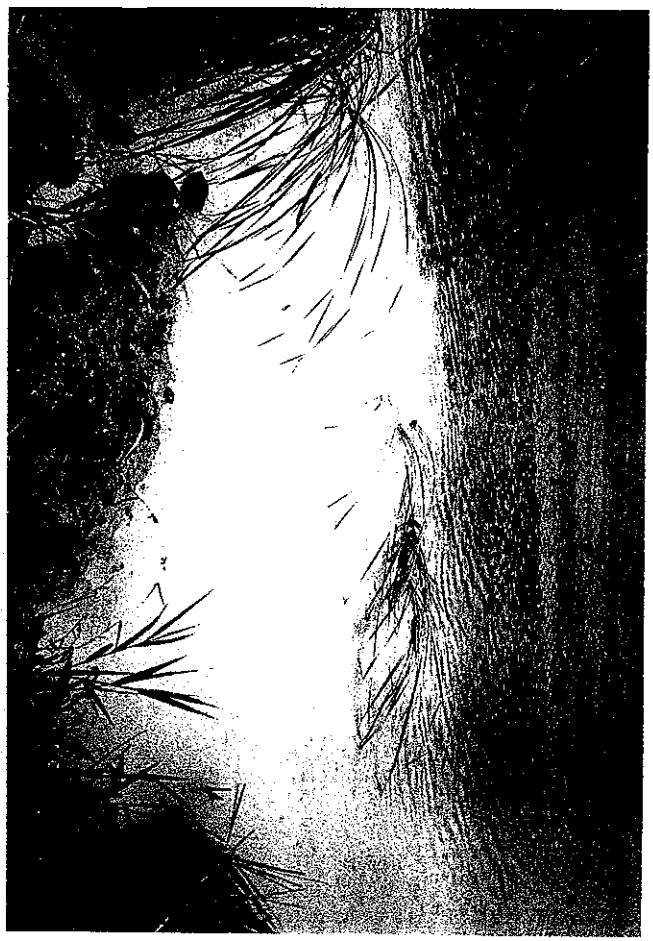
C

Location: Along Grand Cal

Subject (movement): Water pooling, soil pushed to river

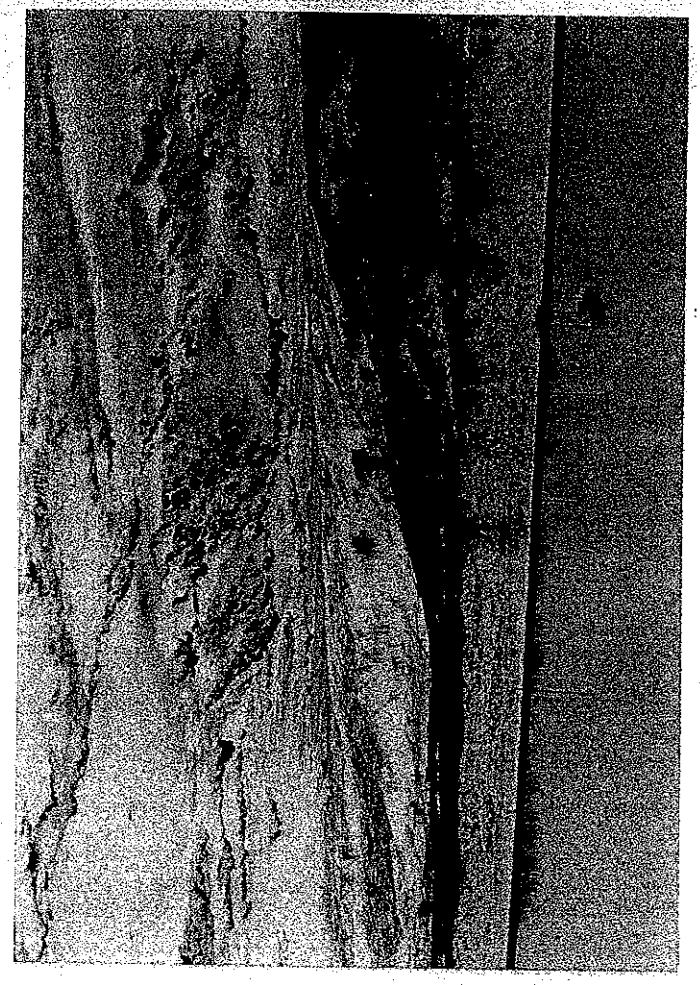
Facility: Gary Delvp. Co. (GDC)
Photographer: Roudebush
Date: 1/13/93
Time: ~5 pm
Others Present: M. Herdrich - IDEM
L. Hagen - GDC
Location: Top of capped fill looking west/so. west

Subject (movement): 4th monitoring well - Not indicated on (PRC) 1992 report. Well circled. Catch basin in background between GDC & AMG Res.

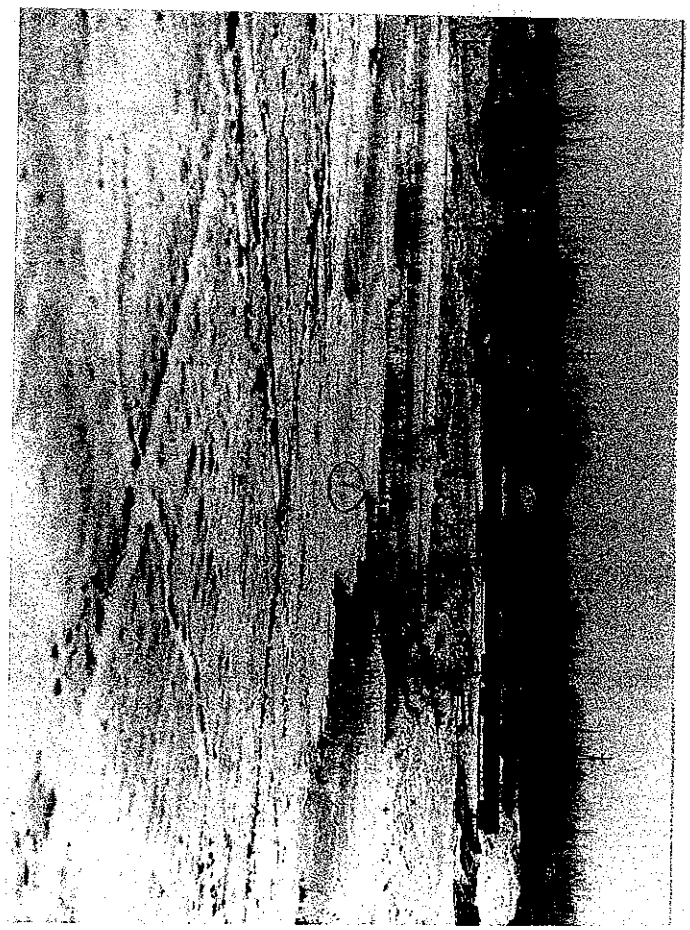
Facility: Gary Delvopment Company, Inc (GDC)
Photographer: Roudebush
Date: 1/13/93
Time: ~5pm
Others Present: M. Herdrich - IDEM
Larry Hagen, GDC
Location: Top (capped) portion of fill looking westward (west/so. west)

Subject (movement): Catch basin between AMG Resources and GDC. - 4th monitoring well - Not indicated on (PRC) 1992 report. (Well circled on Picture)
