Interim Investigation Report

The Lockformer Company
711 Ogden Avenue and
Undeveloped West Parcel
Lisle, Illinois

Volume 1 of 3
Text, Figures, Tables, Appendices A through C

Clayton Project 15-65263.01

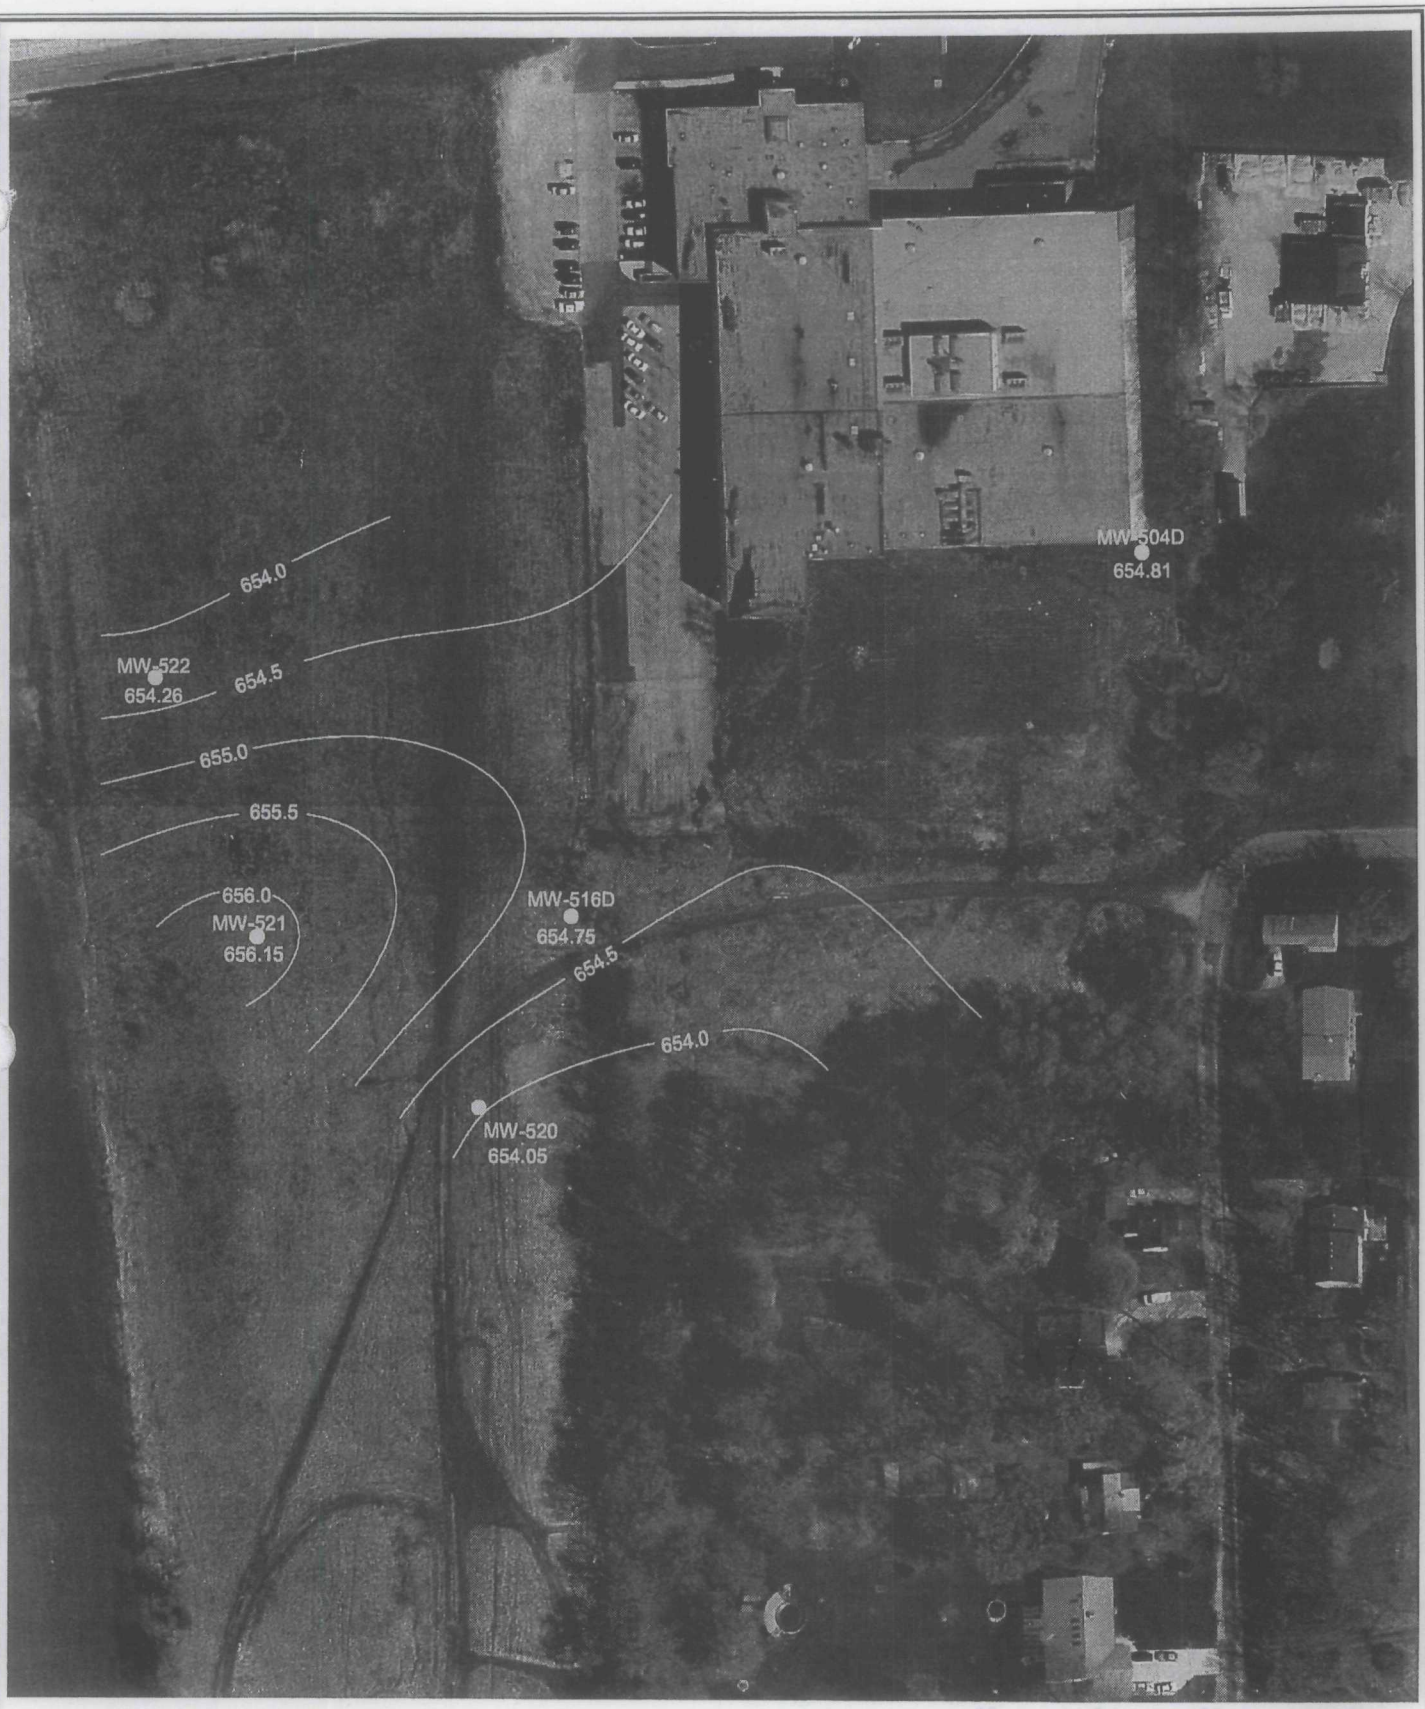
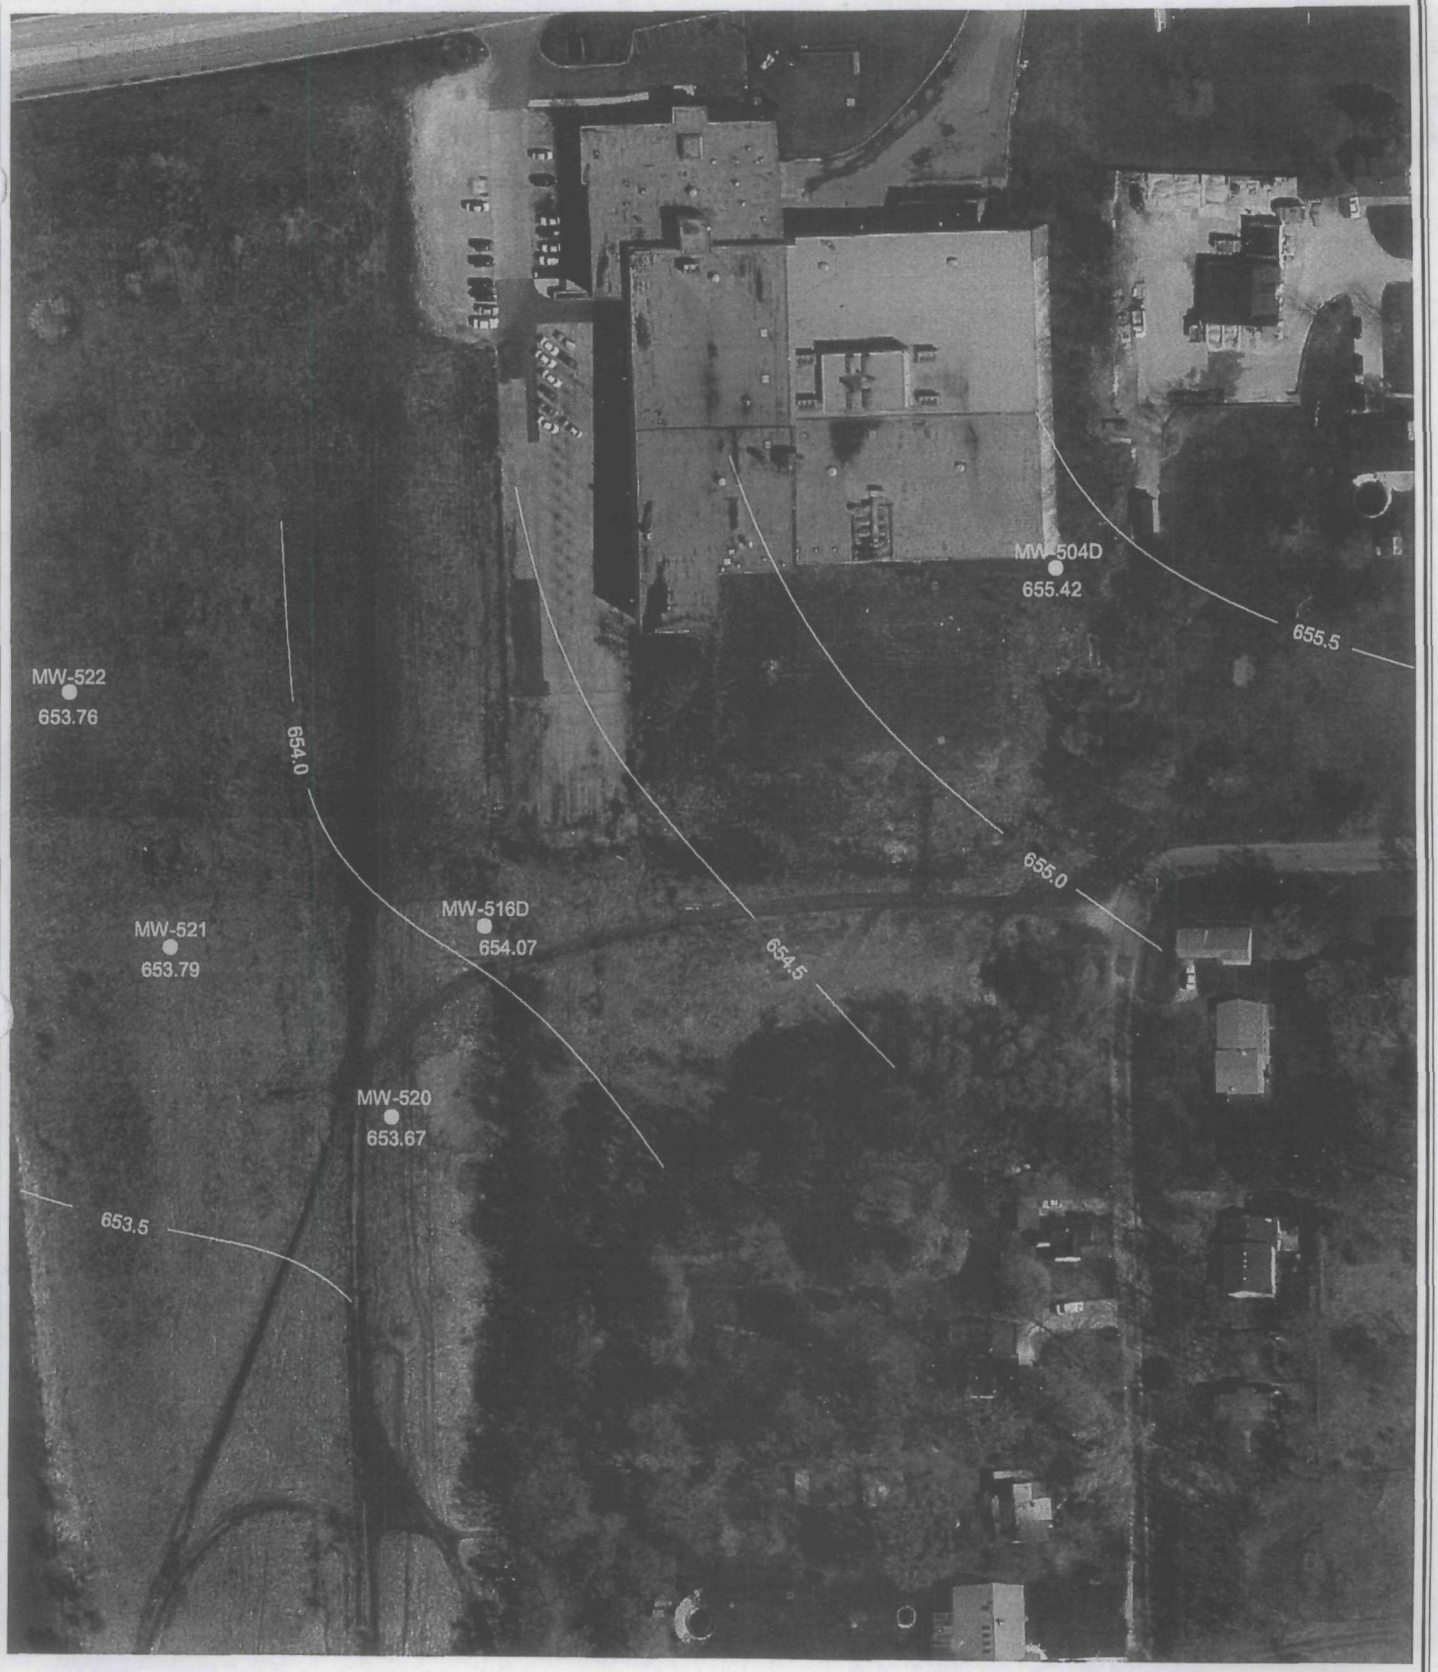
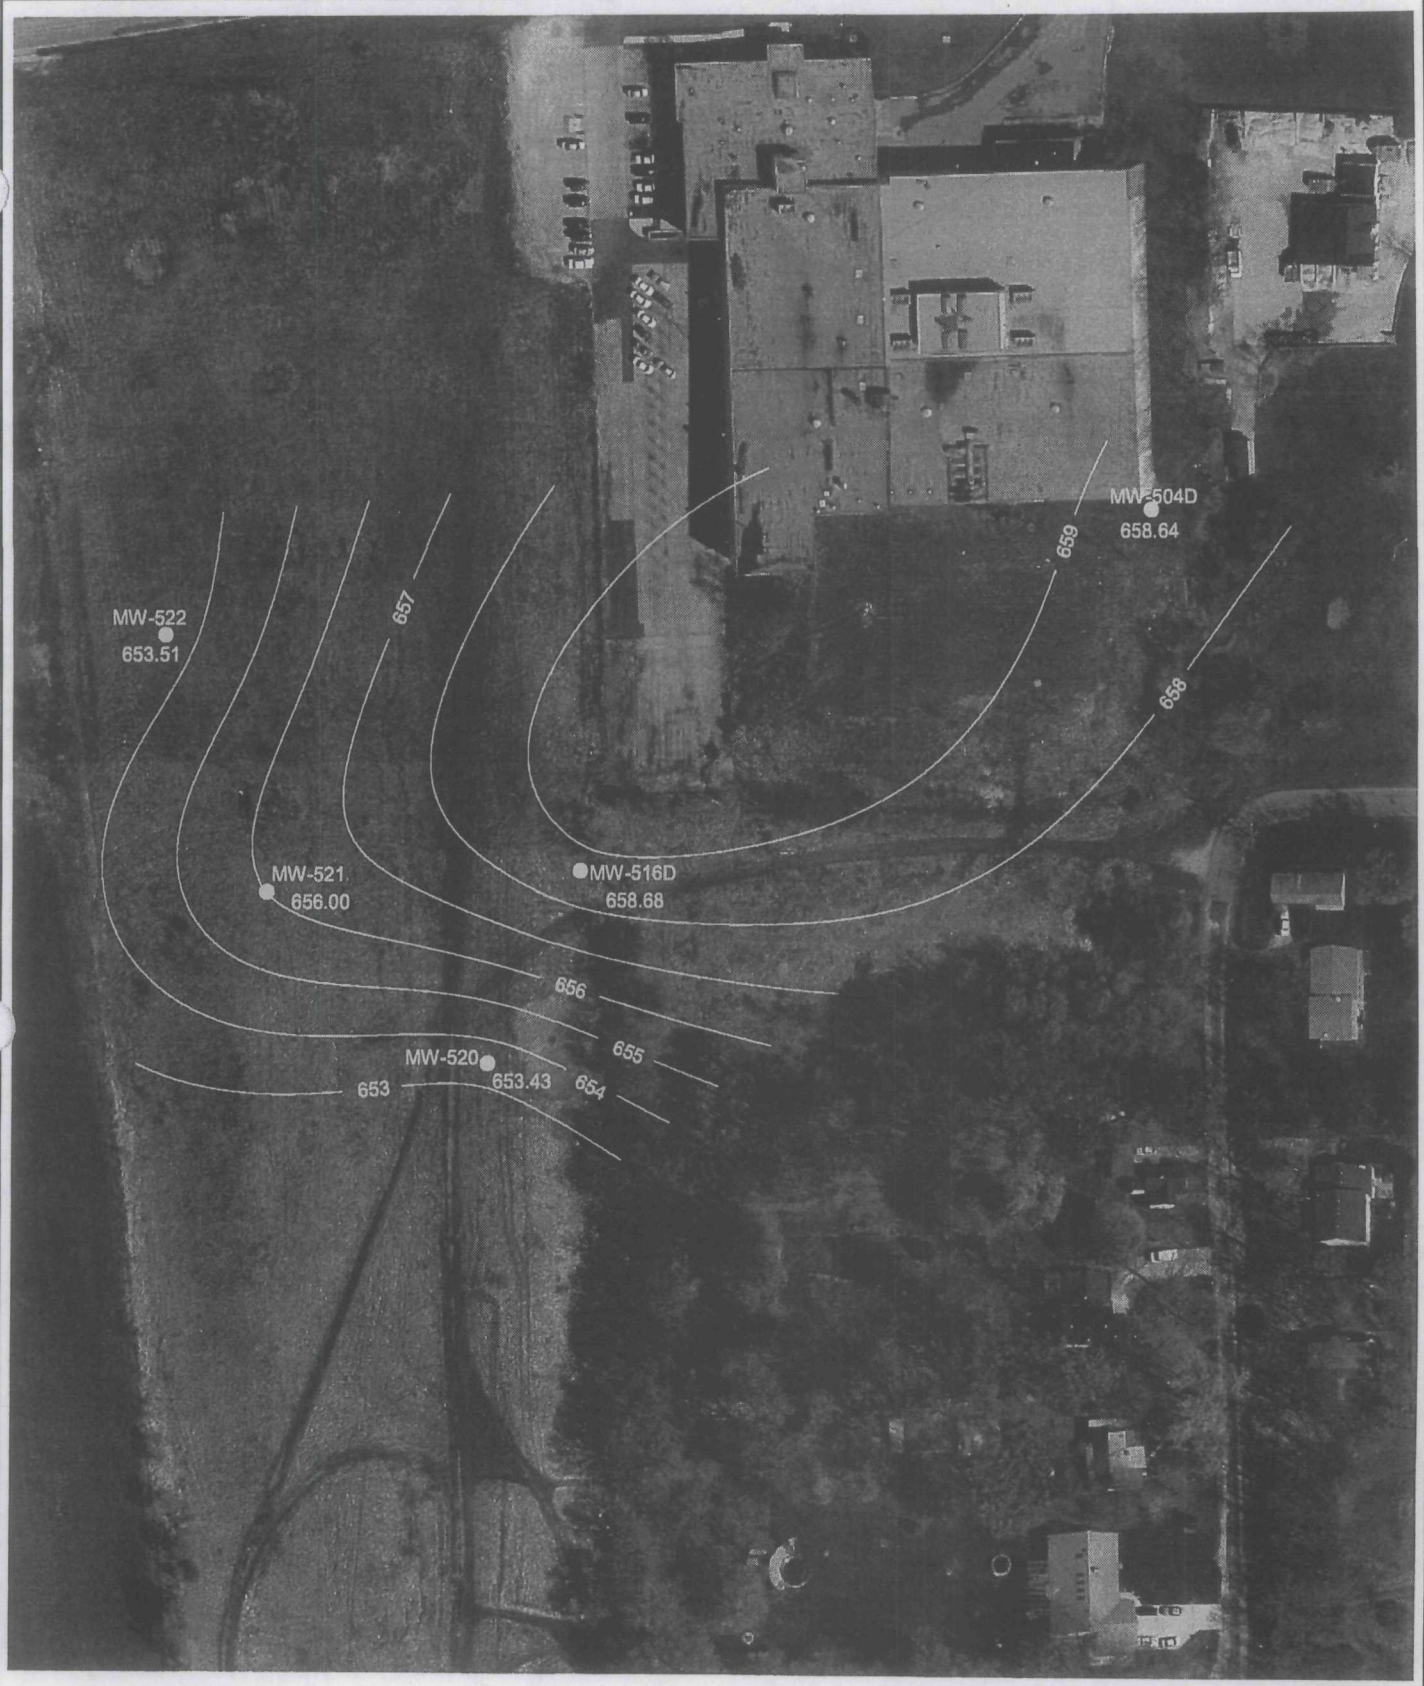
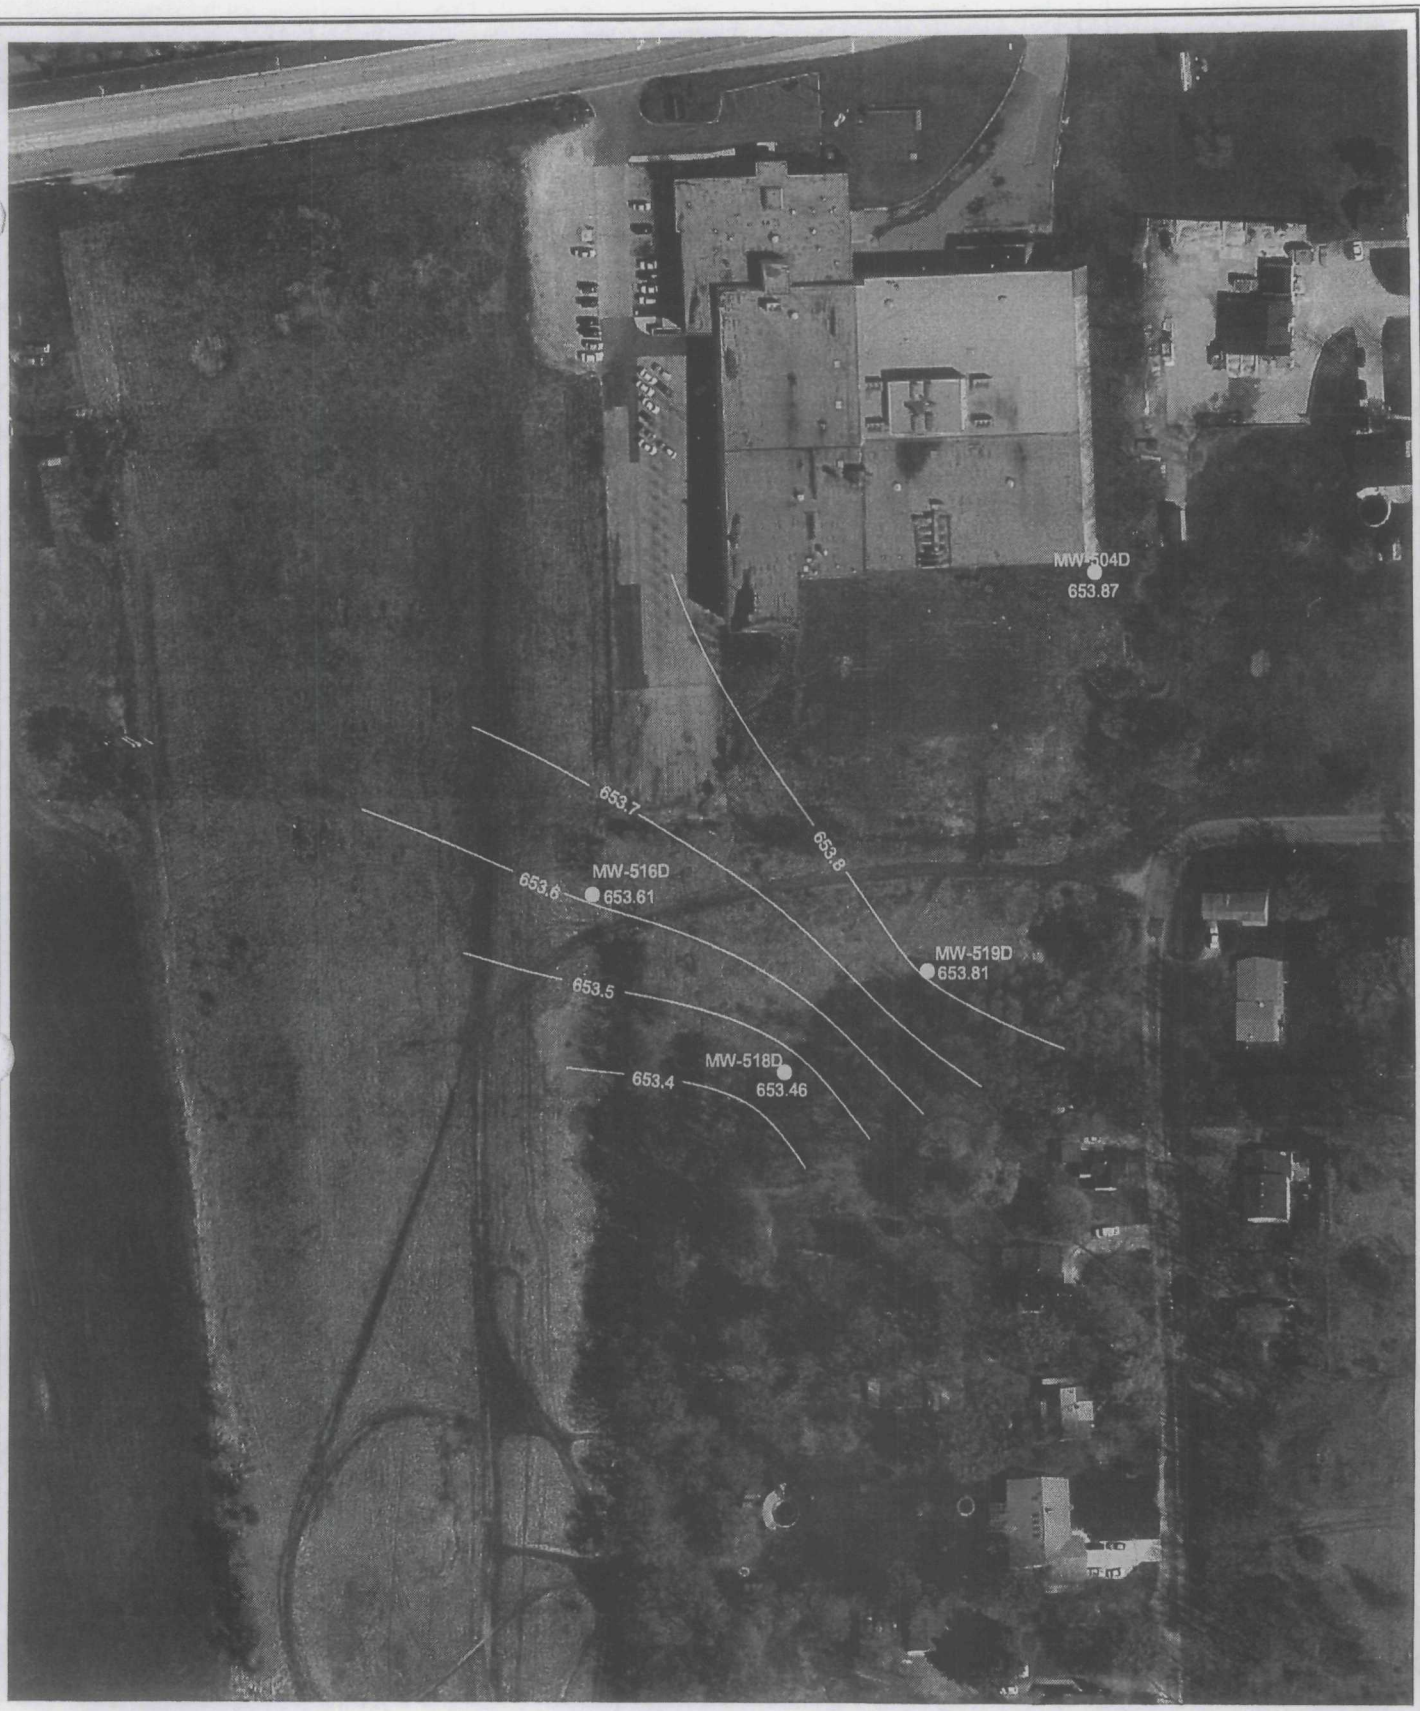
The observations outlined above provided the basis for developing potentiometric surface maps of the groundwater occurrence in the glaciofluvial sediments. Potentiometric surface maps from static water level measurements taken in November 2000, December 2000, and January 2001 appear as Figures 10, 11, and 12, respectively. Additionally, Figure 13 presents groundwater contours for the glaciofluvial sediments that reflect the approximate hydrostatic head measurements from the wells installed as of December 1999. Analysis of the static water level measurements from this date allows the inclusion of monitoring wells MW-518 and MW-519 that were subsequently abandoned due to development on the south side of the east parcel.

Collectively, Figures 10, 11, 12, and 13 indicate that groundwater in the glaciofluvial sediments at the site flows to the west, southwest, and south. On two of the three measurement dates unexpectedly elevated hydrostatic levels have been observed in monitoring well MW-521. The well screen from this well is partially completed in the Silurian dolomite. The database for the site is currently insufficient to determine if water levels in the Silurian dolomite fluctuate independently from the glaciofluvial sediments at the site.
