Monthly Oversight Report 43
ACS NPL Site
Griffith, Indiana
June 25, 2004 - July 30, 2004

USEPA/RAC VII
American Chemical Services RAO (057-ROBF-05J7)

Subject: Monthly Oversight Summary Report No. 43 for July 2004

Monthly Oversight Summary Report No. 43
ACS Superfund Site WA57, 46526.238

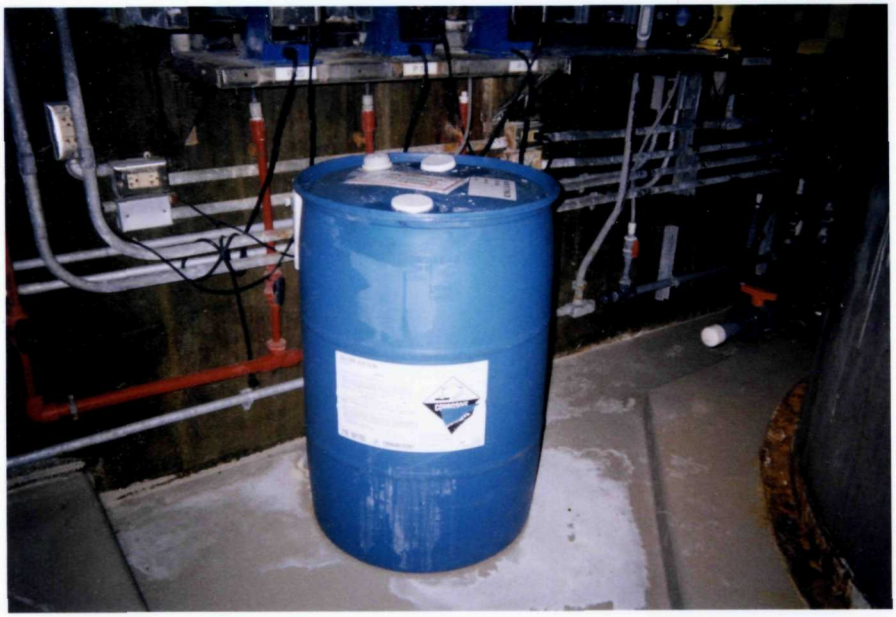
1532 Photo 61-6 looking NW into acid tank secondary containment. Note white marks on wall indicating level of diluted acid when it leaked.

Site: American Chemical Service, Inc.
Proj. #: 46526
Roll: 61 Photo #6
Date: 07-15-04 Time: 1532
Photographer: Larry Campbell
Description: Photo facing northwest into secondary containment for sulfuric acid tank. Leaking tank has been removed.
