US EPA RECORDS CENTER REGION 5
481463

OWNER: Village of Arlington Heights, Illinois	SCALE: None	SITE: Nichols and Schaeffer Roads, Cook County, Illinois
ARCHITECT - ENGINEER: Novak, Dempsey & Associates, Inc. Quality Control Consultants, Des Plaines, Illinois	BY: vaw	PROJECT NAME: Proposed Sanitary Land Fill

Arlington Heights
Municipal Landfill

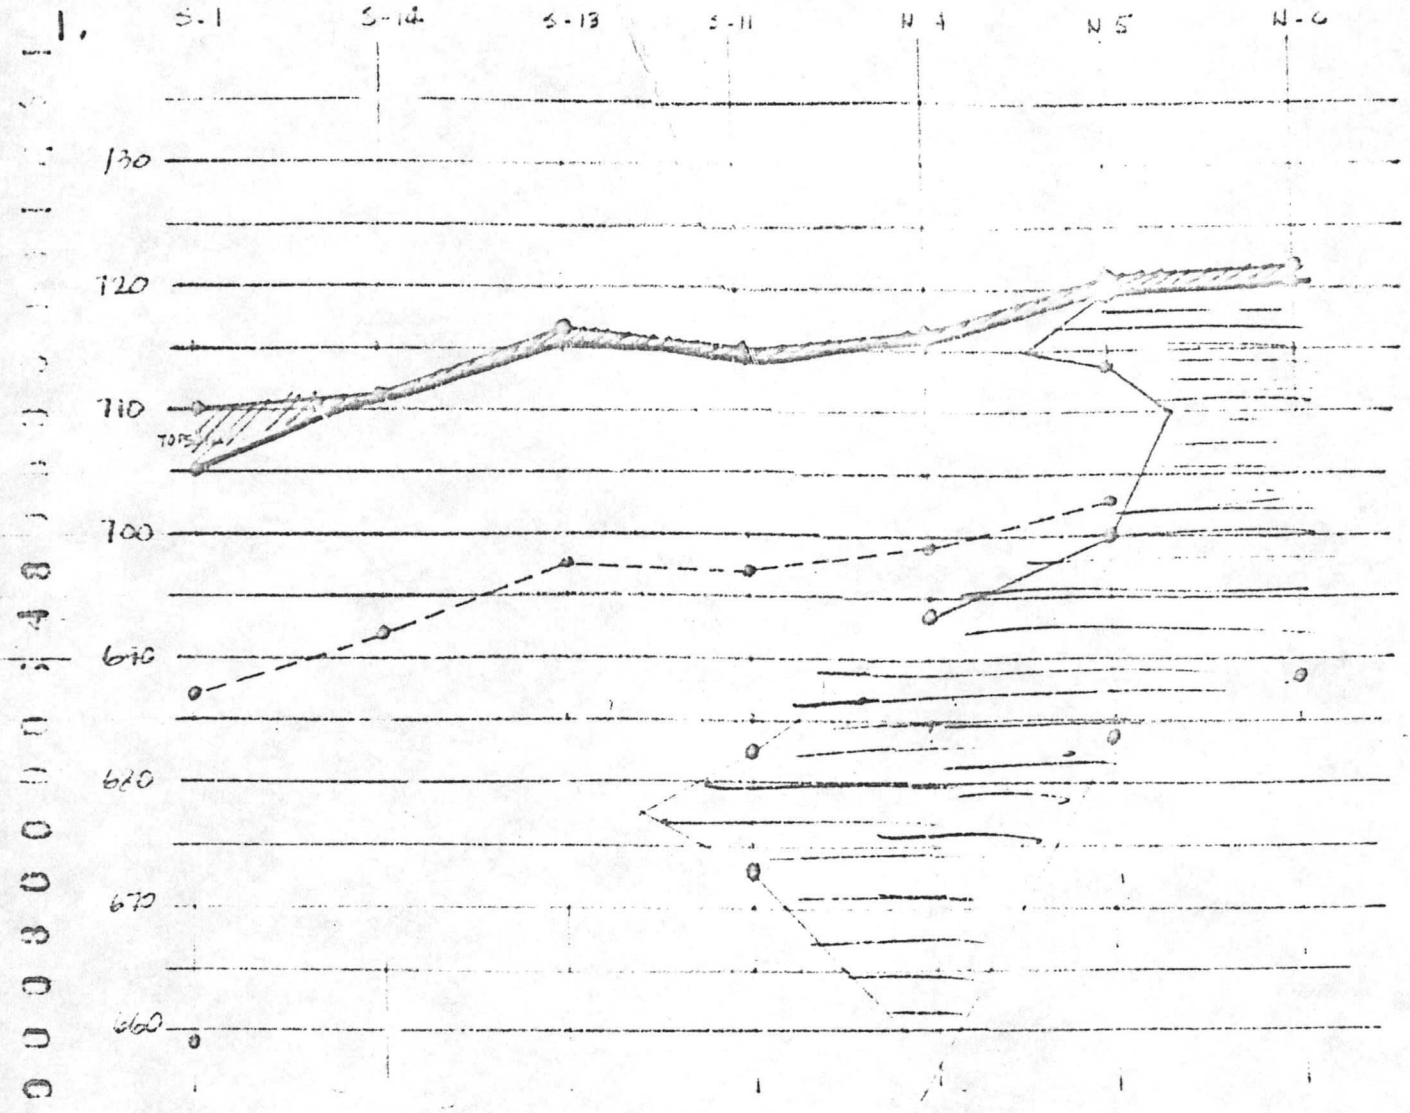
1.

2. ELEVATION OF BELOW SURFACE @ BORING S-11 IS SHOWN AS 721.3 ON THE "SOIL BORING LOG". THE MAP SHOWS S-11 @ ELEV. 717 ±.
