Re: Remediation System Installation and Third Quarter 2000 Performance Report
Avery Landing Recovery System
J-2296-07

J-2296-07 12/00

Figure 1

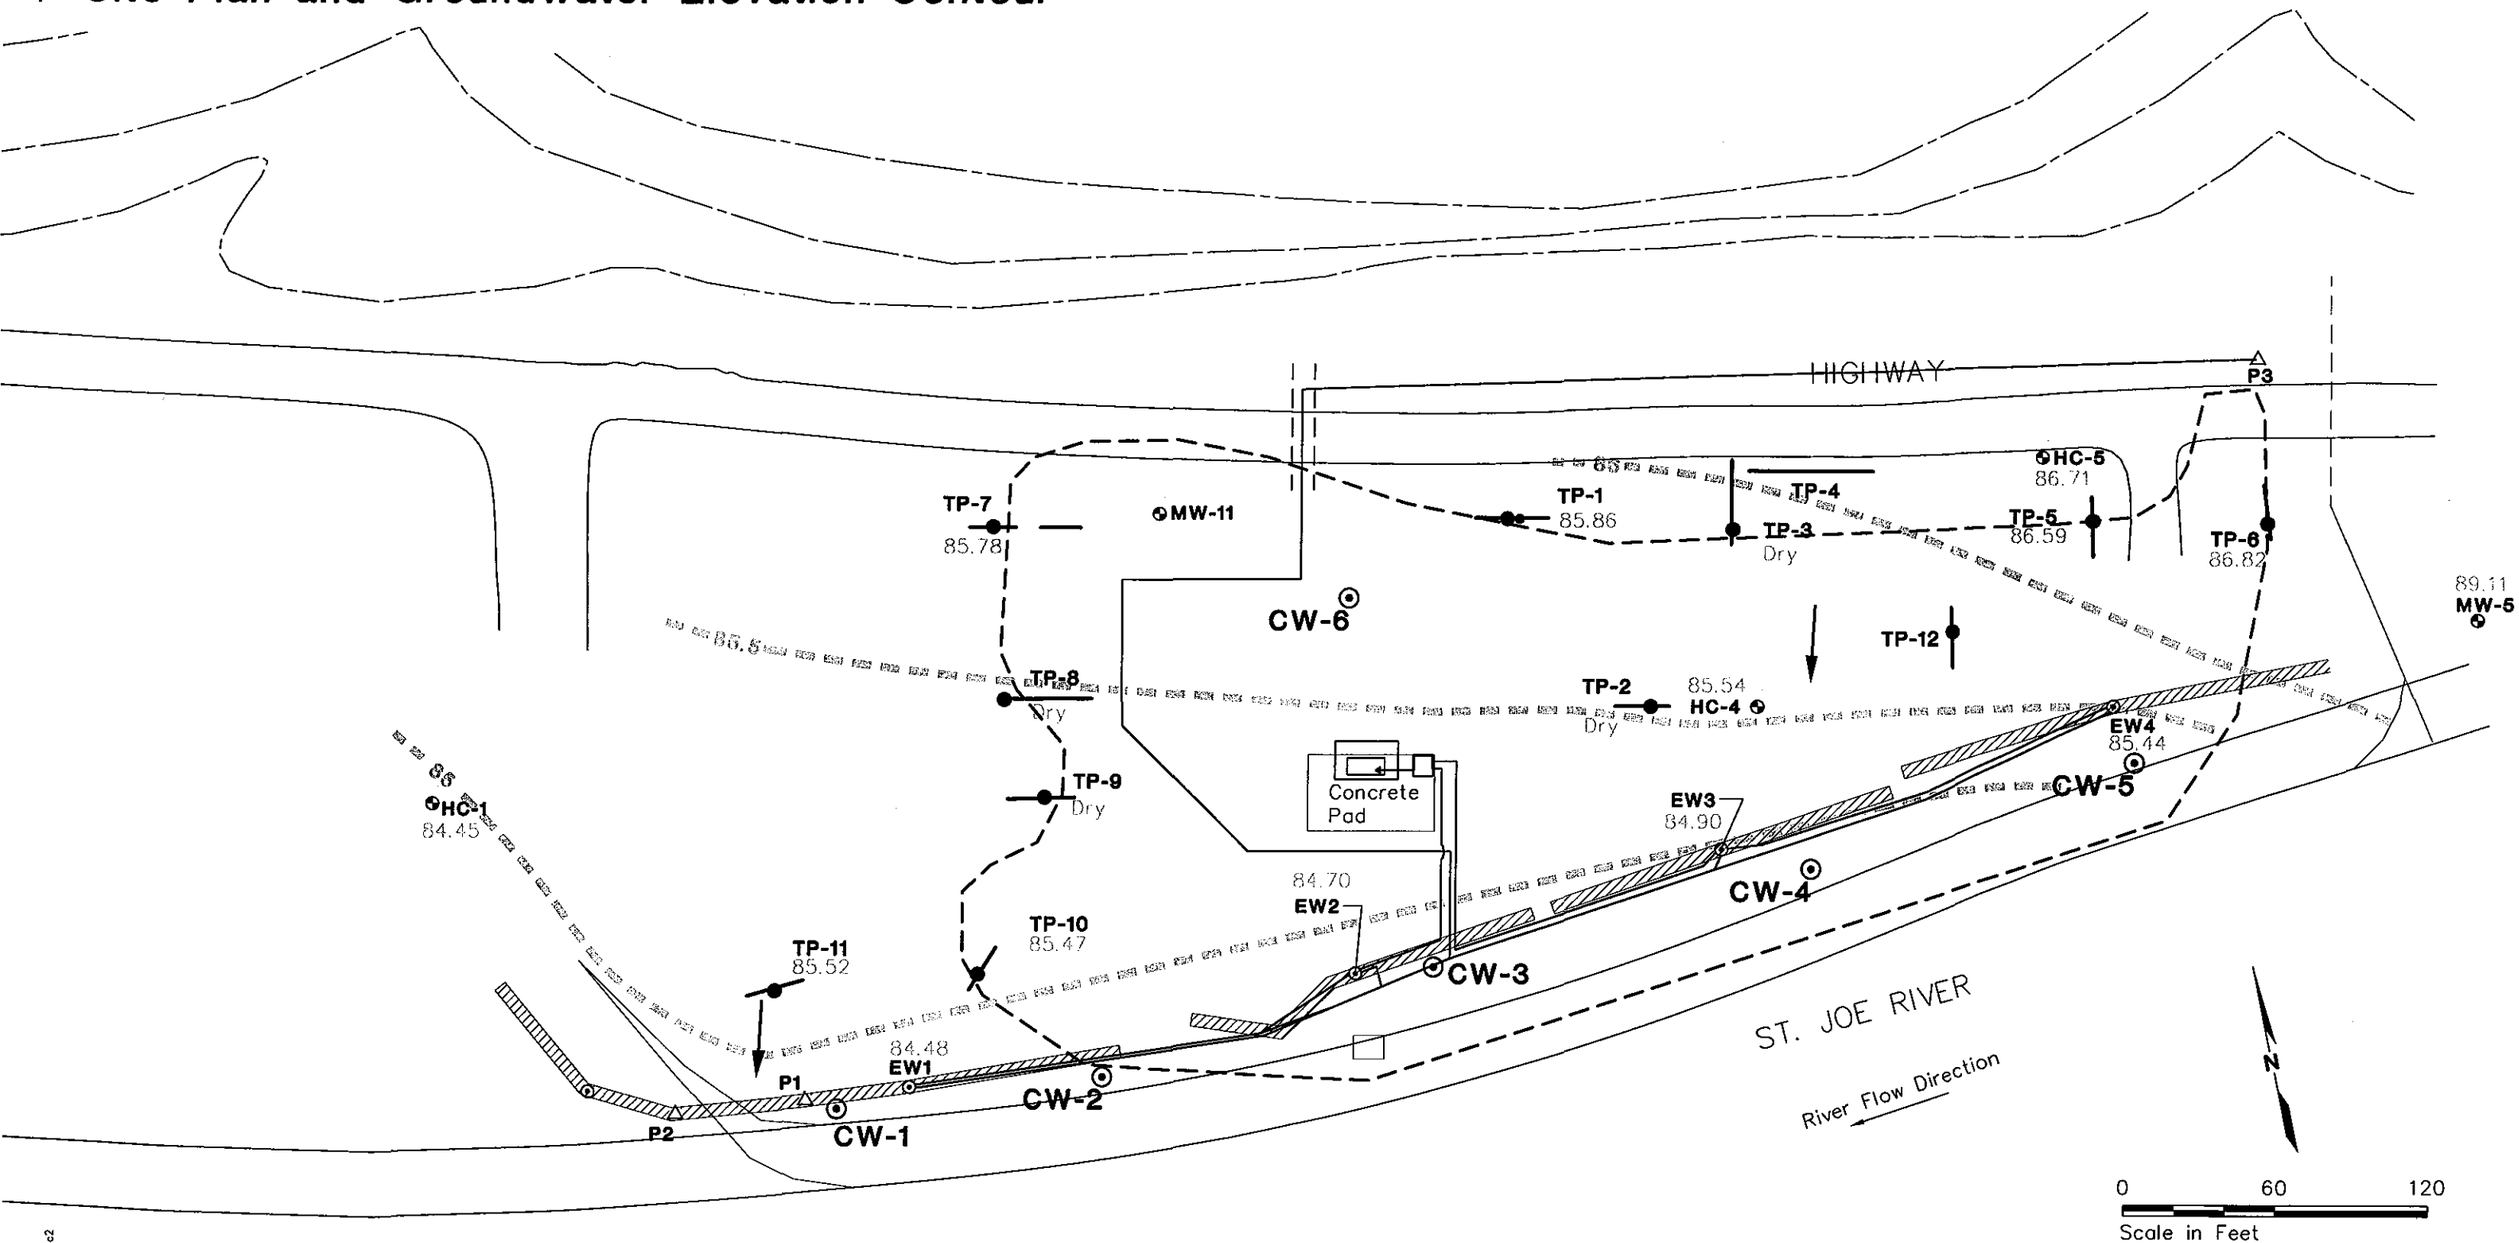
The containment wall and six product collection wells were installed in September and October 2000. Slotted monitoring well casings were installed in the collection wells for free product and groundwater elevation measurement, as well as free product recovery. Figure 1 depicts the location of the containment wall and collection wells. Test pit wells installed during the site characterization are also depicted on Figure 1.

Twelve test pit wells (TP-1 through TP-12), two monitoring wells (HC-4 and HC-5), and five collection wells (CW-1 through CW-5) were monitored on September 21, 2000, prior to the installation of the containment wall. Well, piezometer, and test pit locations are shown on Figure 1. At each monitoring location, depth to product and depth to groundwater measurements were performed using a Solinist, a free-product measuring device. River elevations were not measured because of the presence of the temporary cofferdam placed for the containment wall installation.
