Pioneer Construction
9/3/86

USEPA SF
1316396

Pioneer Construction
Materials Company

Project Code : CDE-013C
Account Code : CDE-XOA

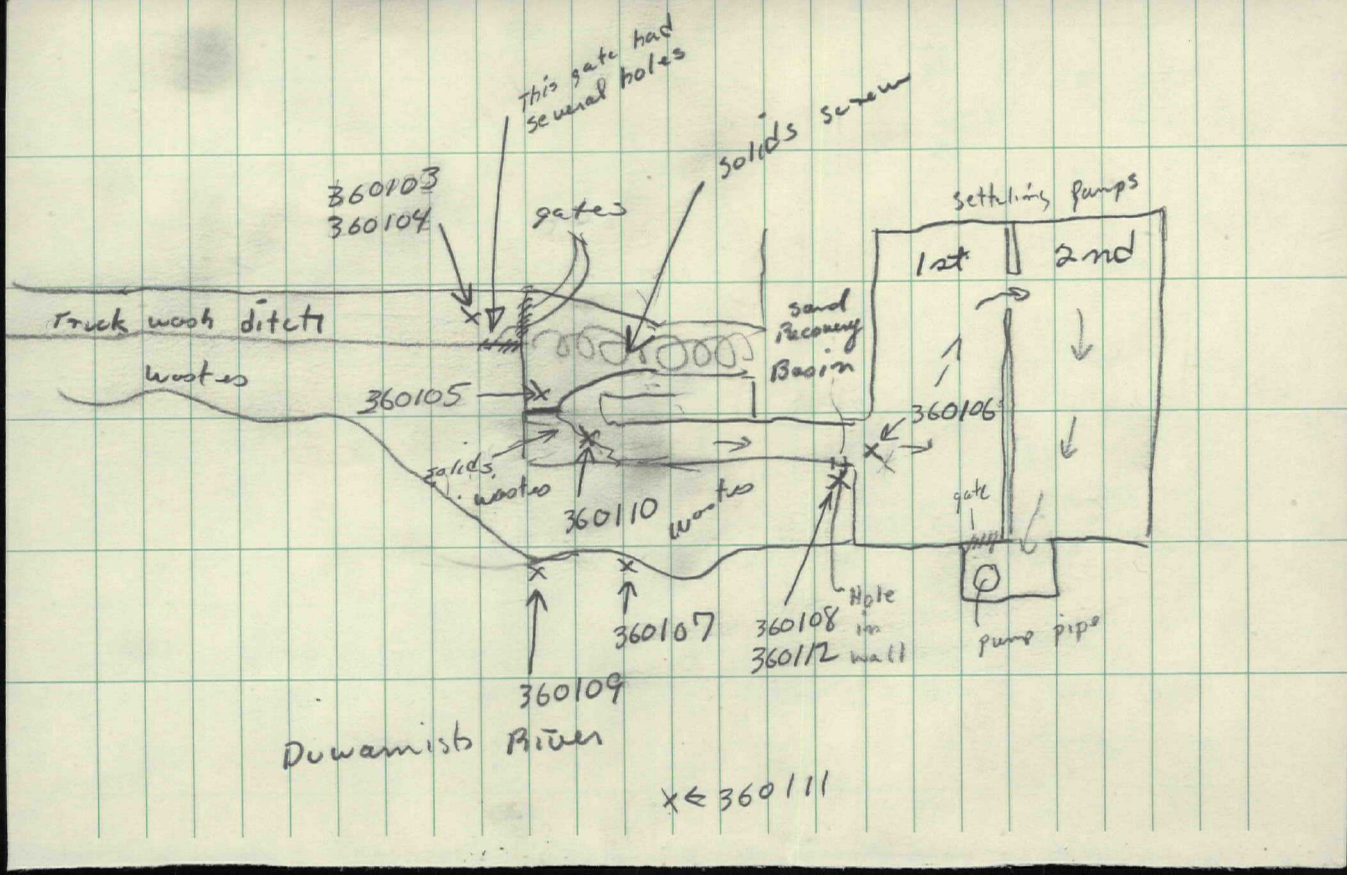
This gate had several holes
solids screw
360103
360104
gates
settling pumps
1st
2nd
Truck wash ditch
wastes
sand Recovery Basin
360105
360106
solids
wastes
360110
wastes
gate
360107
360108
360112
Hole in wall
pump pipe
360109
Duwamish River
360111
