Kitsap County Health
Grant Holdcroft Logbook Notes
for Kitsap Mystery Oil (Bremerton Gasworks Site)

BGWSF
1.5

Thompson Oil 9/24/2010

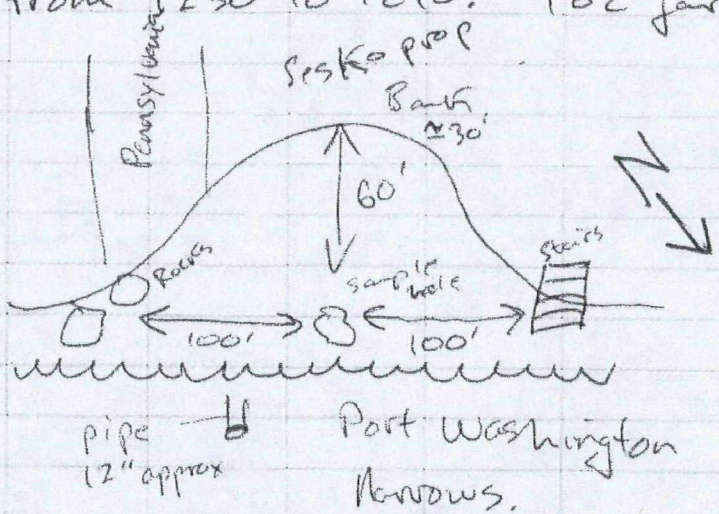
- Spots visible on beach. Hydrocarbon sheen. Sampled hole in beach dug w/ standard long handled shovel. mix of oil, sand, and water. Photos taken. Multiple holes dug to locate limits hydrocarbons in one spot only. Oil approximately 1-2" down in beach sediment. Gravel at 6-8". GPS hole position.. Moved stake to hole. Sampling from 1230 to 1240. 4oz jar.

Dug hole 2' in diameter -
