DAM INSPECTION CHECKLIST
POSSUM POINT POWER STATION
POND ABC

INSPECTION DATE: 5/13/15

INSPECTED BY: D. West, K. Homza

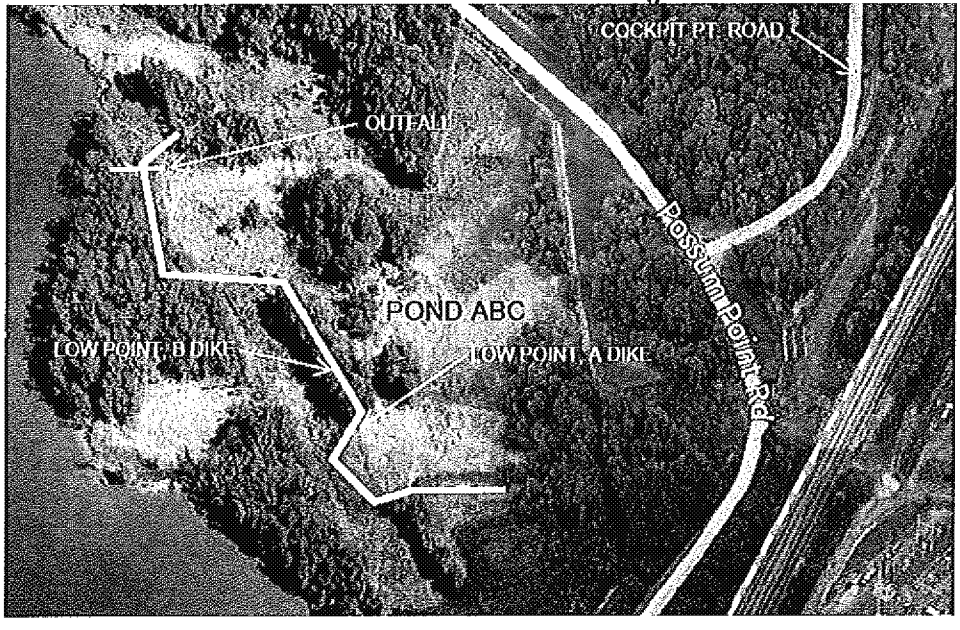
* See figure below.

Location/ Condition	(y/n)	Change (y/n)	Comments
Low Point, A dike*			
Flow	N	N	0810 hrs. Standing water along perimeter of pond
Erosion	N	N	near road. Standing water behind sandbags. No flow or seep under sandbags.
Low Point, B dike*			
Flow	N	N	0815 hrs. No standing water. Sand bags and
Erosion	N	N	rip rap in place.
Outfall water surface El. (top of stoplogs to water)			0817 hrs. Standing water behind sandbags. Standing water behind concrete weir structure. No flow or seep at the discharge pipe. 44½".
