DAM INSPECTION CHECKLIST
POSSUM POINT POWER STATION
POND ABC

INSPECTION DATE: FEB 17, 2016

INSPECTED BY: K. ACREE

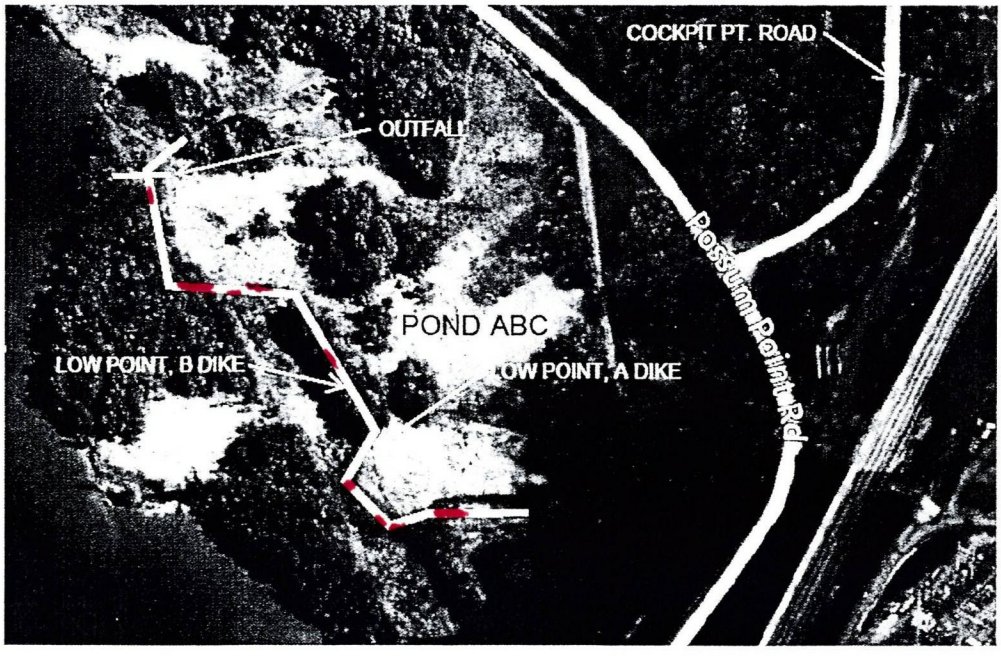
-> SOME WATER AT TOE OF POND A EMBANKMENT (TYPICAL OF PONDS B&C)

-> STANDING WATER AT TOP OF EMBANKMENT OF PONDS A, B AND C (SEE FIGURE BELOW, RED INDICATES STANDING WATER)
