DAM INSPECTION CHECKLIST
POSSUM POINT POWER STATION
POND ABC

INSPECTION DATE: FEB. 26, 2016

INSPECTED BY: K. AGEE

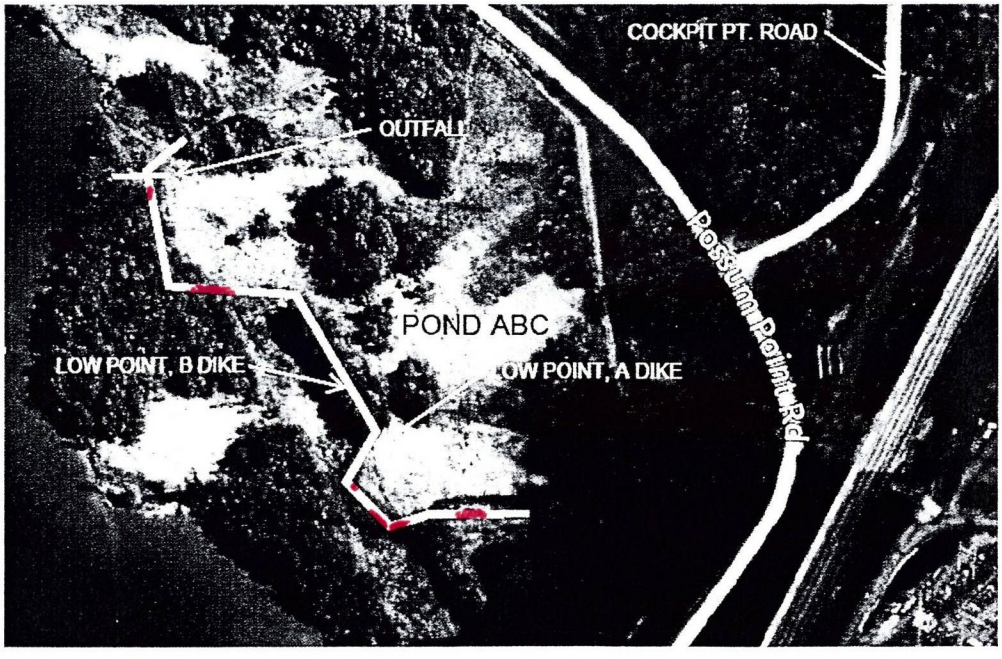
* See figure below.

Location/ Condition	(y/n)	Change (y/n)	Comments
Low Point, A dike*			
Flow	N	N	1012 → SAND BAGS + RIPRAP IN PLACE, AND NO STANDING WATER AGAINST SAND BAGS
Erosion	N	N	SEVERAL SAND BAGS RIPPED
Low Point, B dike*			
Flow	N	N	1015 → SAND BAGS IN PLACE AND NO STANDING WATER AGAINST SAND BAGS
Erosion	N	N	SEVERAL SAND BAGS ARE RIPPED
Outfall water surface El. (top of stoplogs to water)			1022 → NO STANDING WATER AGAINST WIER, WIER APPEARS TO BE DRY, NO FLOW THROUGH WIER.

Additional Comments (Note any changes observed along the embankment crest or downstream slope observed from the crest.): LOW POINT, C DIKE → 1020 → SAND BAGS IN PLACE, SEVERAL SAND BAGS RIPPED, AND NO STANDING WATER AGAINST SAND BAGS
- STANDING WATER AT TOP OF PONDS EMBANKMENTS (AS NOTED ON FIGURE BELOW)
- STANDING WATER, WITHIN POND LIMITS, AT TOE OF EMBANKMENT OF POND C. SOME WATER AT TOE OF EMBANKMENT FOR PONDS A+B AS WELL.
