DAM INSPECTION CHECKLIST
POSSUM POINT POWER STATION
POND ABC

INSPECTION DATE: 4-14-15

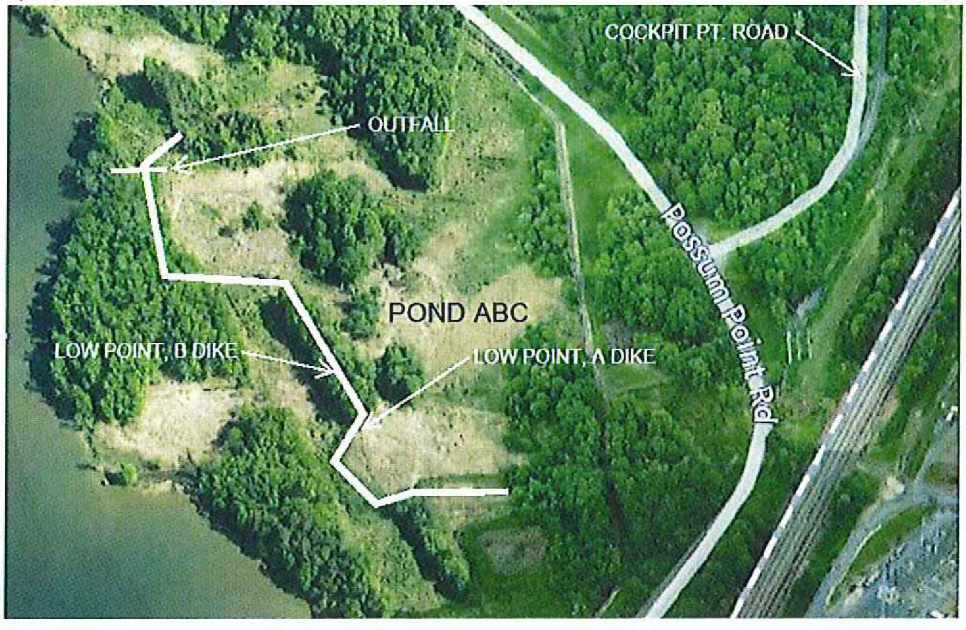
* See figure below.

Location/ Condition	(y/n)	Change (y/n)	Comments
Low Point, A dike*			
Flow	N	N	1056 hrs. Standing water along perimeter of road. Standing water behind sandbags and in road ruts. Standing water at base of A.L slope.
Erosion	N	N	
Low Point, B dike*			
Flow	N	N	1100 hrs. Sandbags and rip rap in place. No standing water.
Erosion	N	N	
Outfall water surface El. (top of stoplogs to water)			1104 hrs. 51" Standing water behind sandbags and concrete weir structure. water seeping into concrete weir structure. (DISCHARGE)
