RAILROAD COMMISSION OF TEXAS

SURFACE MINING AND RECLAMATION DIVISION

RE: Weesatche Project, Goliad County
Uranium Exploration Permit No. 123A
Inspection Report

RAILROAD COMMISSION OF TEXAS
SURFACE MINING AND RECLAMATION DIVISION
URANIUM EXPLORATION INSPECTION REPORT

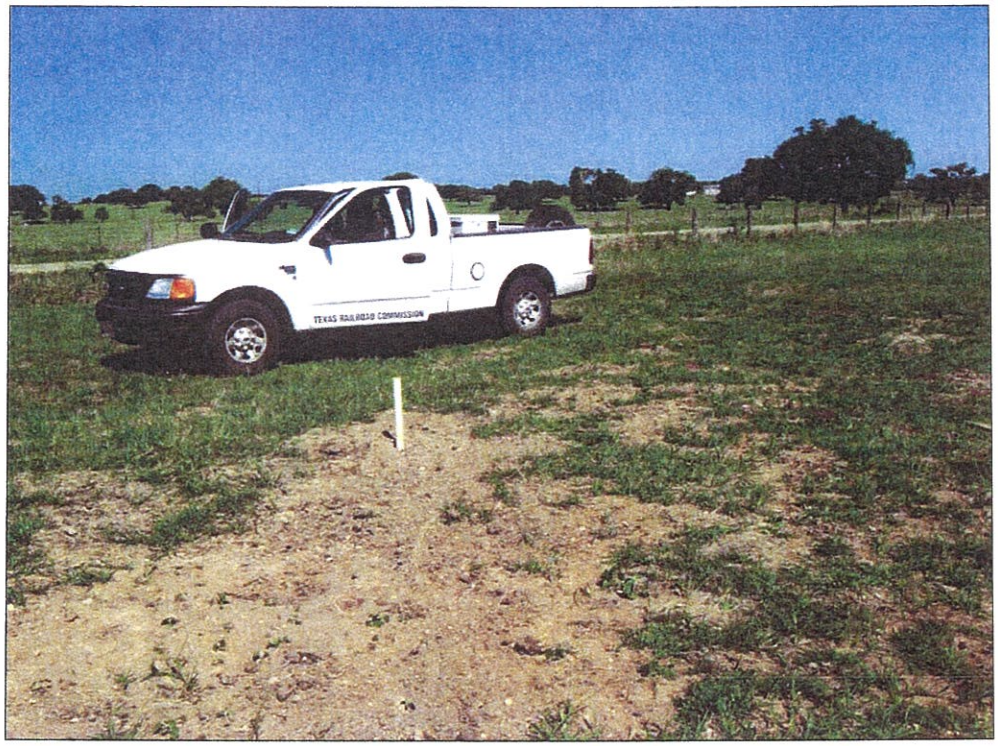
Photo 1: Drill site of borehole 32199-4 on Karnei Lease.

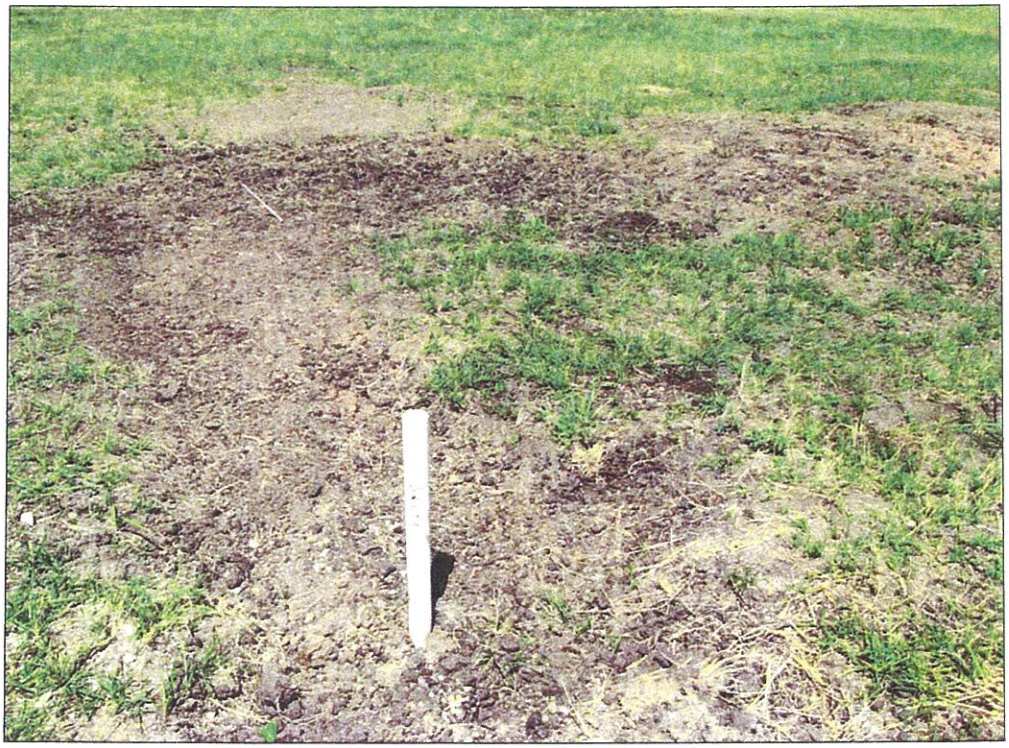
Photo 2: Borehole 32199-34.

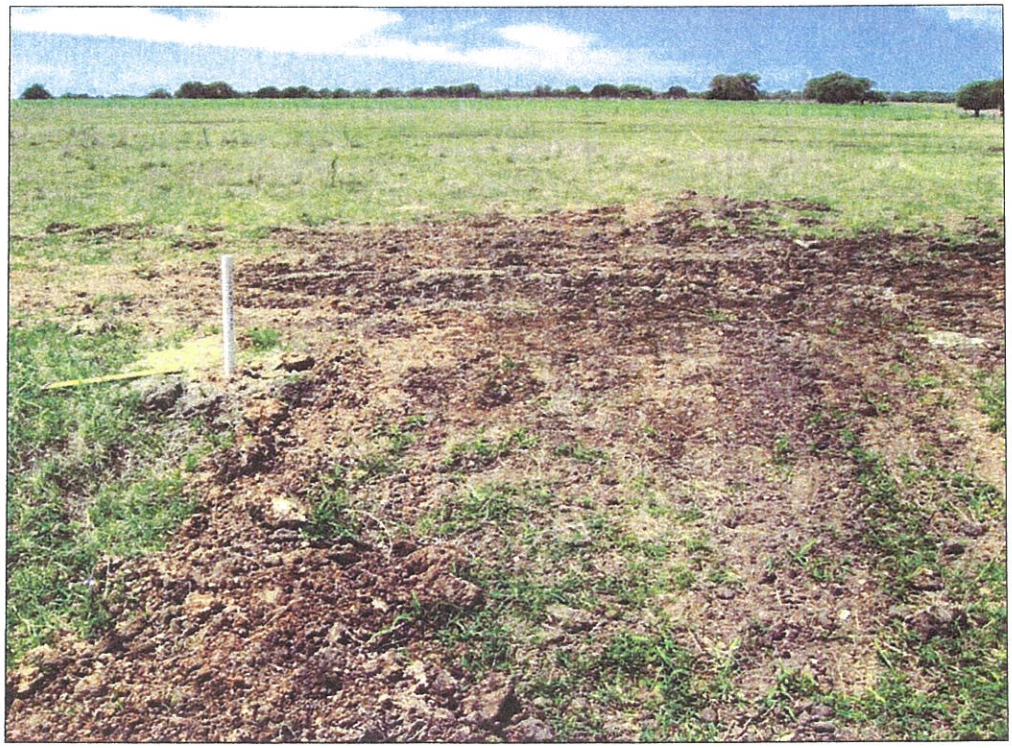
The portion of the Halapeska lease (#32206) inspected visible from Bluntzer Road, seen in photo 4 has been photographed previously included in the February 2008 inspection report. There are a dozen or so borehole locations barely visible in the background of photo 4. After borehole plugging and settling, UEC tops the plug with cement to three-feet below the surface, places a section of PVC pipe to facilitate the RCT's with verification of the plug and backfills the surface with soil as seen in photo 5. A comparison between recently restored drill sites and older restoration on the Halapeska property can be seen in photo's 6 and 7. The site restoration was still in progress on several locations like the borehole seen in Photo 8 that has been plugged, note metal probe, and only requires a final survey, top off, and placement of the marker to be completed. The coordinates and borehole identification for the 24 sites inspected and upon which all work was completed are given on page 4.

Photo 4: Borehole 32206-45 on Halapeska lease visible from Bluntzer Road.

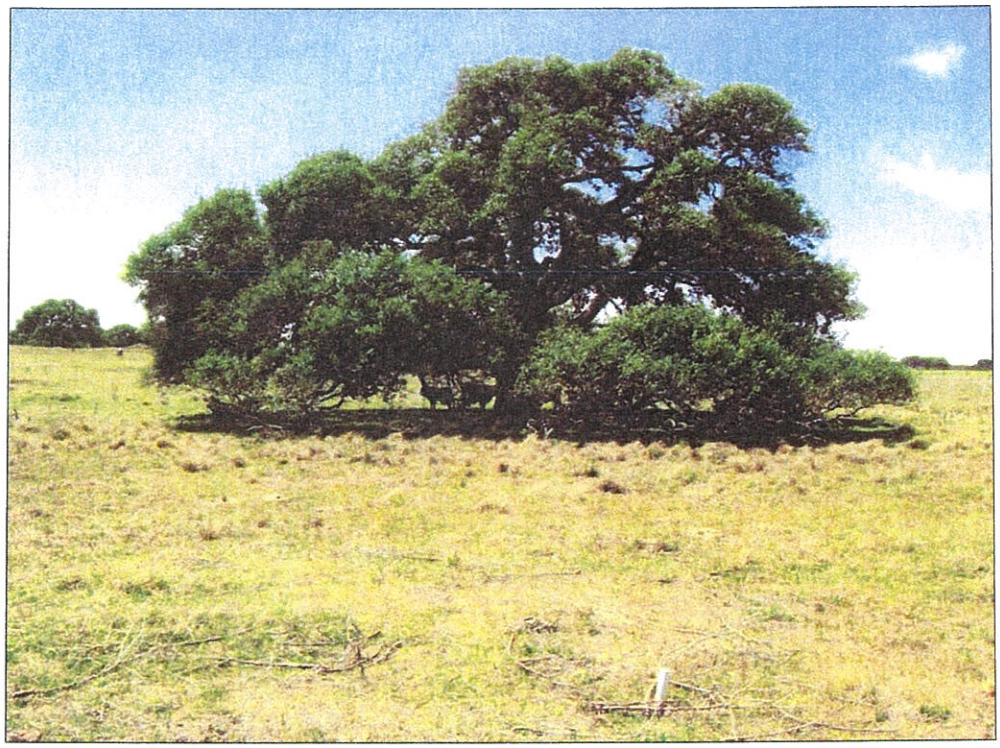
Photo 7: Site restoration at older drill location on Halapeska lease.

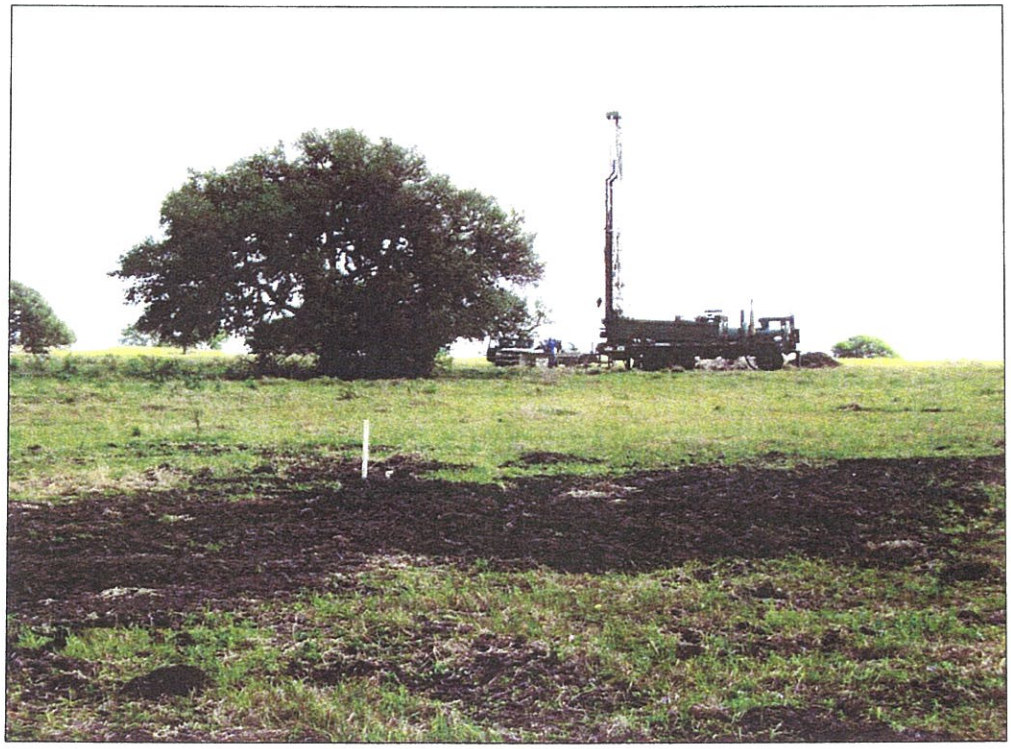
Activity also continues on the Schrade lease (#32002) where several rigs have been working. Plugging and site restoration was inspected and verified complete at the 12 locations reported on Page 5. Photo 9 documents the typical site restoration of the boreholes located in this area. Site restoration was observed in progress at the several borehole locations also examined; as well as the drilling operations at active rigs such as seen in Photo 10.

Photo 10: Current operations observed on Schrade lease.

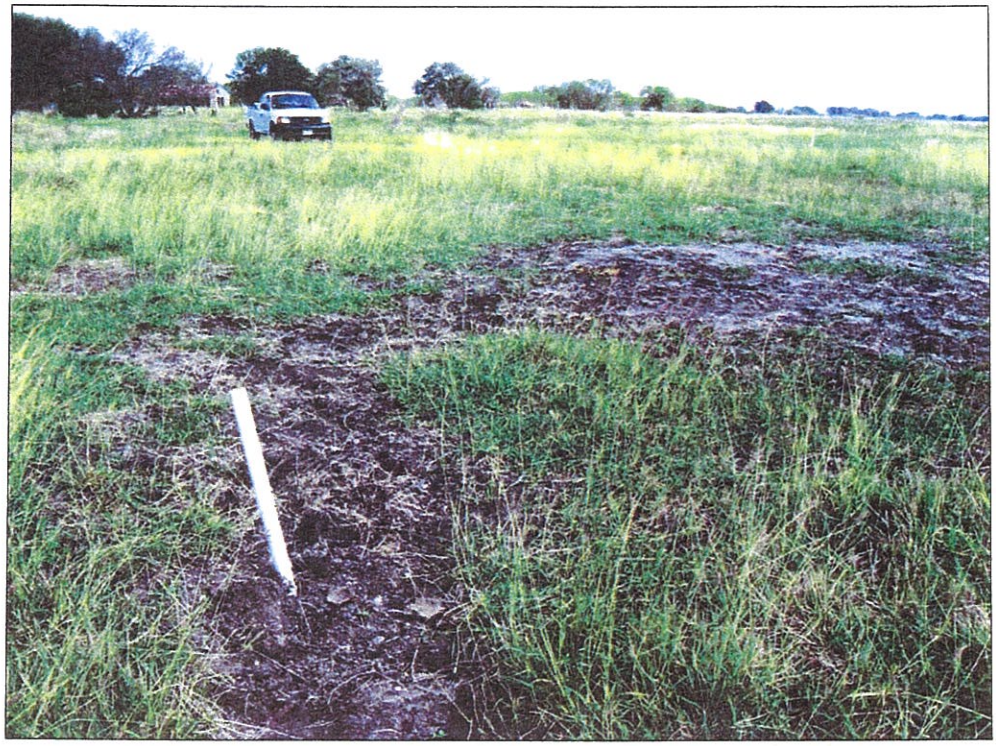
Photo 1: Borehole N-5 on South Schrade property.

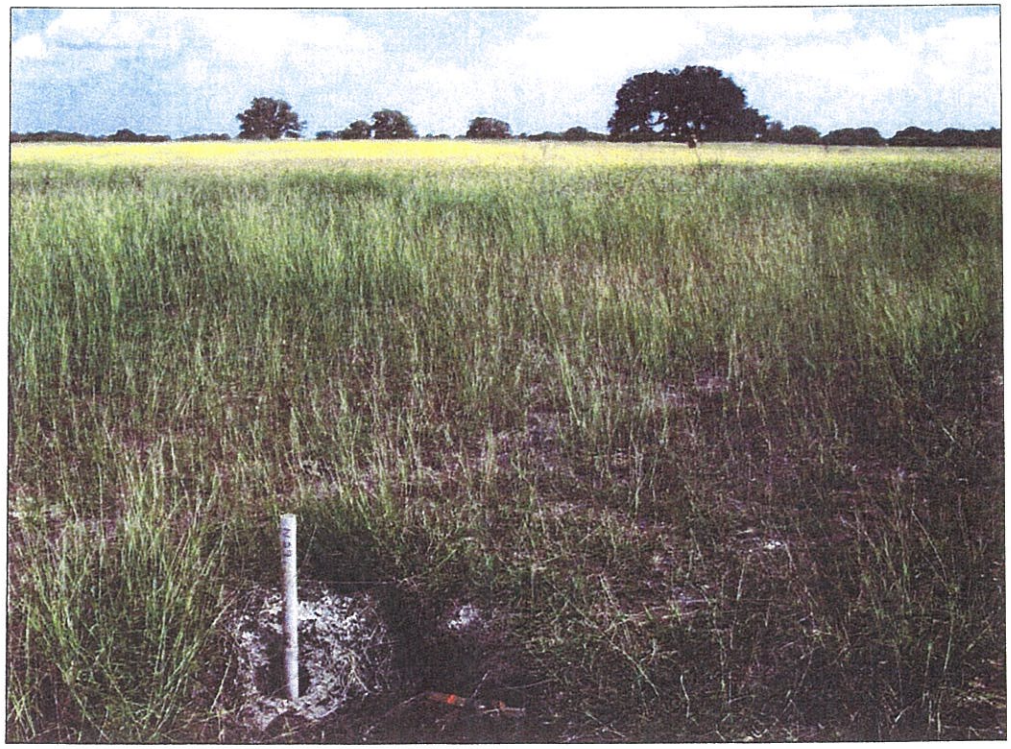
Photo 10: Borehole N-29 restoration in progress and requiring final top off.

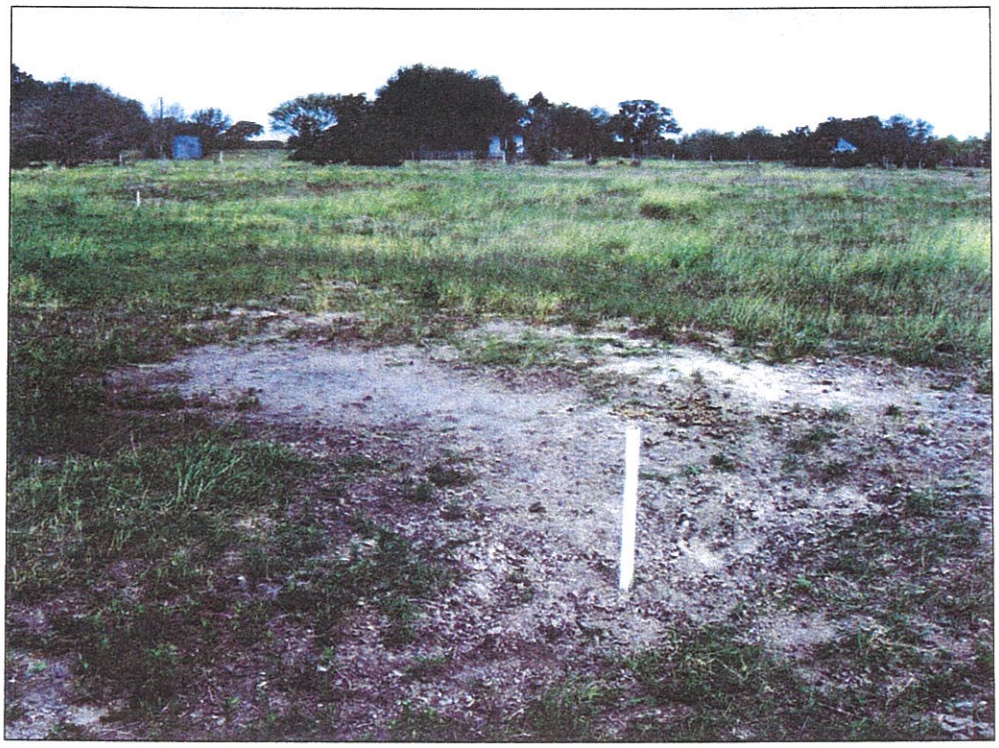
Photo 11: South Schrade drill location with old Braquet house in background.

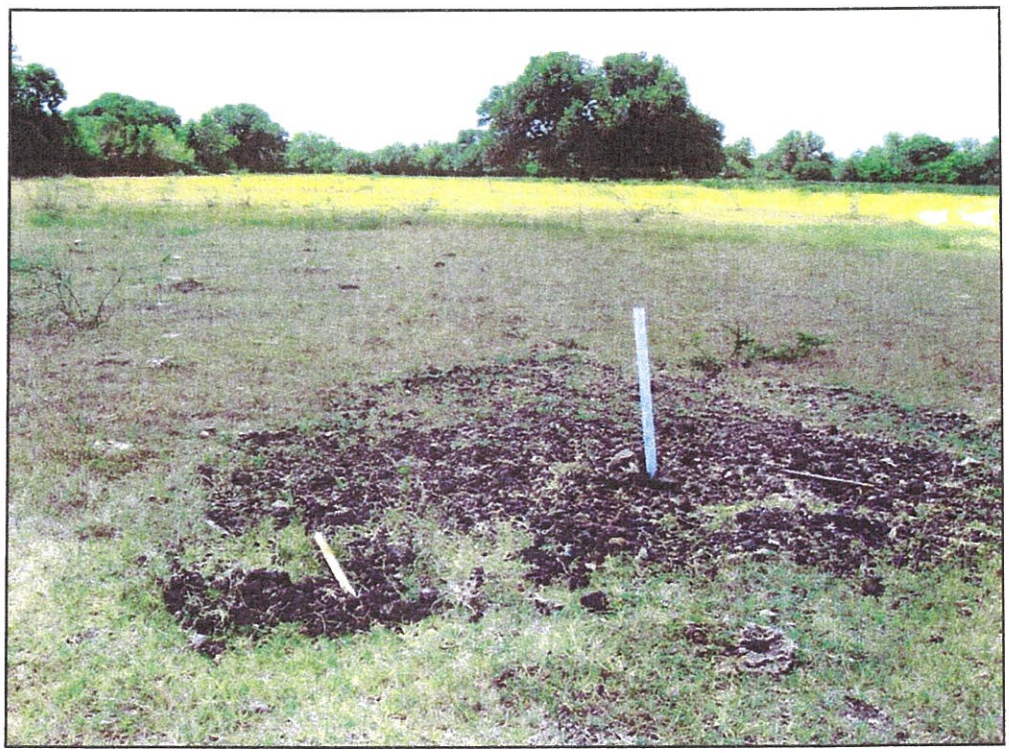
Photo 2: Borehole 93 on Abramite Lease 30892.

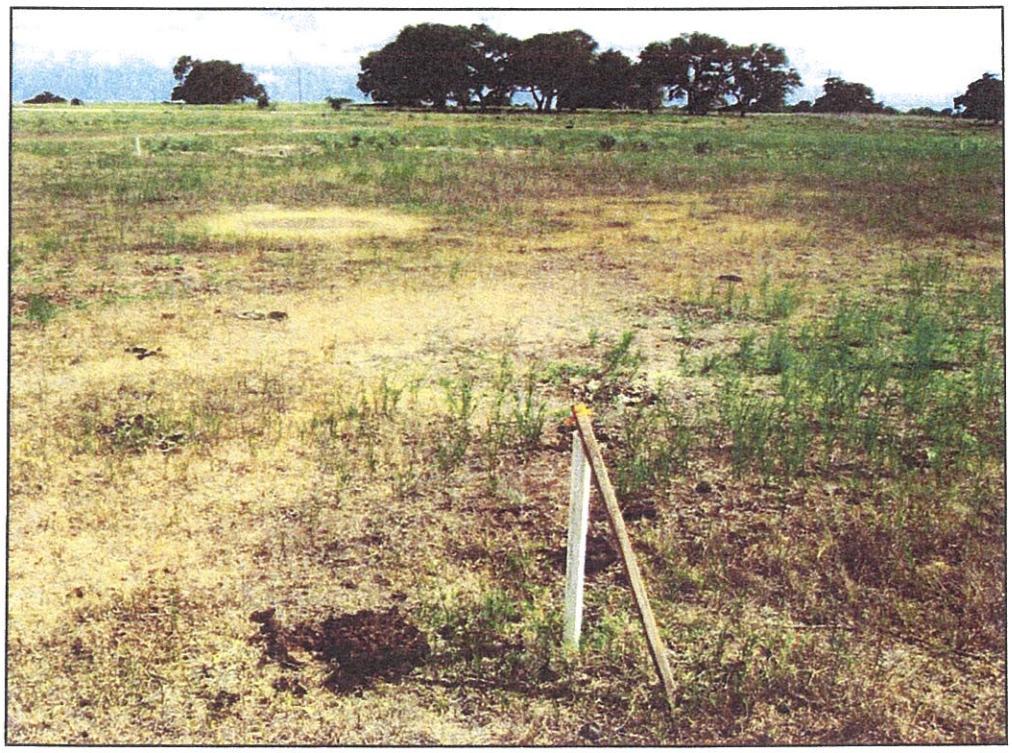
Photo 4: Borehole 205 on Schrade property.

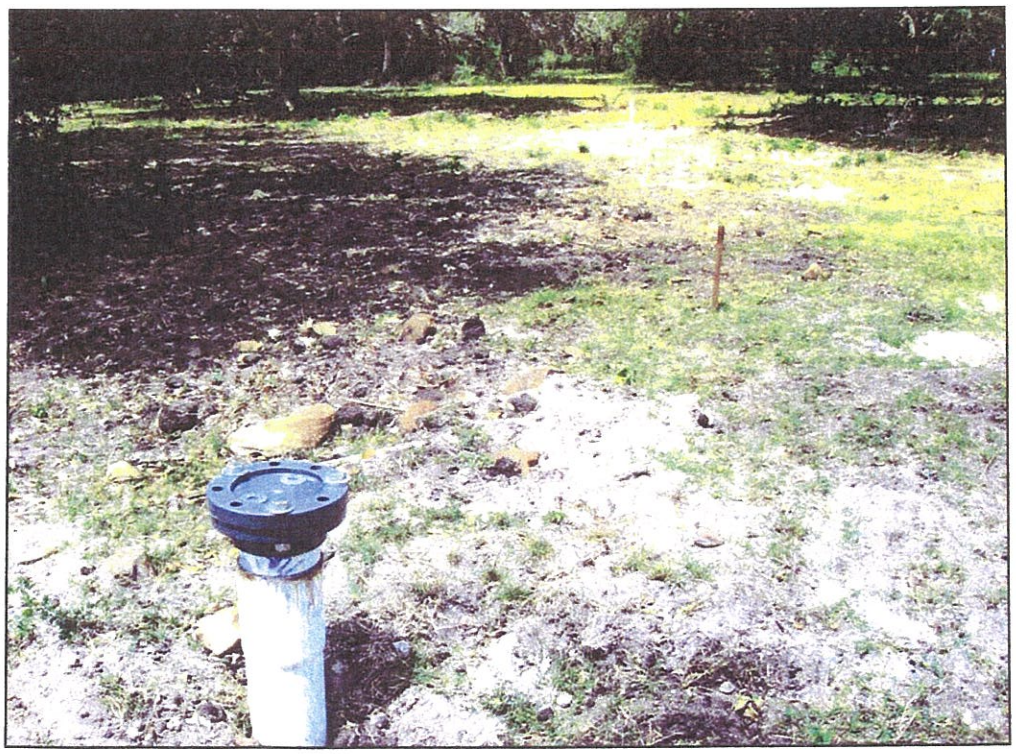
Photo 6: Capped monitor well RBLA4 on Abramite lease.

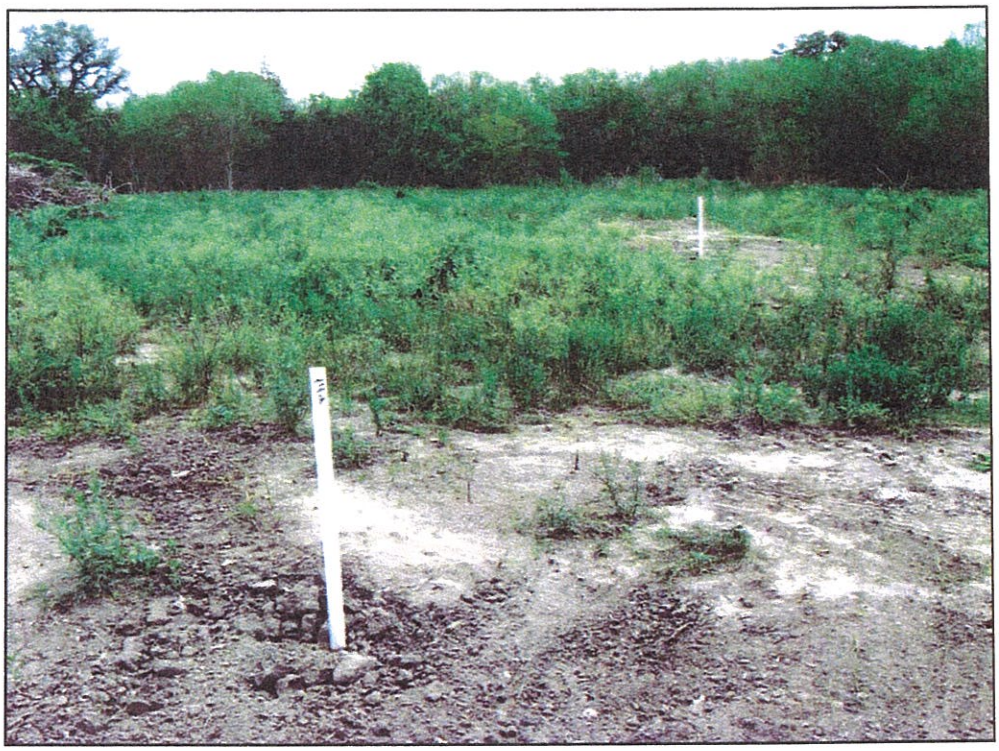
Photo 1: Borehole N142 site restoration.

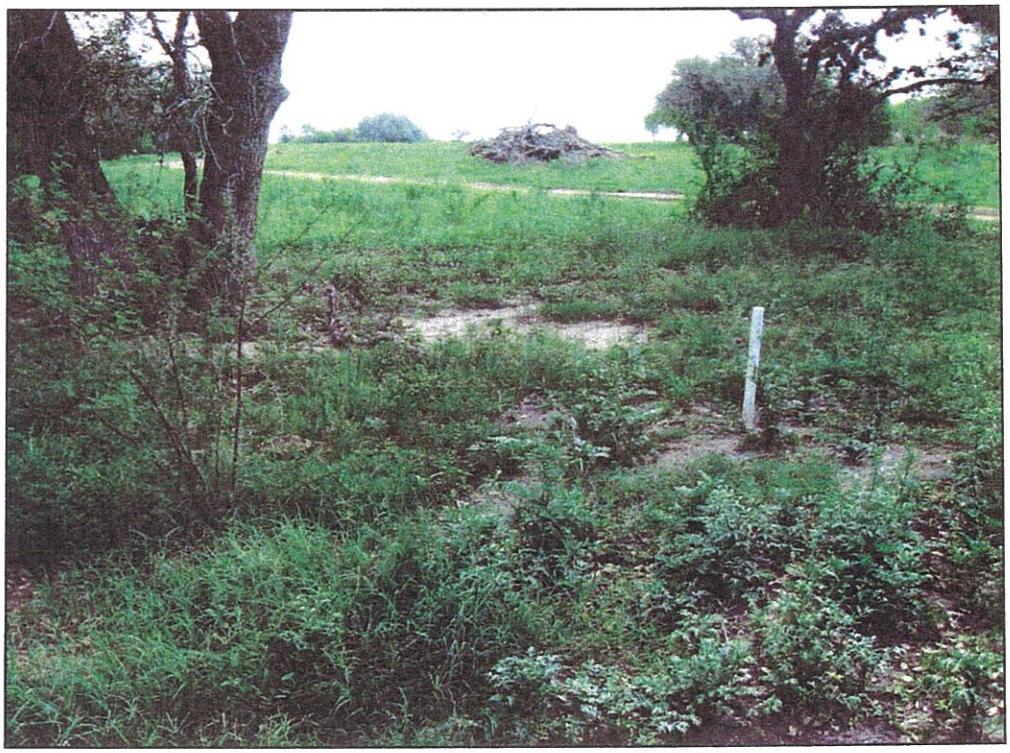
Photo 2: Re-vegetation at borehole N149.

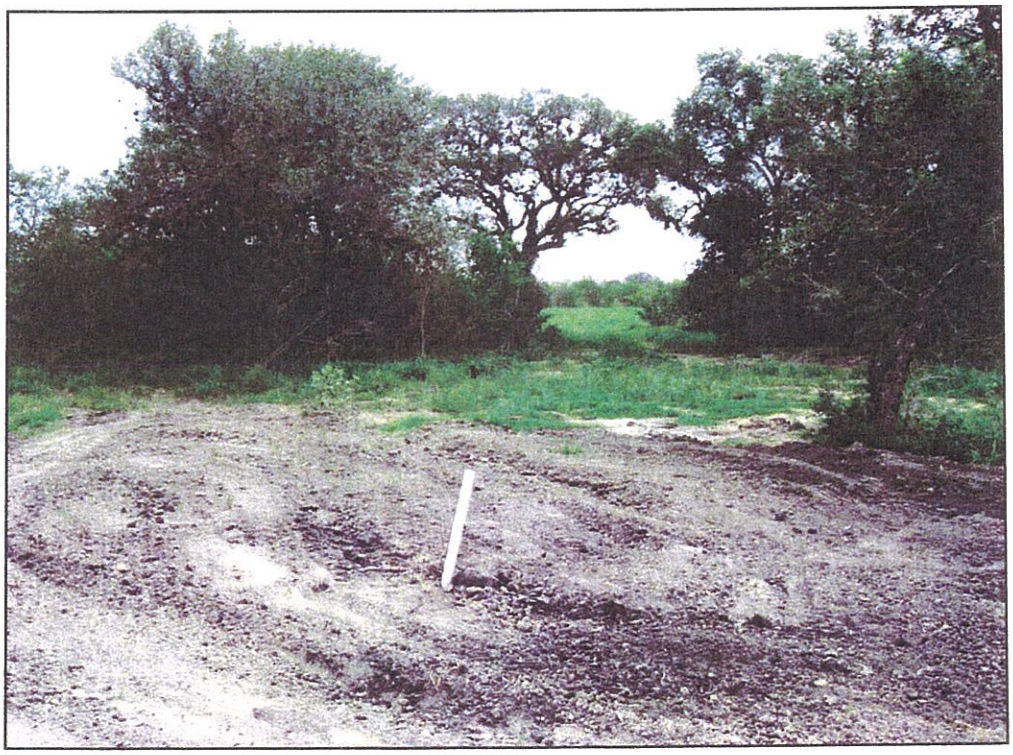
Photo 3: Borehole N185 site restoration.

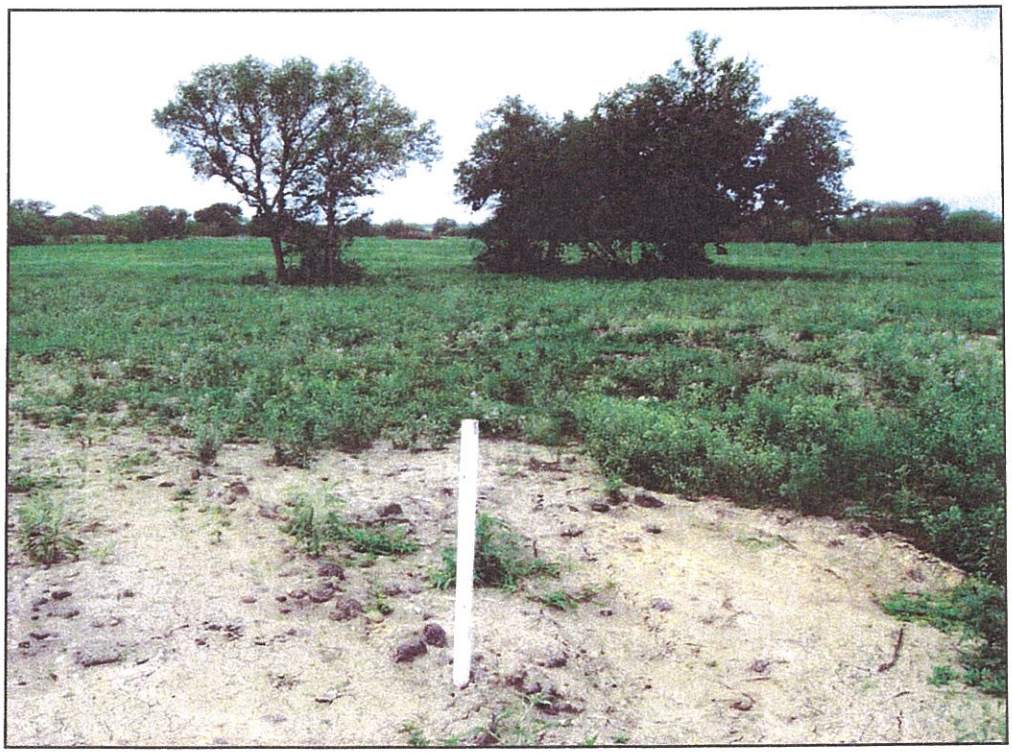
Photo7: Core hole CB1 with markers for other holes visible in background.

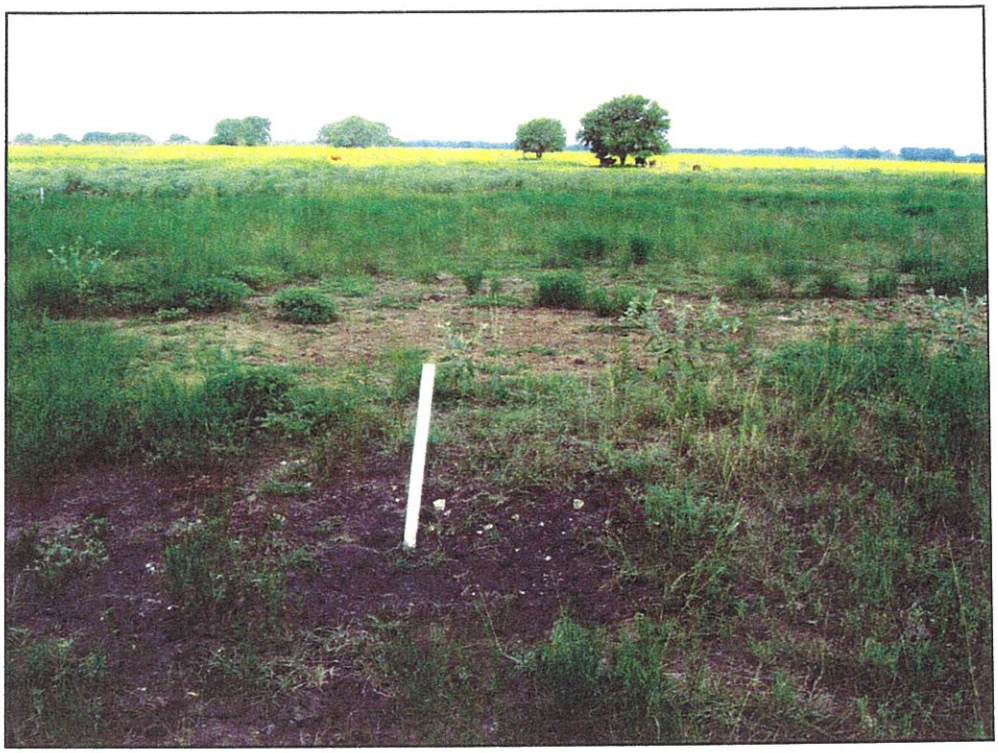
Photo 3: Borehole 32206-43 site restoration.

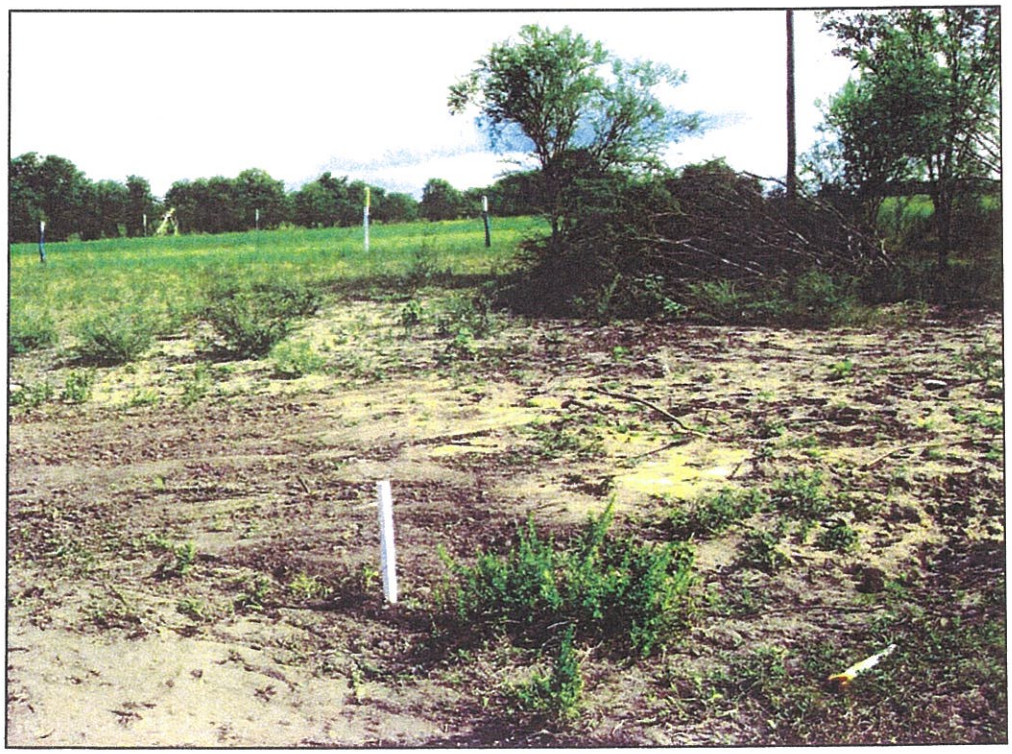
Photo 10: Fresh site restoration at P1-07-JN47.

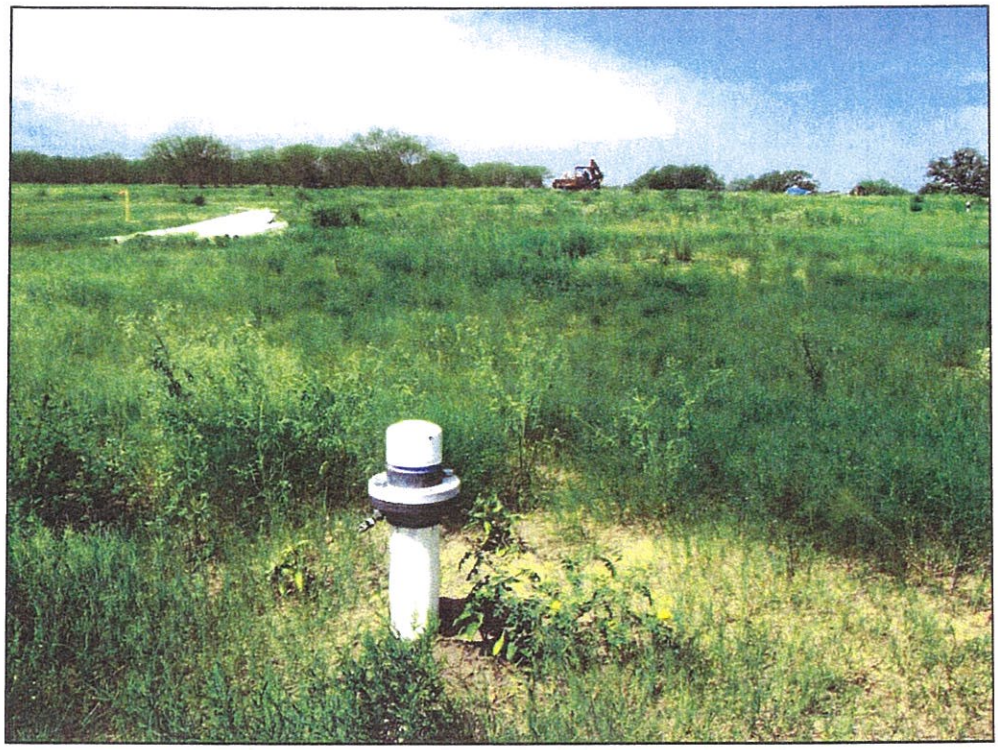
Photo 5: Cased well OMW-4 on Braquet property.

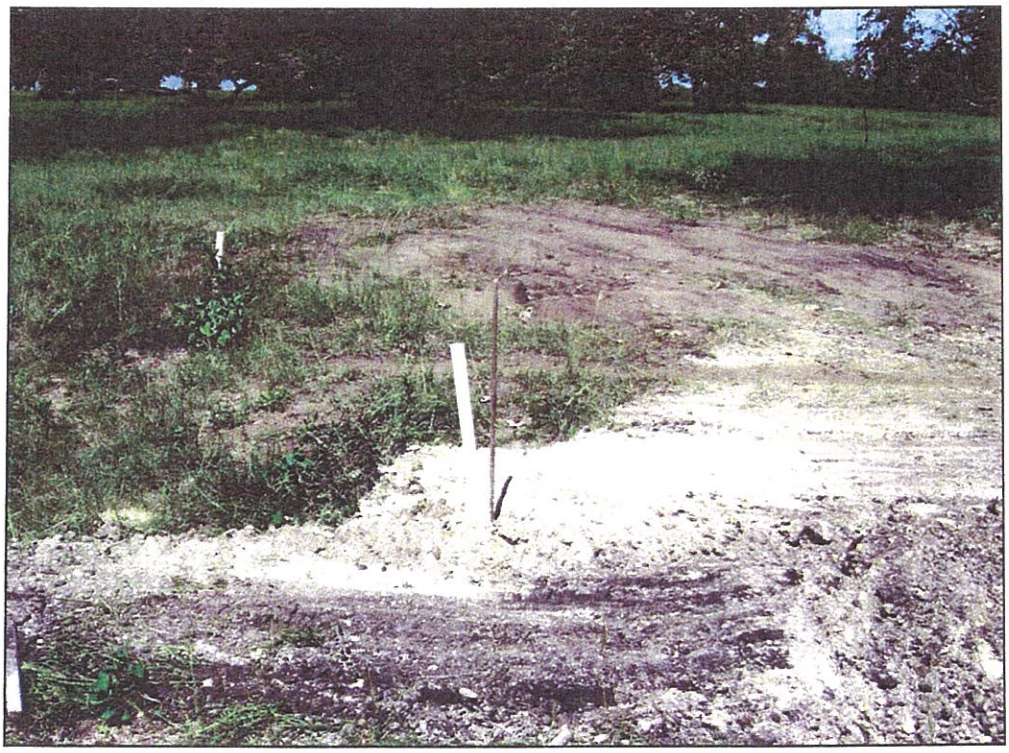
Photo 6: Site restoration in progress at boreholes 30892-134 and 30892-145.

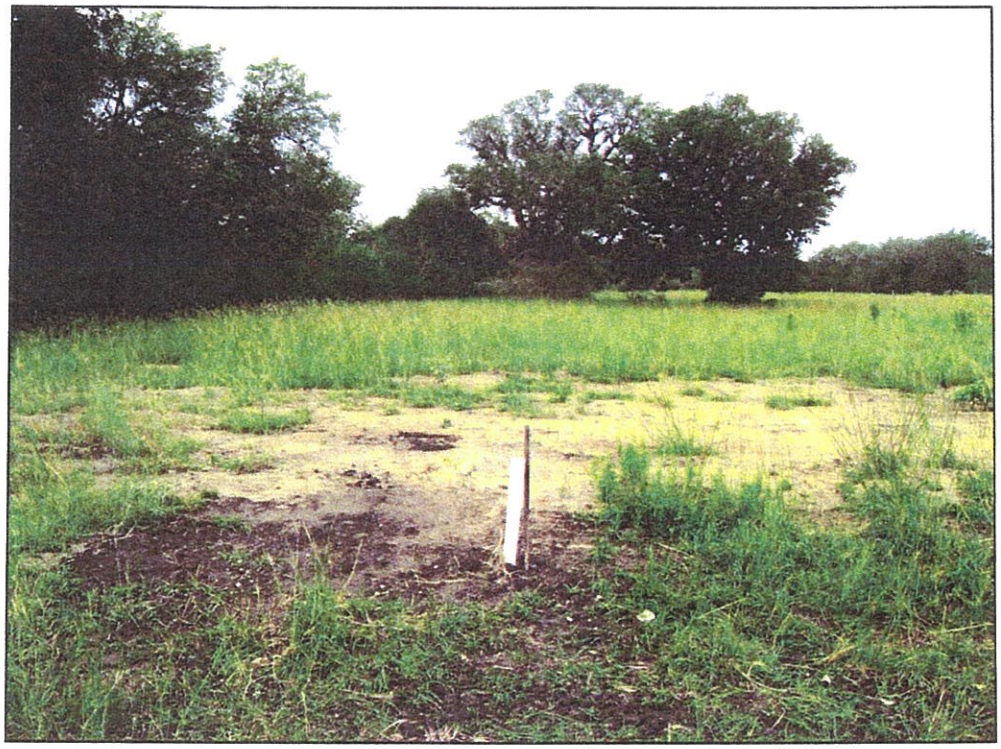
Photo 9: Borehole 32202-238 on Schrade lease..

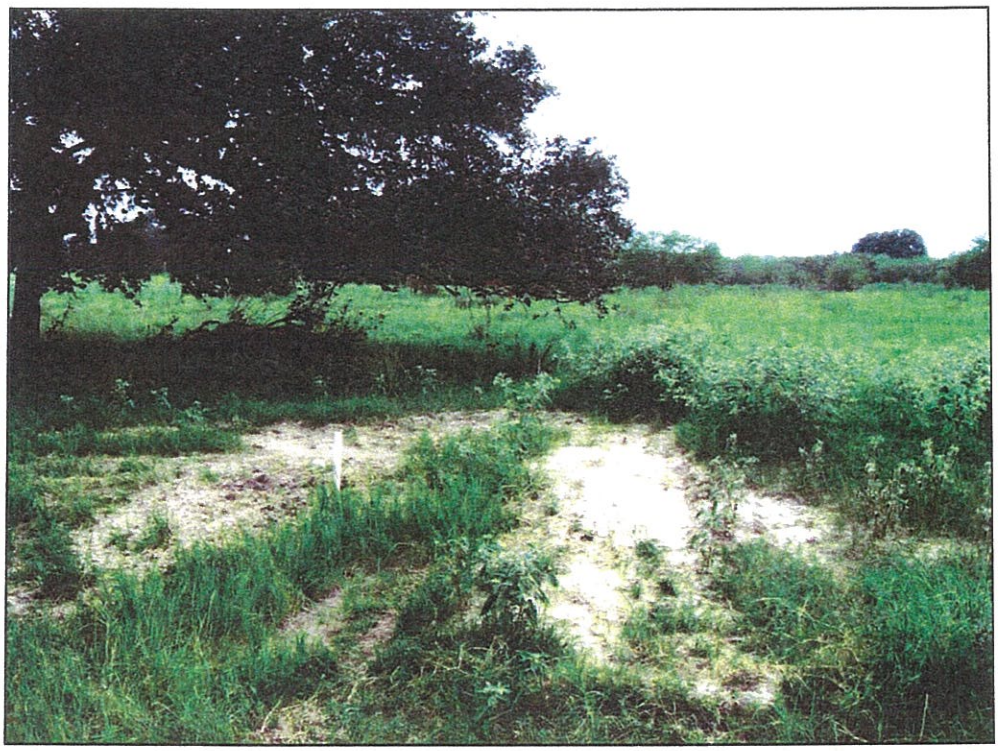
Photo 13: Borehole 33100-25U on Gram lease.

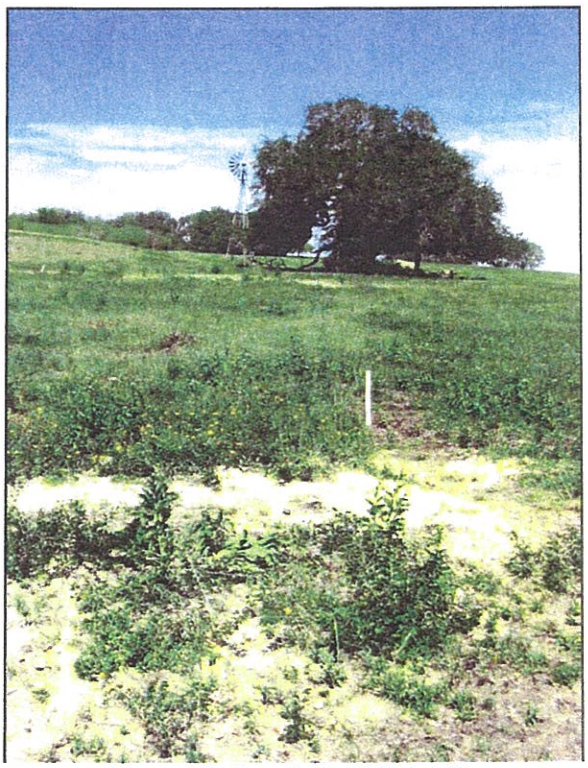
Photo 16: Borehole 30892-140.

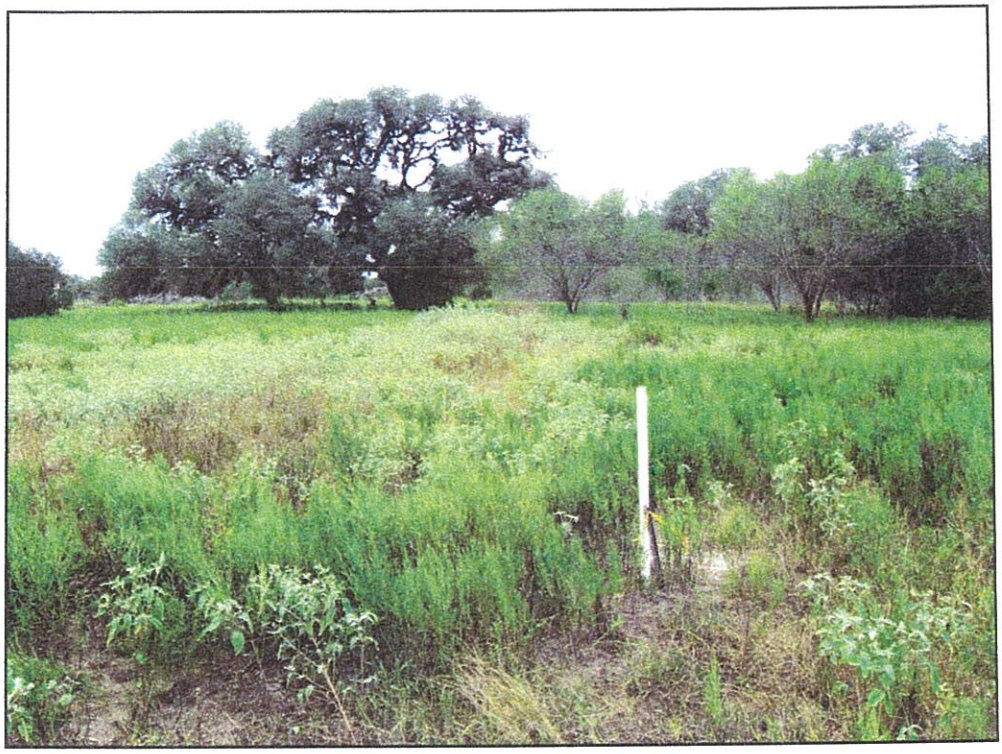
Photo 7: Borehole N-306 on Braquet lease.

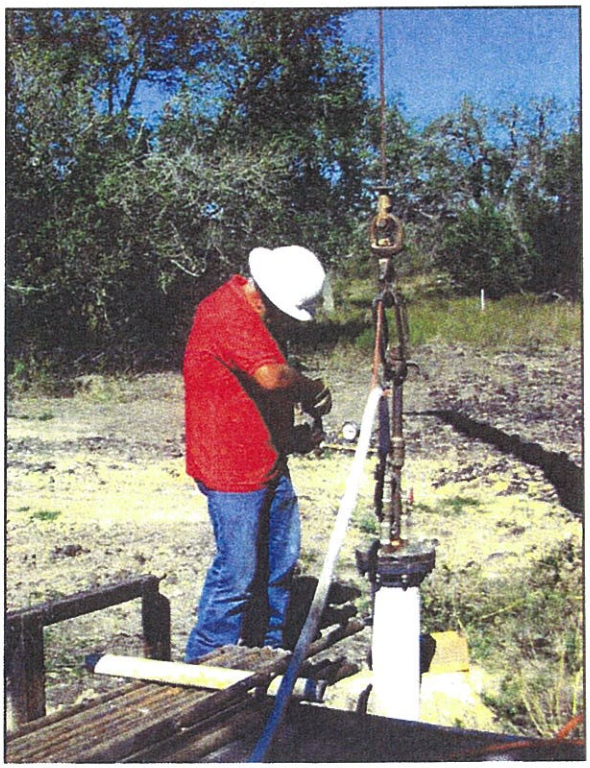
This inspection of UEC's Permit No. 123 found no exploration drilling in progress anywhere in the permitted area. Pressure tests of cased wells were underway as documented in Photos 1-3. This procedure involves pressuring up of the casing to 110 PSI and monitoring for a period of 10 minutes to verify structural integrity of the downhole assemblies. I witnessed the well testing of well PTW9 located on the Braquet property.

Photo 2: Cased well pressure test.

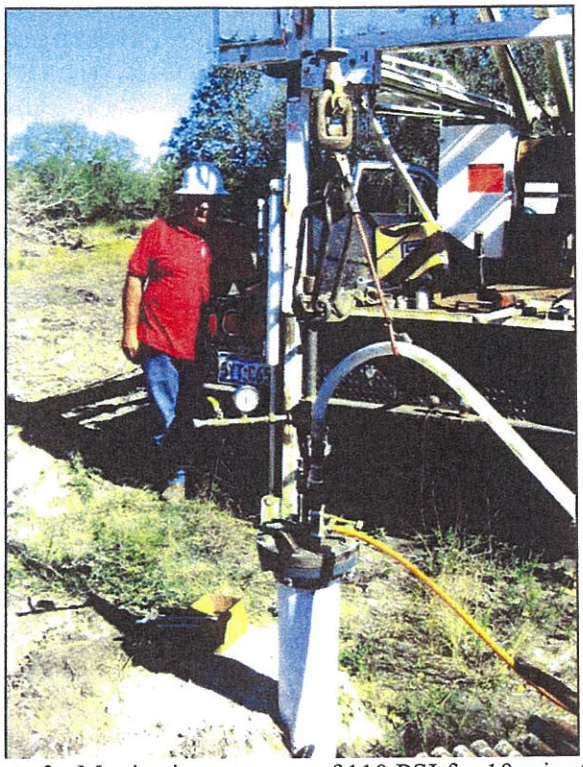
Photo 3: Monitoring pressure of 110 PSI for 10 minutes.

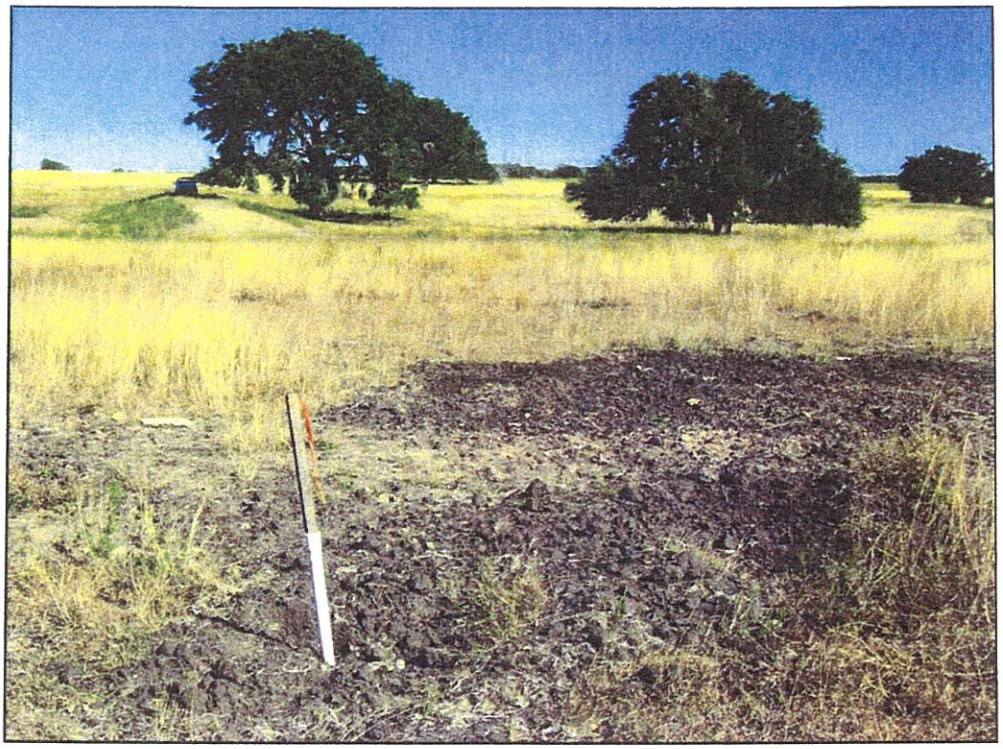
Photo 5: Borehole 258 site restoration on Schrade property.

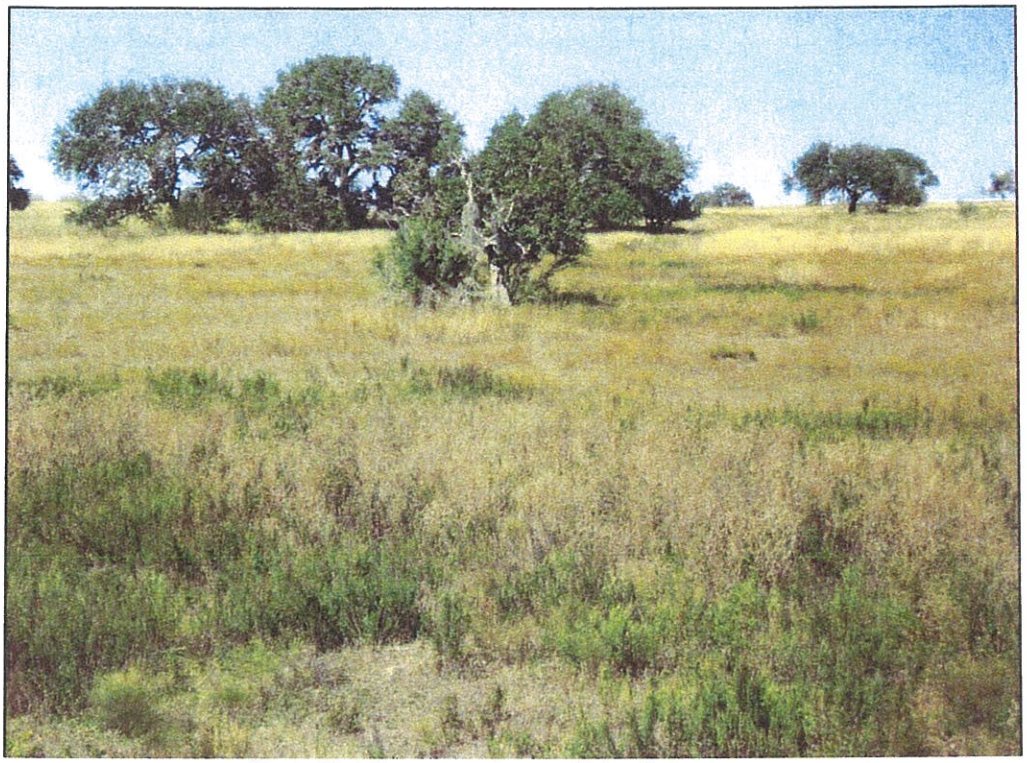
Photo 7: Site restoration on Schrade property.

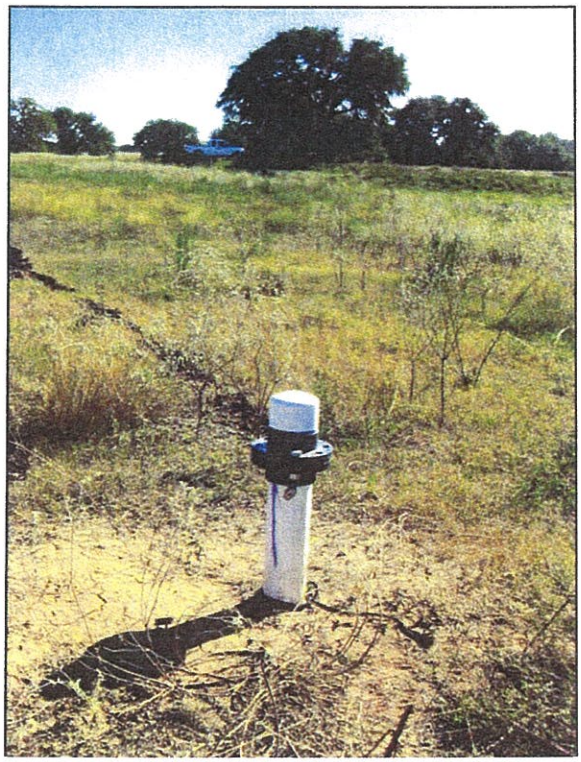
Photo 9: Cased well secured with lock.
