**RE:** Weesatche Project, Goliad County
Uranium Exploration Permit No. 123C
**Inspection Report**

# RAILROAD COMMISSION OF TEXAS
## SURFACE MINING AND RECLAMATION DIVISION
## URANIUM EXPLORATION INSPECTION REPORT

Project Name: Weesatche Permit Number: 123C

Inspector: Steve Meadows Date of Inspection: August 26, 2009

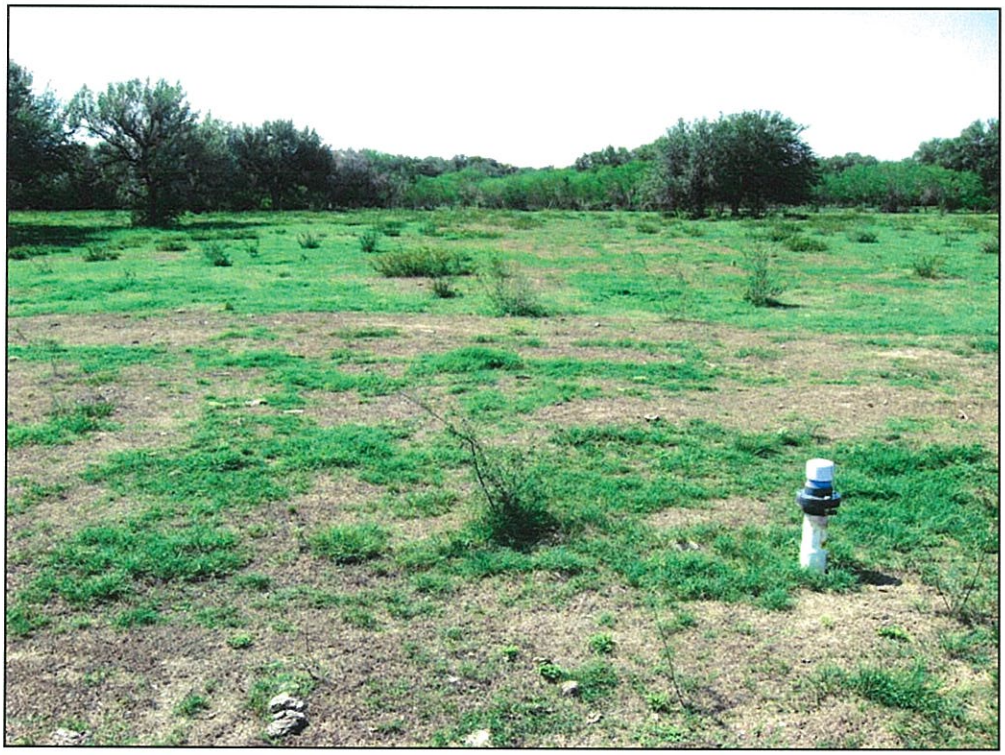
Photo 1: Site restoration at cased wells RBLD-3 and RBLD-5 on 3-25-09.

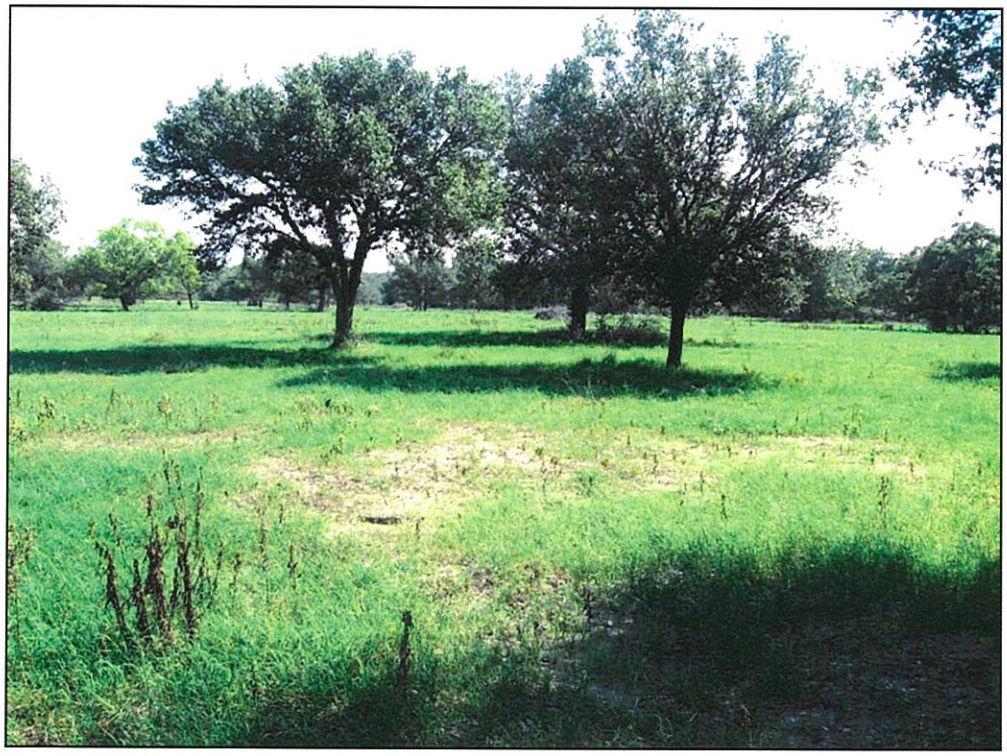
Previously inspected exploration borehole drilling locations on the Colbert and South Colbert are seen in Photos 7-11. No subsidence or incomplete restorations were noted in these areas. A mud pit exhibiting some evidence of subsidence was found on the Abramite property as seen in Photo 12. UEC representative James Gale stated that the problem area would be repaired and equipment to do so is present on the permit.

Photo 7: Site restoration at marked drilling location on Colbert lease.

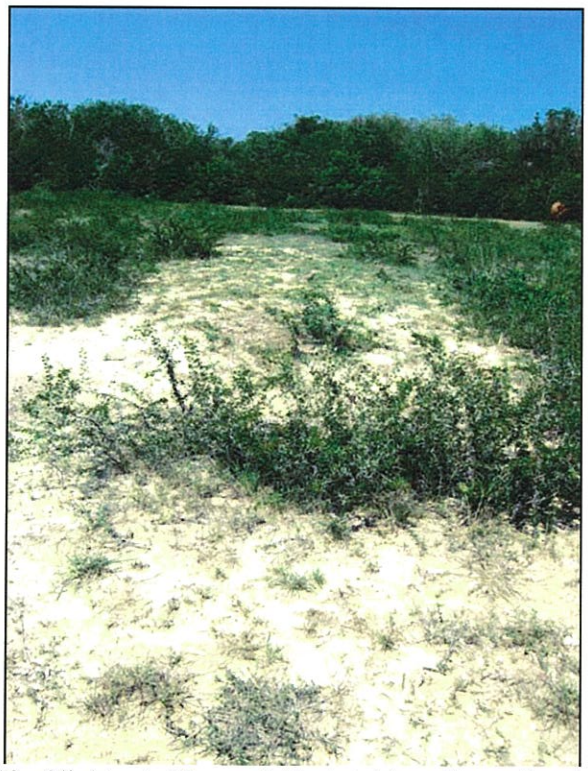
Photo 11: Site restoration at South Colbert drilling location.
