RAILROAD COMMISSION OF TEXAS

SURFACE MINING AND RECLAMATION DIVISION

RE: Weesatche Project, Goliad County
Uranium Exploration Permit No. 123A
Inspection Report

RAILROAD COMMISSION OF TEXAS
SURFACE MINING AND RECLAMATION DIVISION
URANIUM EXPLORATION INSPECTION REPORT

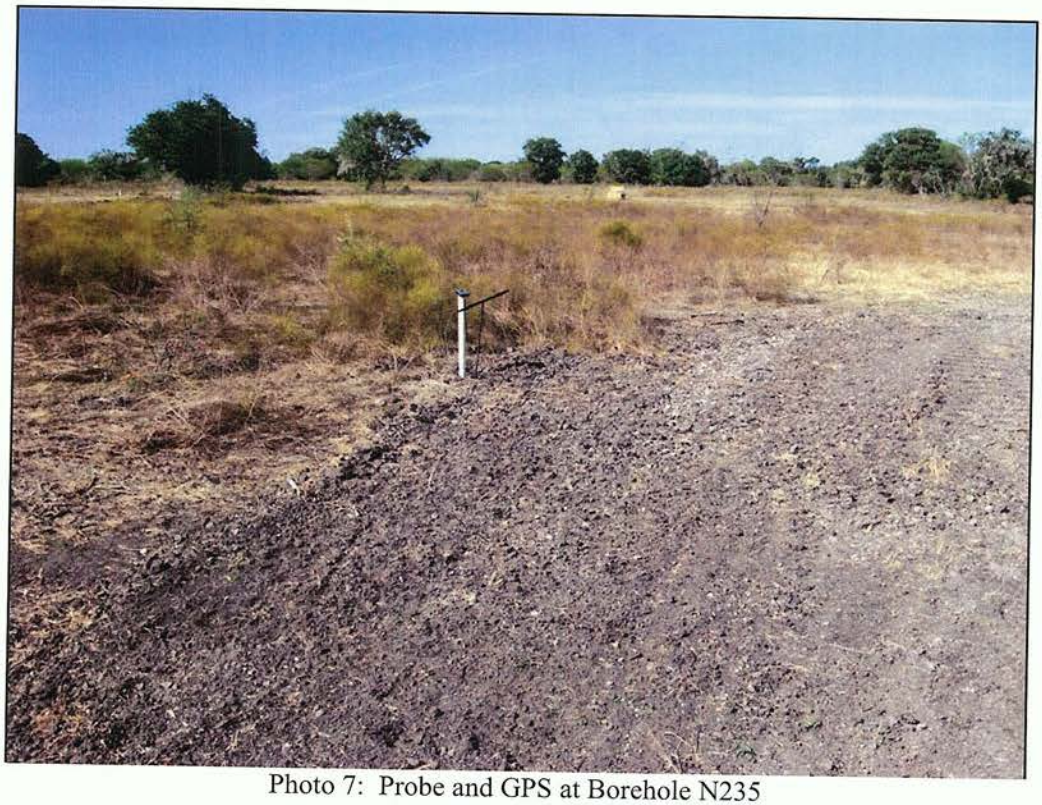
Photo 7: Probe and GPS at Borehole N235

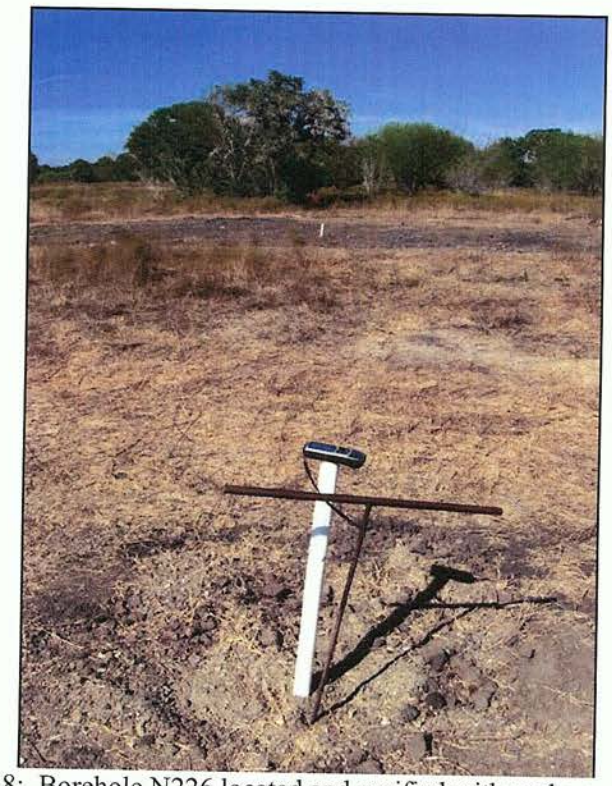
Photo 8: Borehole N226 located and verified with probe and GPS

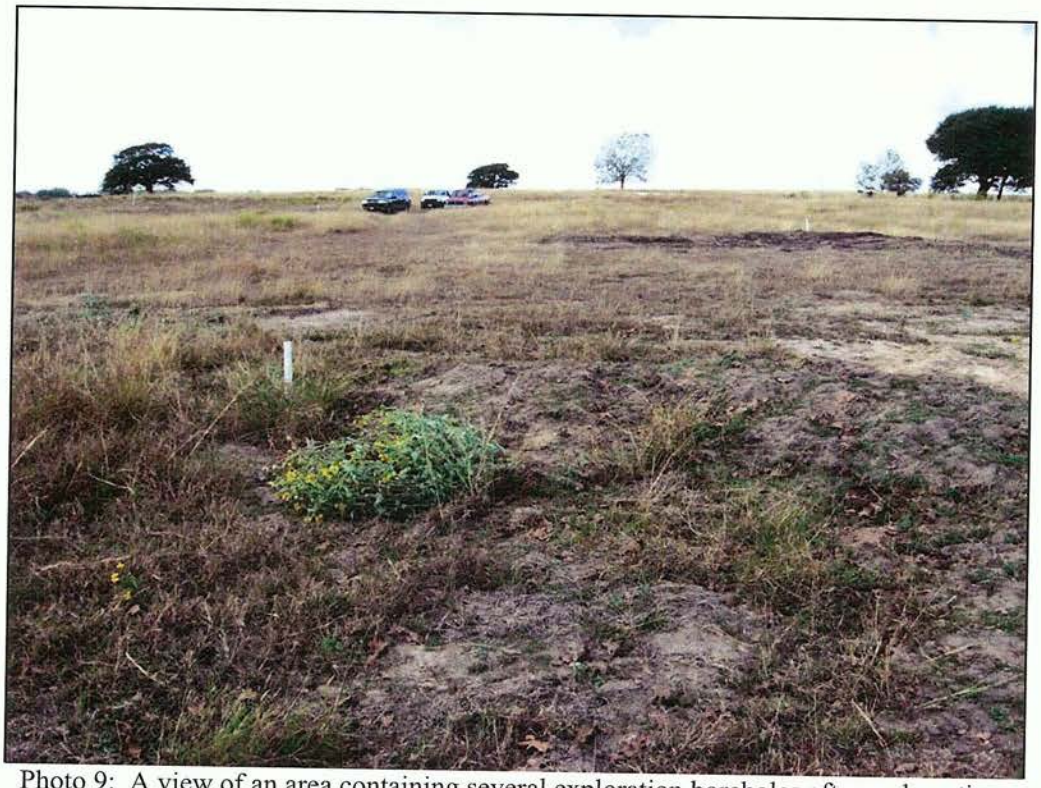
Photo 9: A view of an area containing several exploration boreholes after reclamation.
