ENGINEERING INVESTIGATIONS AT INACTIVE HAZARDOUS WASTE SITES

PHASE I INVESTIGATION

CARBORUNDUM BUILDING 82, SITE NUMBER 932048B
CITY OF NIAGARA FALLS, NIAGARA COUNTY

January 1990

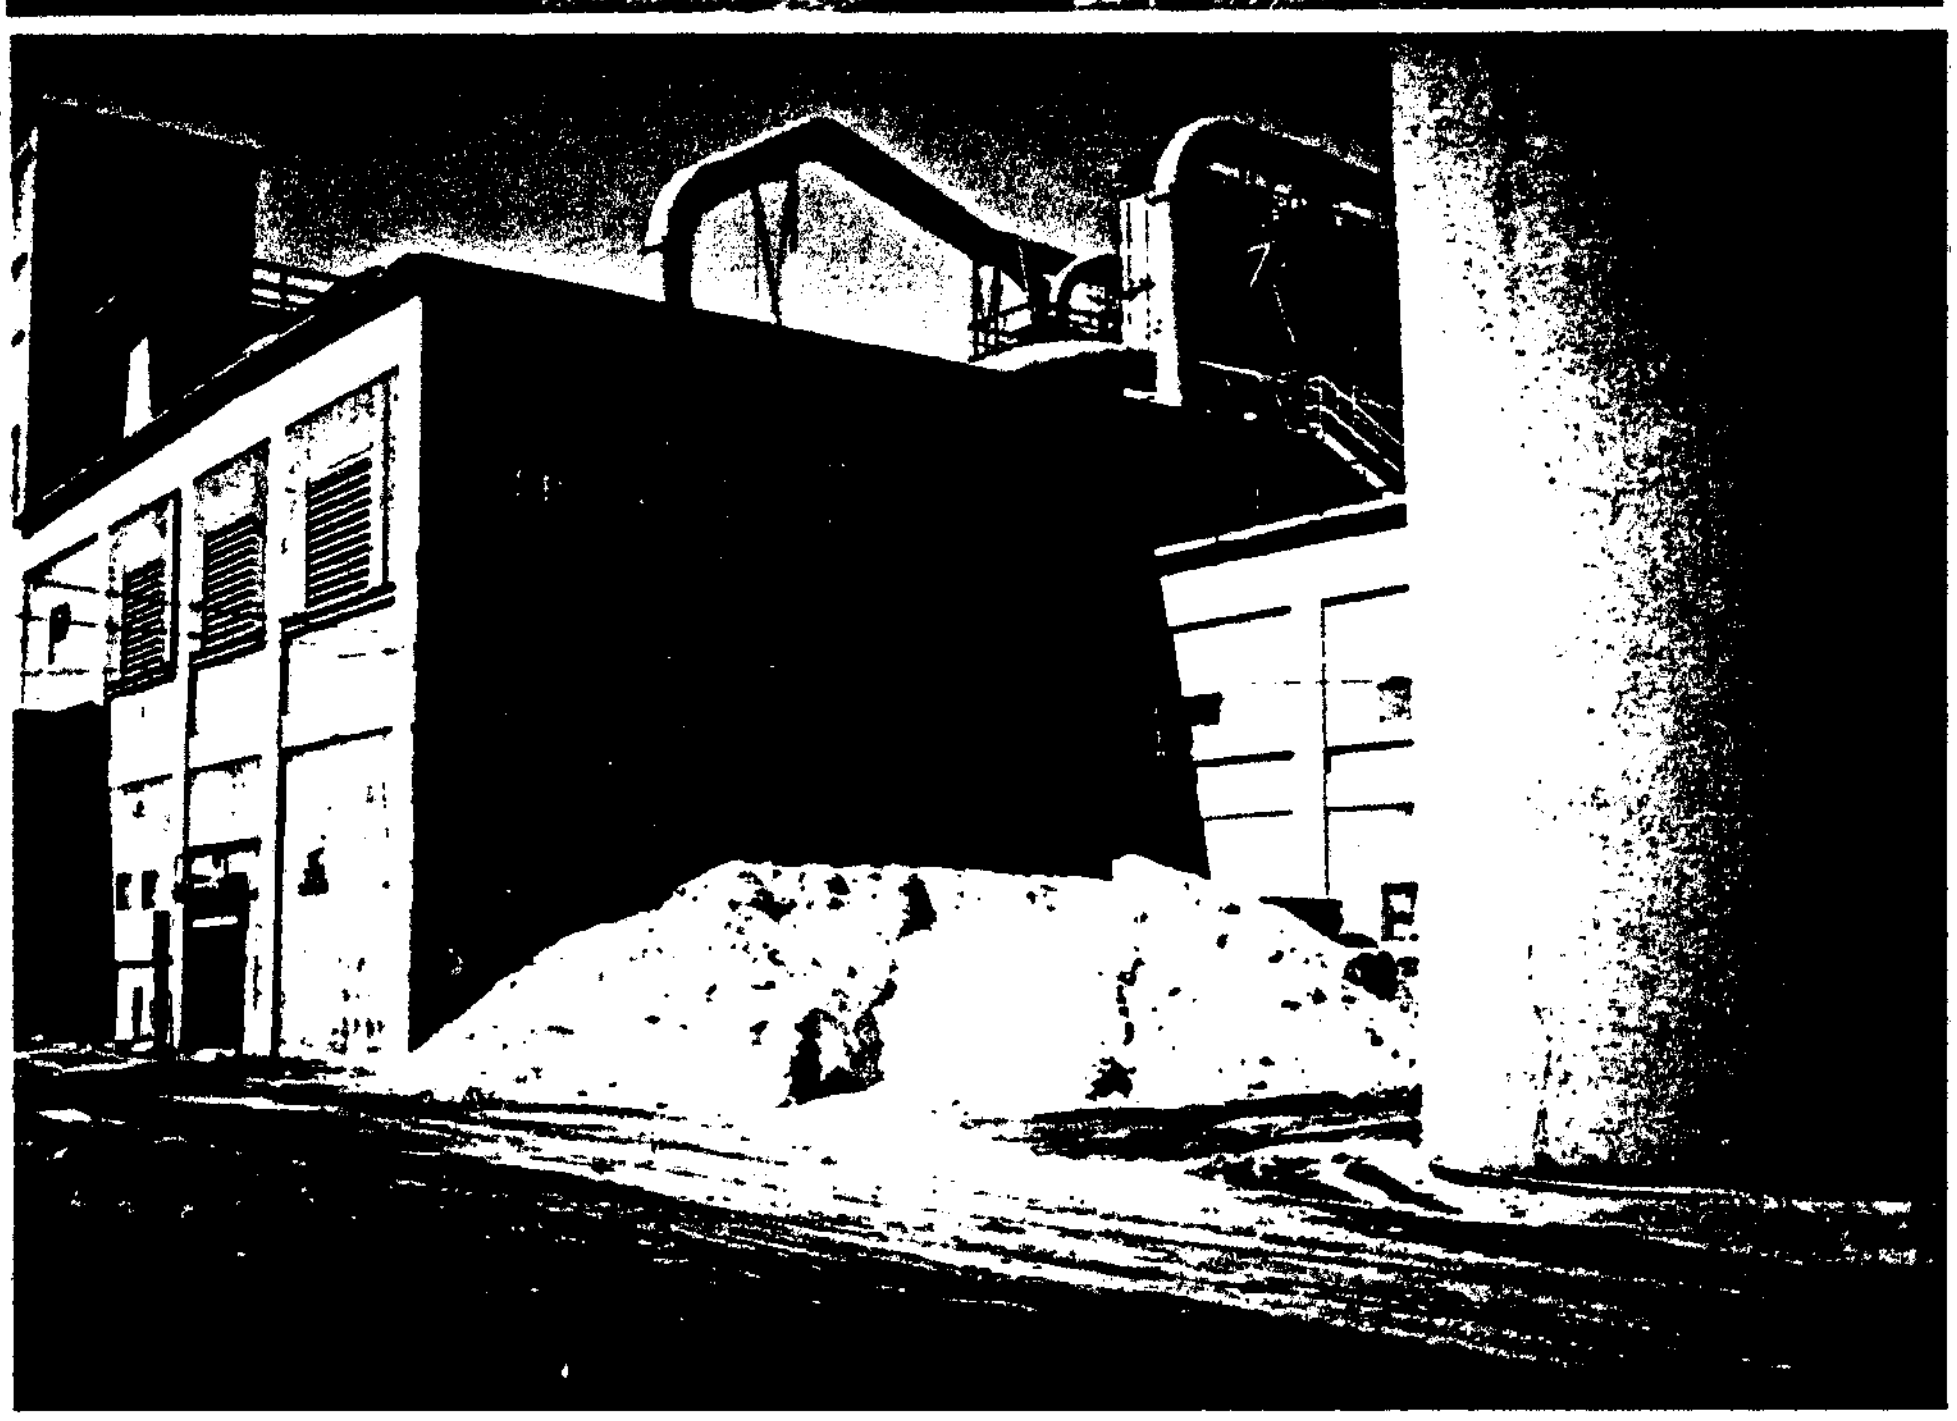
Frame No.: 3

Comments*: Mixed pile of aluminum oxide and silica carbide near west end of Buildings 86 and 84. Note rainwater runoff. West of Building 82.
