ENGINEERING INVESTIGATIONS AT INACTIVE HAZARDOUS WASTE SITES

PHASE I INVESTIGATION

REPUBLIC STEEL, SITE NUMBER: 915047
CITY OF BUFFALO, ERIE COUNTY

June 1989

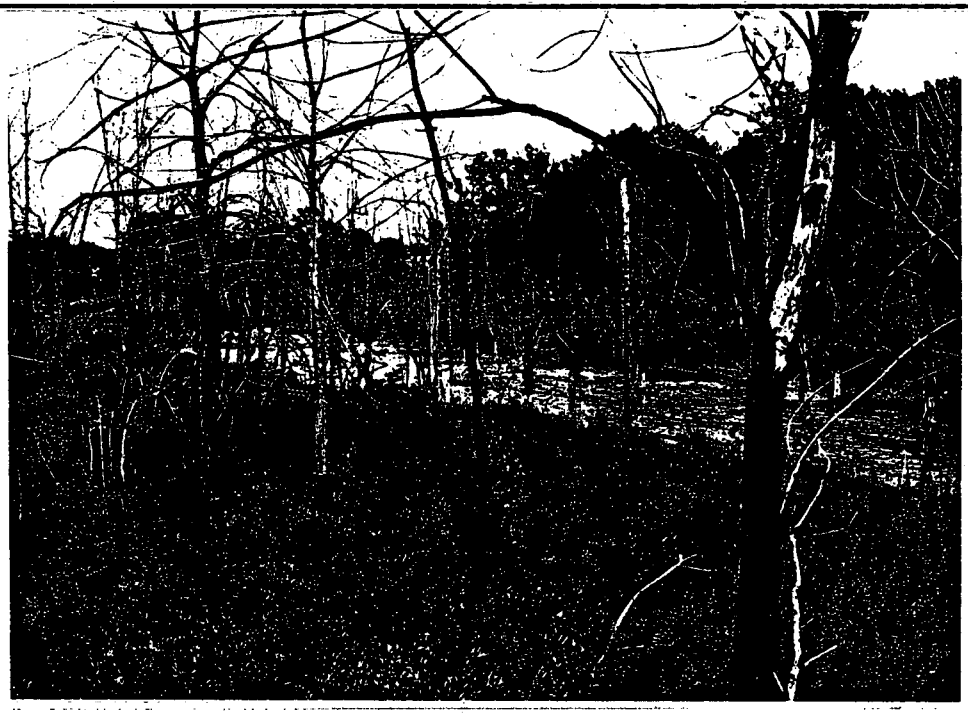
Frame No.: 20

Comments*: State wetland, looking from west on site.
