Washington University in St. Louis
ENVIRONMENTAL HEALTH & SAFETY

Re: Urbauer Hall EPA Site Visit Summary Report October 29, 2018

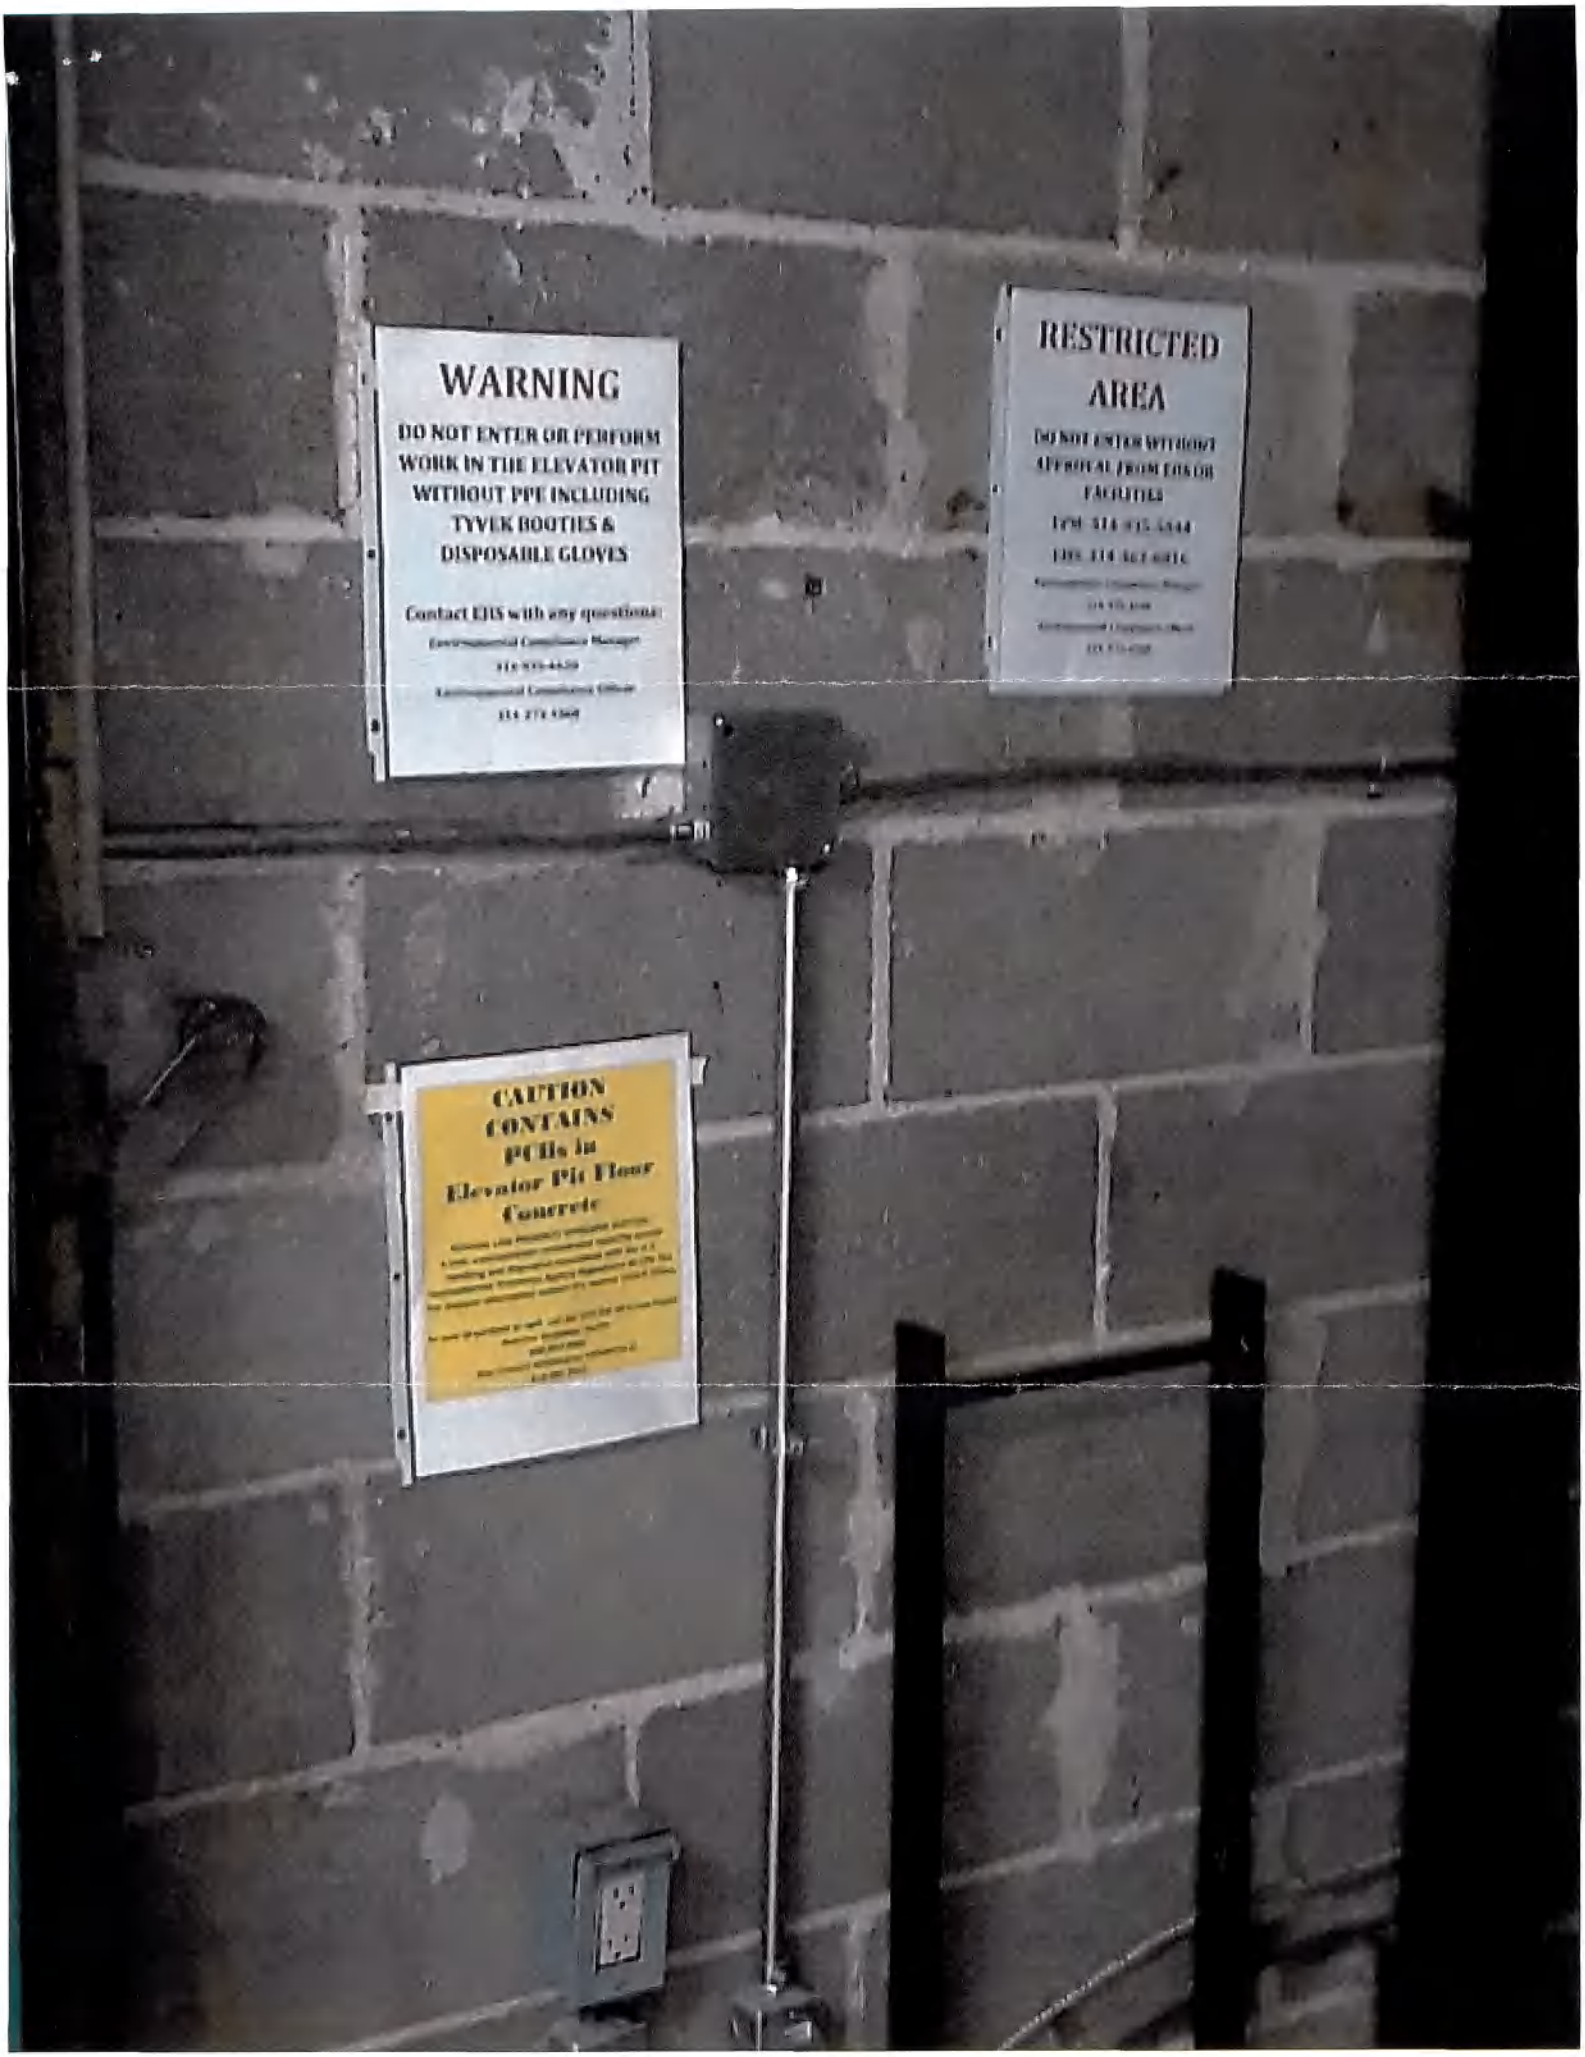
WU has modified the signage in the pit area to address "markings" (M^L) concerns. This signage (Attachment 3) details the presence of PCB's, as well as cautions and instructions for entering the elevator pit.

WARNING
DO NOT ENTER OR PERFORM WORK IN THE ELEVATOR PIT WITHOUT PPE INCLUDING TYVEK BOOTIES & DISPOSABLE GLOVES
Contact EHS with any questions:
RESTRICTED AREA
CAUTION CONTAINS PCBs in Elevator Pit Floor Concrete
