FIGURE 3 - GROUNDWATER SAMPLE EXCEEDANCES
CITY AND COUNTY OF DENVER
HIGH STREET STORM DRAINAGE PROJECT

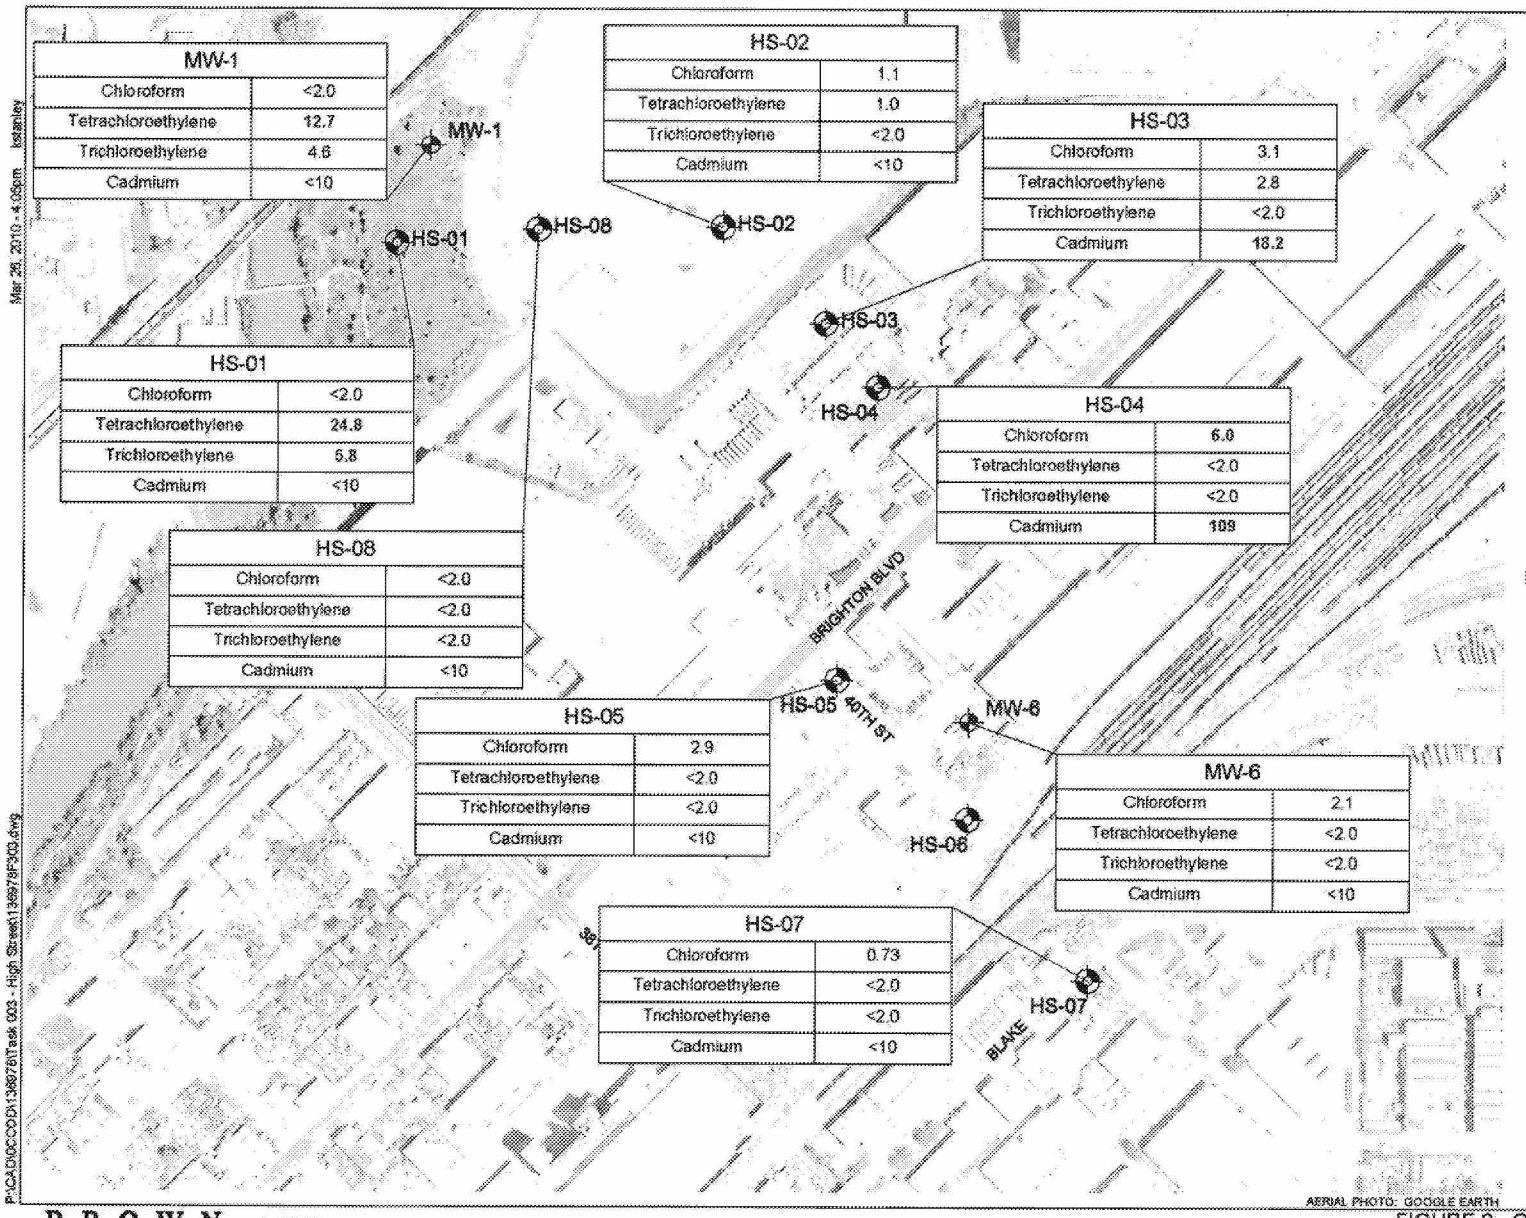
MW-1	
Chloroform	<2.0
Tetrachloroethylene	12.7
Trichloroethylene	4.6
Cadmium	<10

HS-02	
Chloroform	1.1
Tetrachloroethylene	1.0
Trichloroethylene	<2.0
Cadmium	<10

HS-03	
Chloroform	3.1
Tetrachloroethylene	2.8
Trichloroethylene	<2.0
Cadmium	18.2

HS-01	
Chloroform	<2.0
Tetrachloroethylene	24.8
Trichloroethylene	5.8
Cadmium	<10

HS-04	
Chloroform	6.0
Tetrachloroethylene	<2.0
Trichloroethylene	<2.0
Cadmium	109

HS-08	
Chloroform	<2.0
Tetrachloroethylene	<2.0
Trichloroethylene	<2.0
Cadmium	<10

HS-05	
Chloroform	2.9
Tetrachloroethylene	<2.0
Trichloroethylene	<2.0
Cadmium	<10

MW-6	
Chloroform	2.1
Tetrachloroethylene	<2.0
Trichloroethylene	<2.0
Cadmium	<10

HS-07	
Chloroform	0.73
Tetrachloroethylene	<2.0
Trichloroethylene	<2.0
Cadmium	<10

BOLD BLUE TEXT INDICATES EXCEEDANCE
