RE: 4-RIN-0708-92
Rome Coal Tar Pit/GAD981002983
West Florida Natural Gas/FLD982119729
Palatka Gas Works/FLD981932007
Durham Coal Gasification/986176938
CNCO

RE: Rome Coal Tar Pit
Rome, Floyd County, Georgia
GAD981002983

PRELIMINARY ASSESSMENT COVER SHEET
ROME COAL TAR PIT
GAD981002983

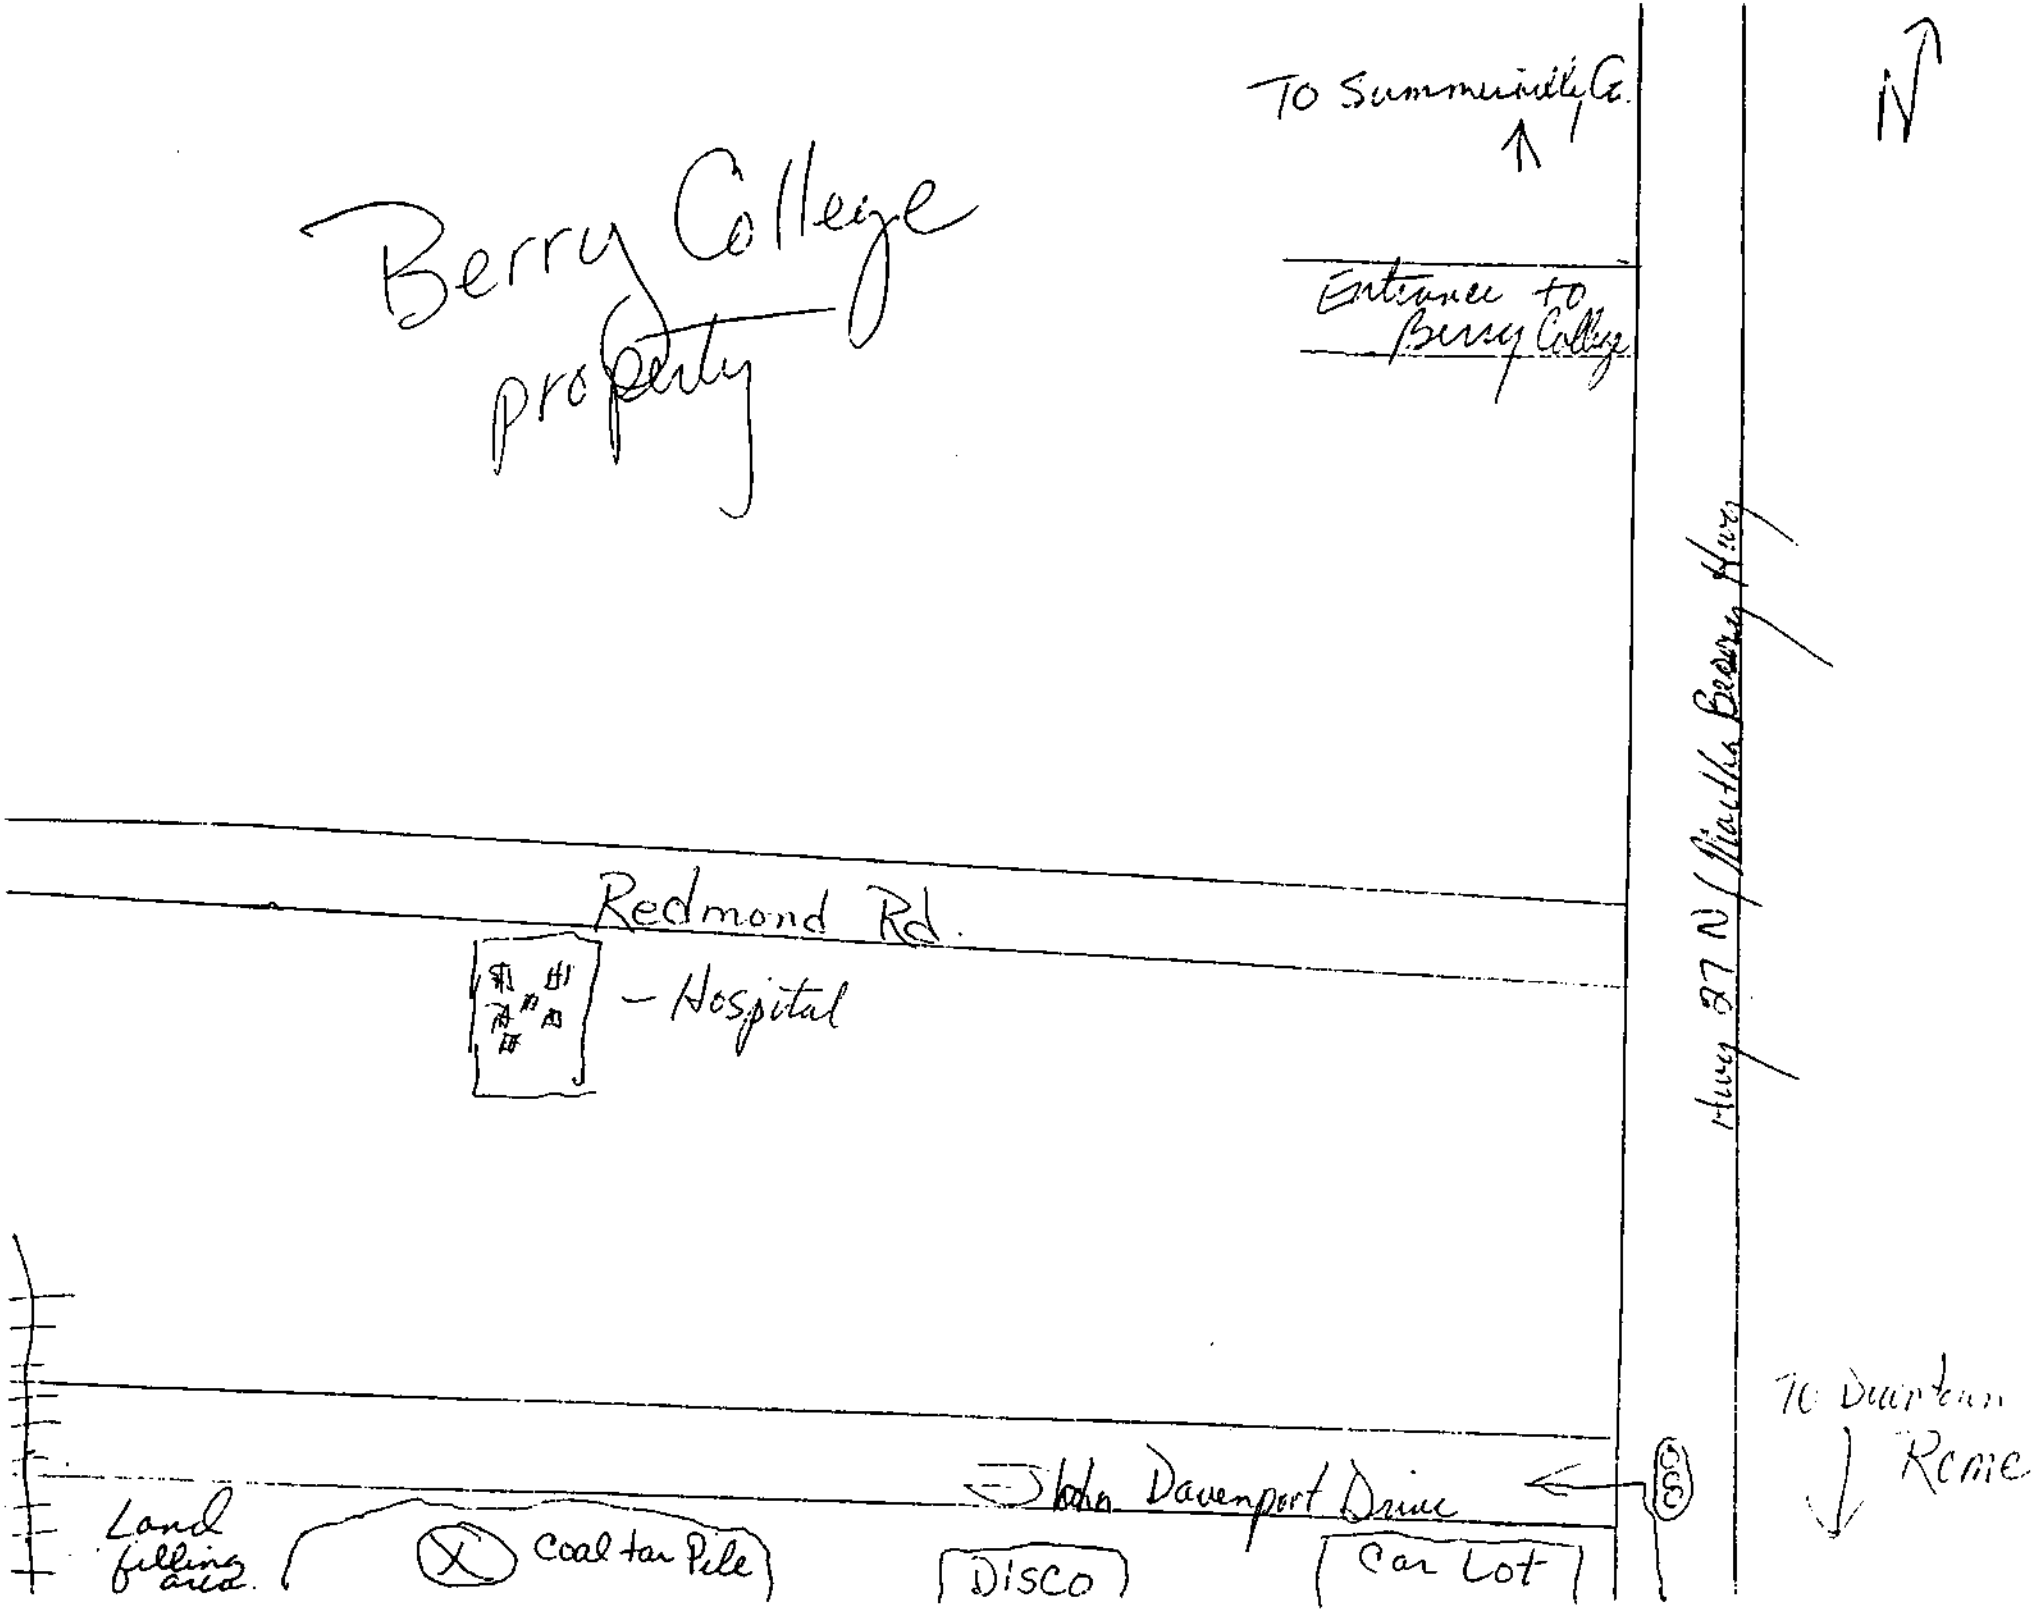
To Summerville Ga.
N
Berry College property
Entrance to Berry College
Hwy 27 N / Martha Berry Hwy
Redmond Rd.
- Hospital
To Downtown Rome
John Davenport Drive
Land filling area
Coal tar Pile
DISCO
Car Lot
