S05-0007-015 Nicor Mercury Spill 9-28-00

0743 START Sass arrives a Dekalb Iron and Metal, 900 Oak St., Dekalb, IL, to conduct walkthrough. Nicor reps, their contractors, IL EPA, and OSC Faryan to meet on site at 0800. Weather: Sunny, 55°F, expected high in mid-60s.

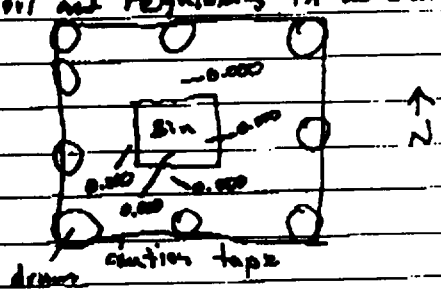
0850 East yard: Jerome reading (outside gate) 0.002/0.000. Just outside secured bin area (south of) at breathing zone = 0.000. Nine mercury type regulators were recently taken off site. Readings from soil and regulators in and around bin.

Cup screening (2 min) used.

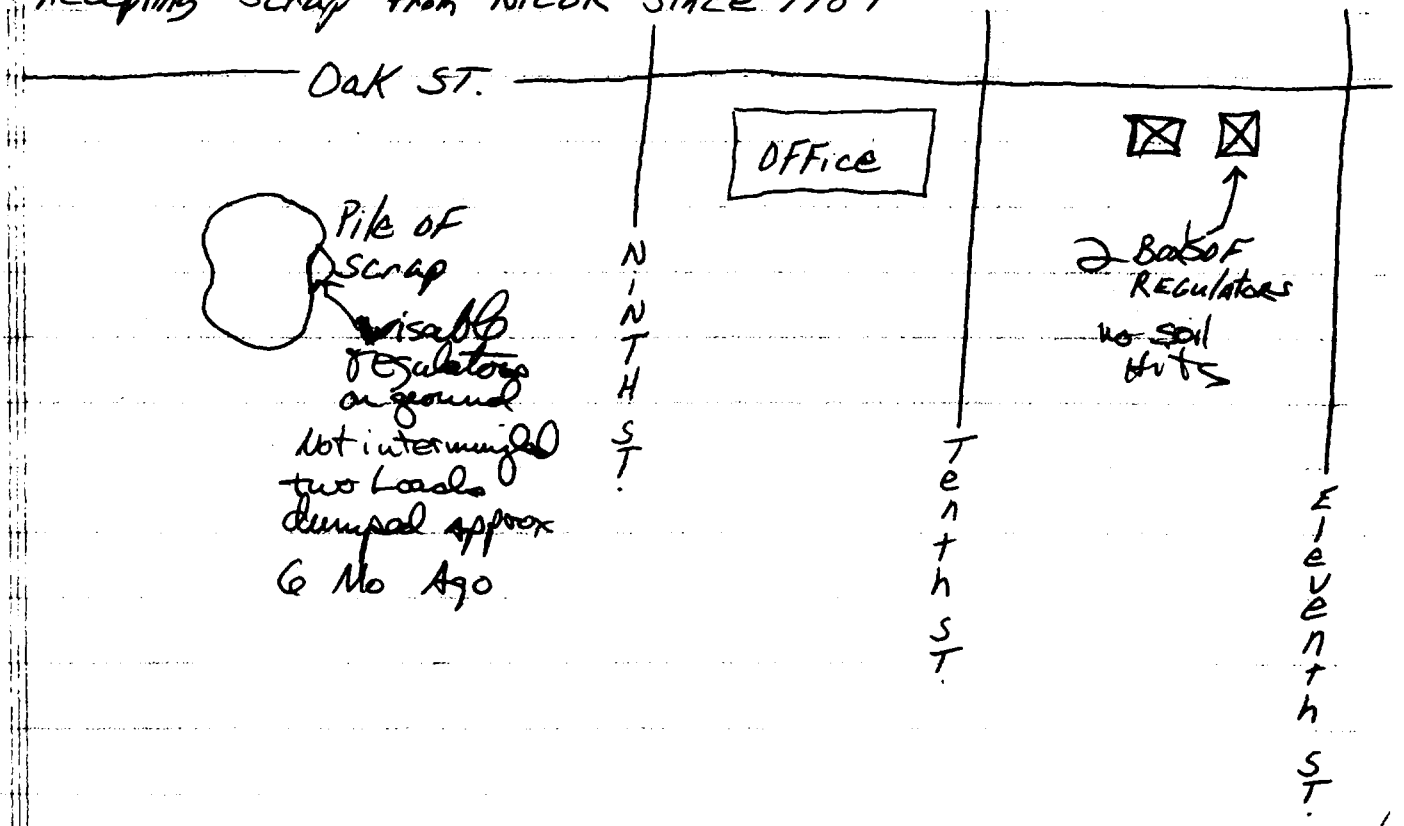
(1) DeKalb Iron And Metal Co.
900 Oak ST.
DeKalb, IL 60115
Contact: Jeffrey Gorman - President
815/758-2458

* Jerome 431-X Readings 09/05/00 (Ed and Gino)
Metal Box (4'x4'x4') Containing Regulators
0.005 ← West side of Box
0.017 ← Inside of Cracked Regulator
* Accepting scrap from NICOR since 1989

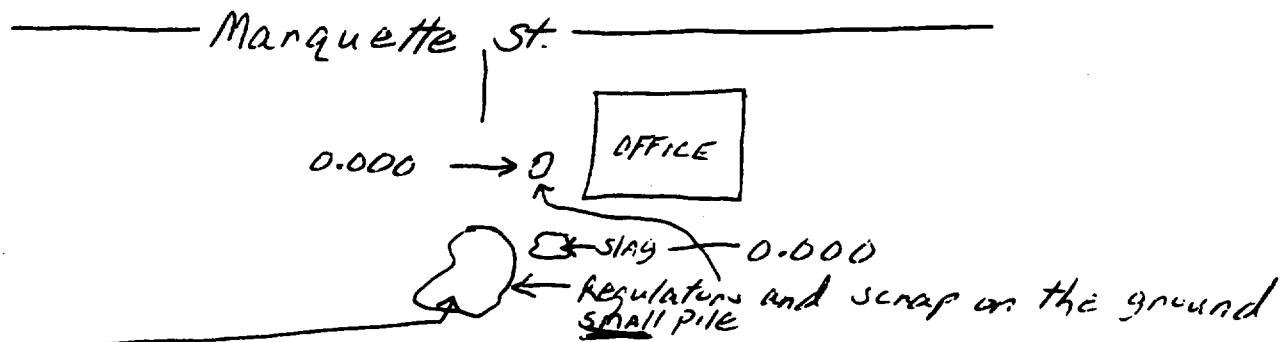
② Newtson Iron & Metal
901 W. Marquette St.
Ottawa, IL. 61350
Contact: Dan Szafranski or Tina Szafranski
815/433-1658

* Jerome 431-X Readings 09/05/00 (Ed AND Gino)
0.003/0.003/0.003/0.009
* started receiving scrap from NICOR in Ottawa ~1yr AGO

- IEPA removed 1 regulator
- Hand separated & put in aluminum breakage pile
- START conducted air monitoring with a Jerome

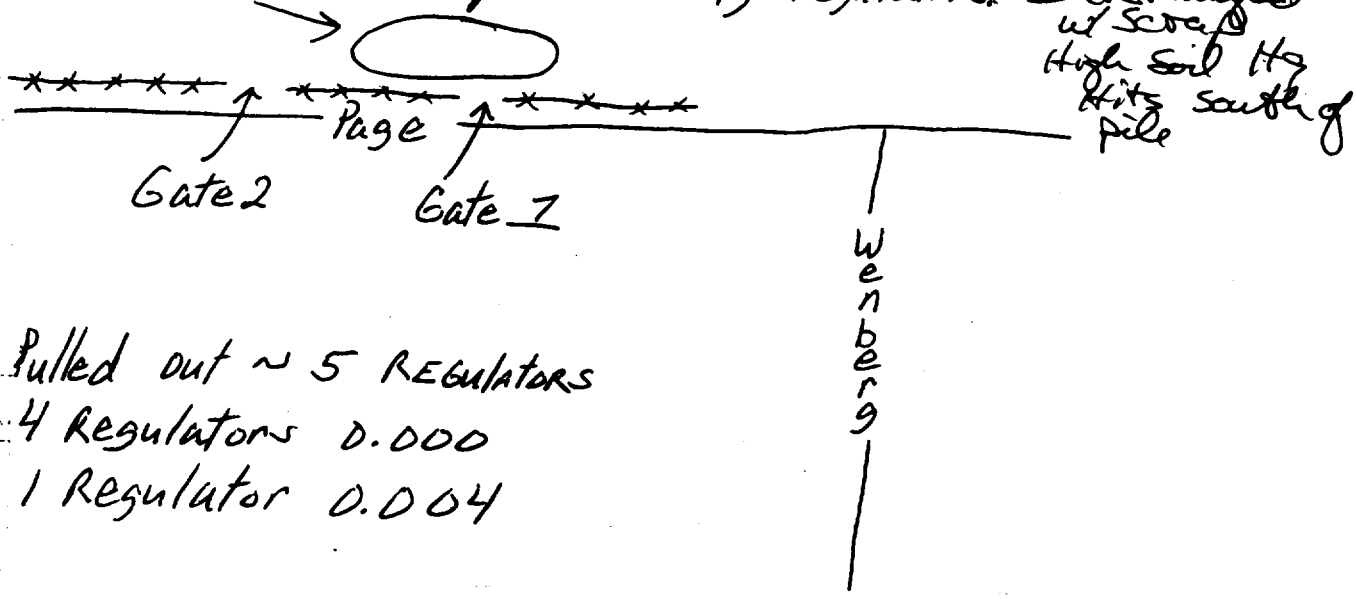
③ Berlinsky Scrap Corp.
212 Page Ave.
Joliet, IL. 60434
Contact: Ken Glassman
815/726-4334

Jerome 431-X Readings (Ed and Gina) 09/02/00
Large pile of scrap containing regulators. Intermingled w/ scrap High soil Hg Hits south of pile

Pulled out ~ 5 Regulators
4 Regulators 0.000
1 Regulator 0.004
