Summary of Current Conditions/Work Plan for Village Harbor

Little Traverse Bay CKD Release Site
Emmet County, Michigan

Prepared for CMS Land Company and CMS Capital, LLC
U.S. EPA Docket No. VW-05-C-810

August 9, 2006

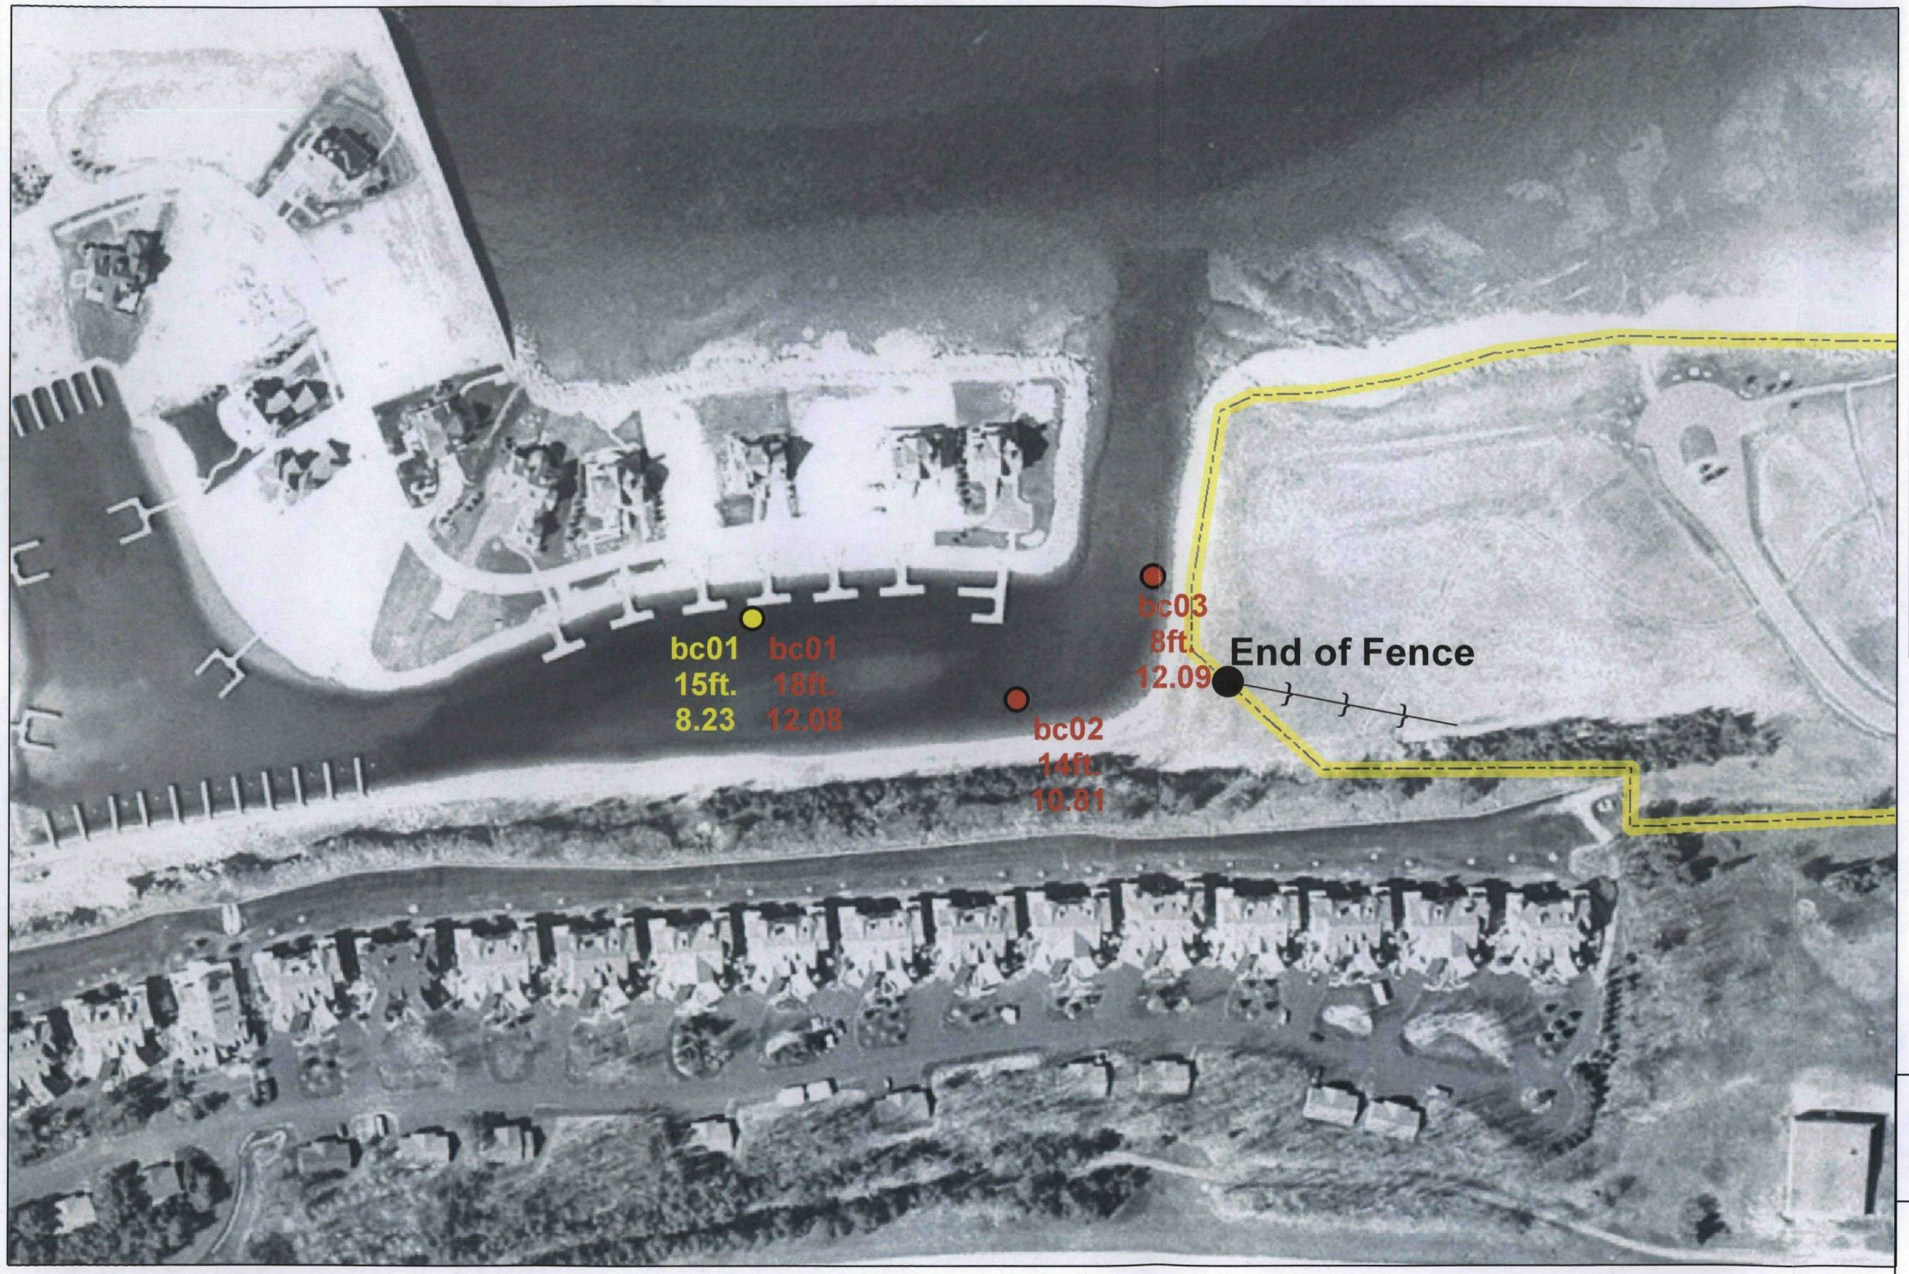
Figure 3-4

On April 10 and April 12, 2006, and on May 2, 2006, EPA/Weston used a calibrated YSI pH meter to monitor pH, specific conductance, and temperature at several locations in Village Harbor Marina. These data are illustrated on figures 3-4 and 3-5.

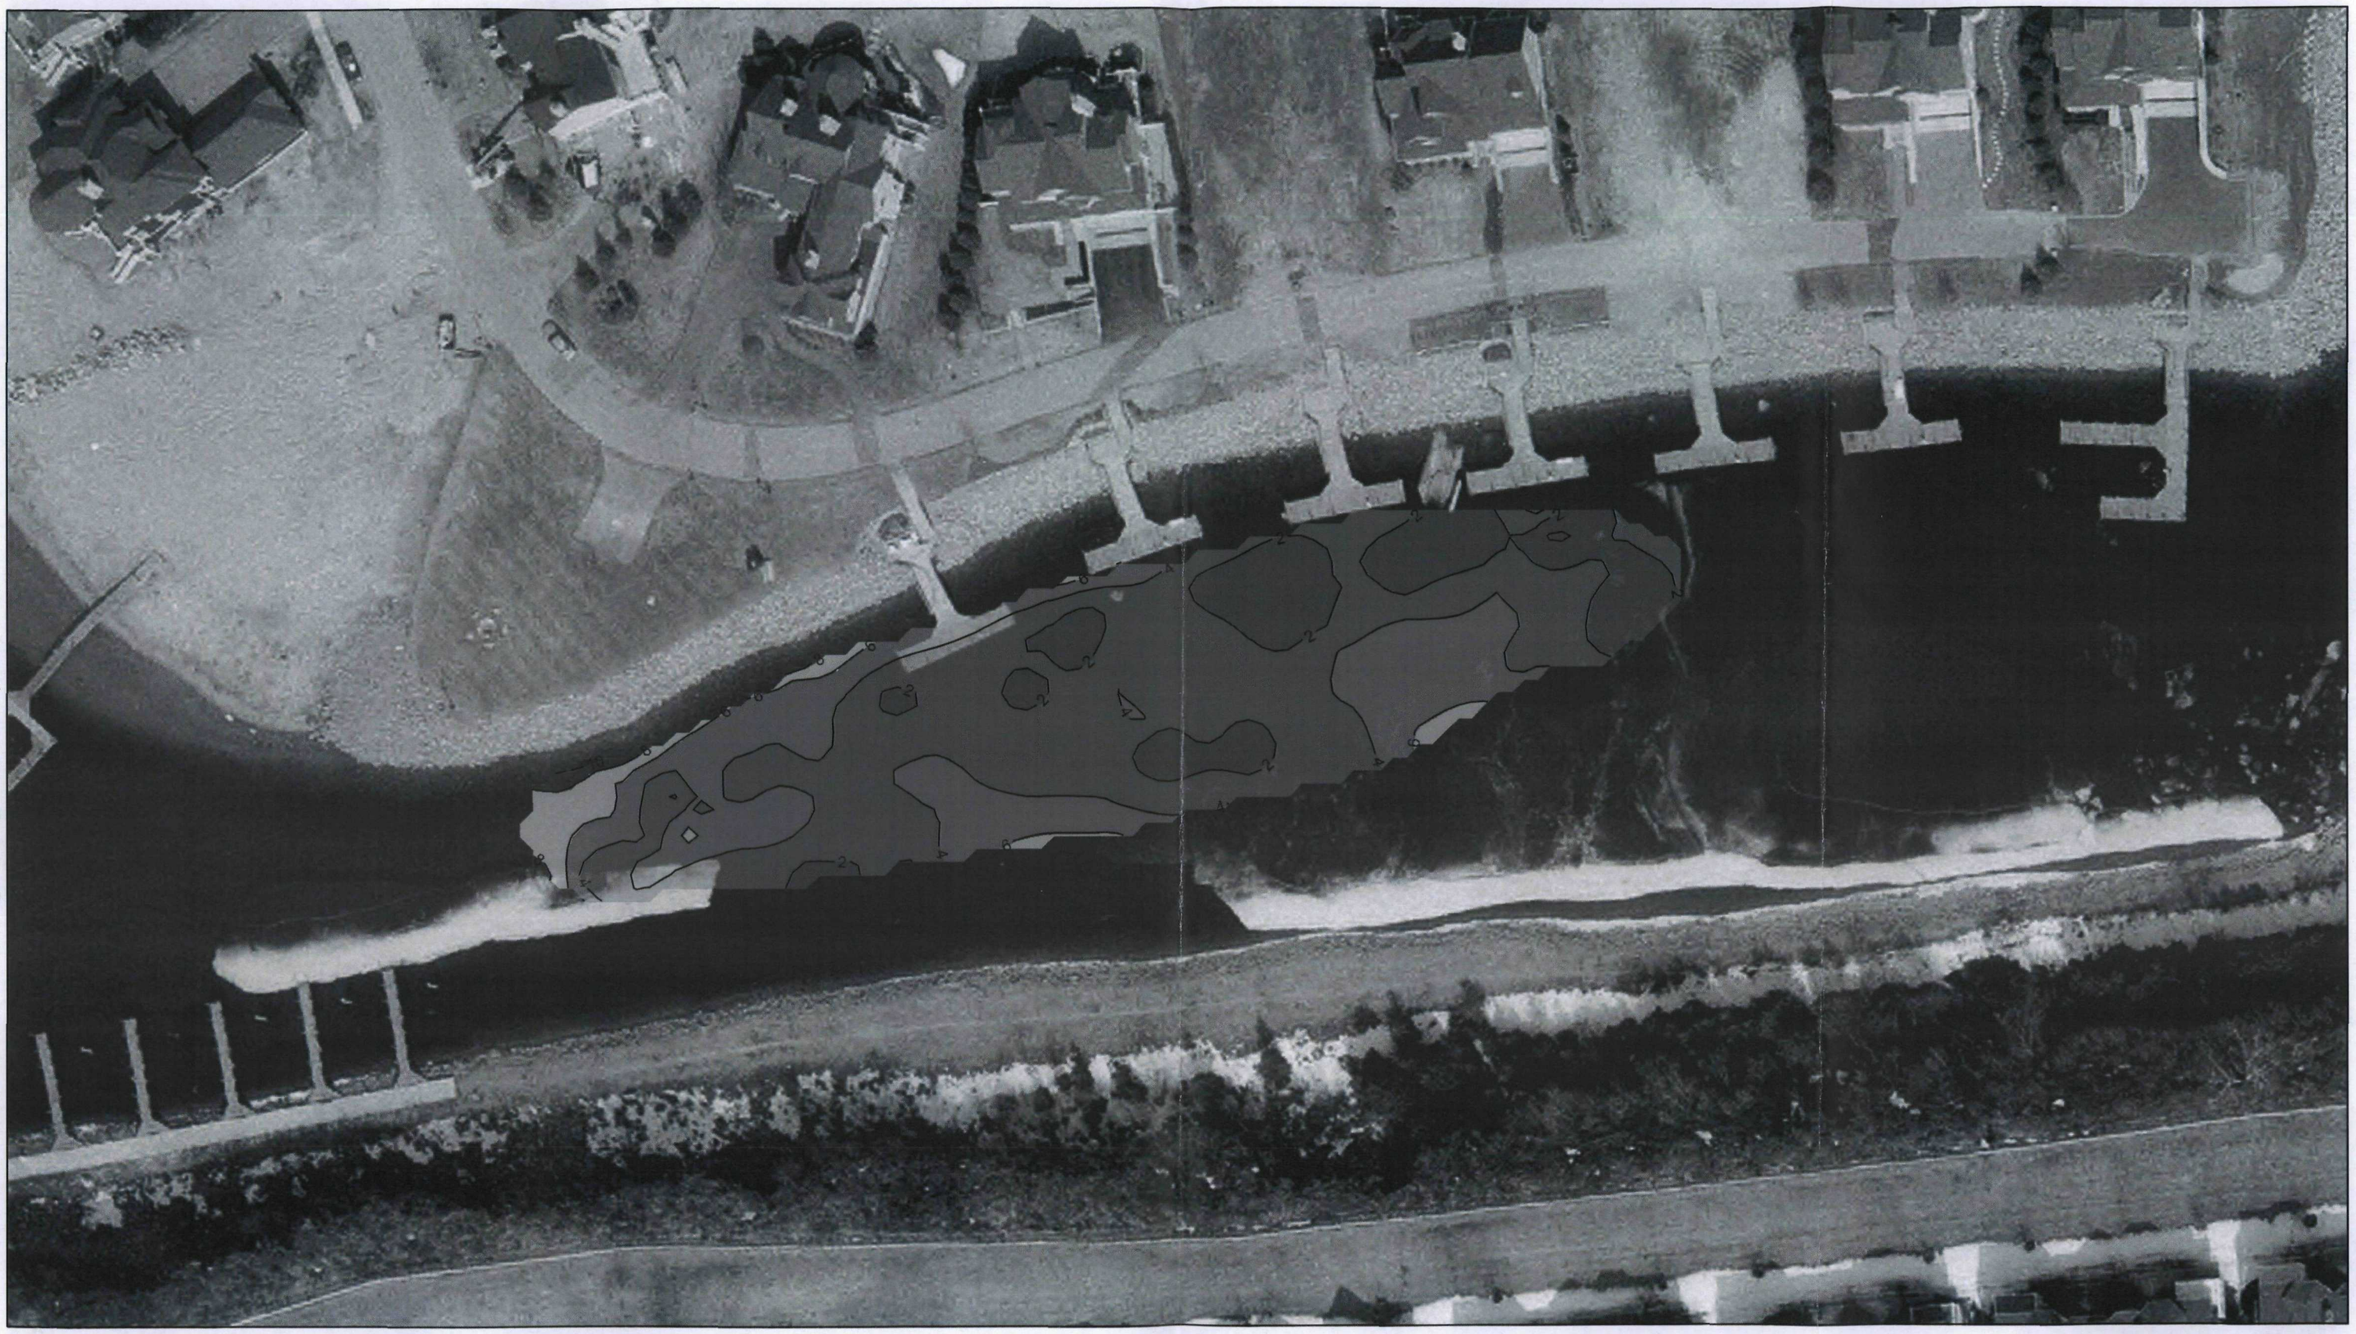
Figure 3-11
ESTIMATED SUMP AREA
SEDIMENT THICKNESS
Little Traverse Bay
CKD Release SIte
Emmet County, Michigan

Soft sediment with a "pudding-like" texture was observed by the U.S. EPA divers within the sump area. Barr performed probing to estimate the thickness of the soft sediment material. A ½-inch diameter rigid probe rod was pushed through the sediment from a boat to refusal in order to estimate the depth of the soft sediment. The coordinates of the probing locations were recorded with a GPS (Figure 3-10). The measurements were then used to estimate the volume of the soft sediment based on the assumption that the probe refusal depth represented the base of the soft sediment.

In the sump area, the sediment is light-colored, with what the U.S. EPA divers described as a "pudding-like" texture. The divers noted a layer of dark brown water extending from the sediment interface up several feet into the water column. As discussed previously, the color may be due to magnesium hydroxide precipitate. The pH in this water was alkaline, and visibility was limited. The absence of TOC, humic-range organics, and metals from water samples from the sump area suggest that the sediment in the sump area is not CKD. As indicated by the results of samples Vharbor-5, Vharbor-7, Vharbor-8, and Vharbor-9, the sediment contains relatively large amounts of potassium, sodium, and sulfate, suggesting the presence of reactive material. The source of high pH in the sump

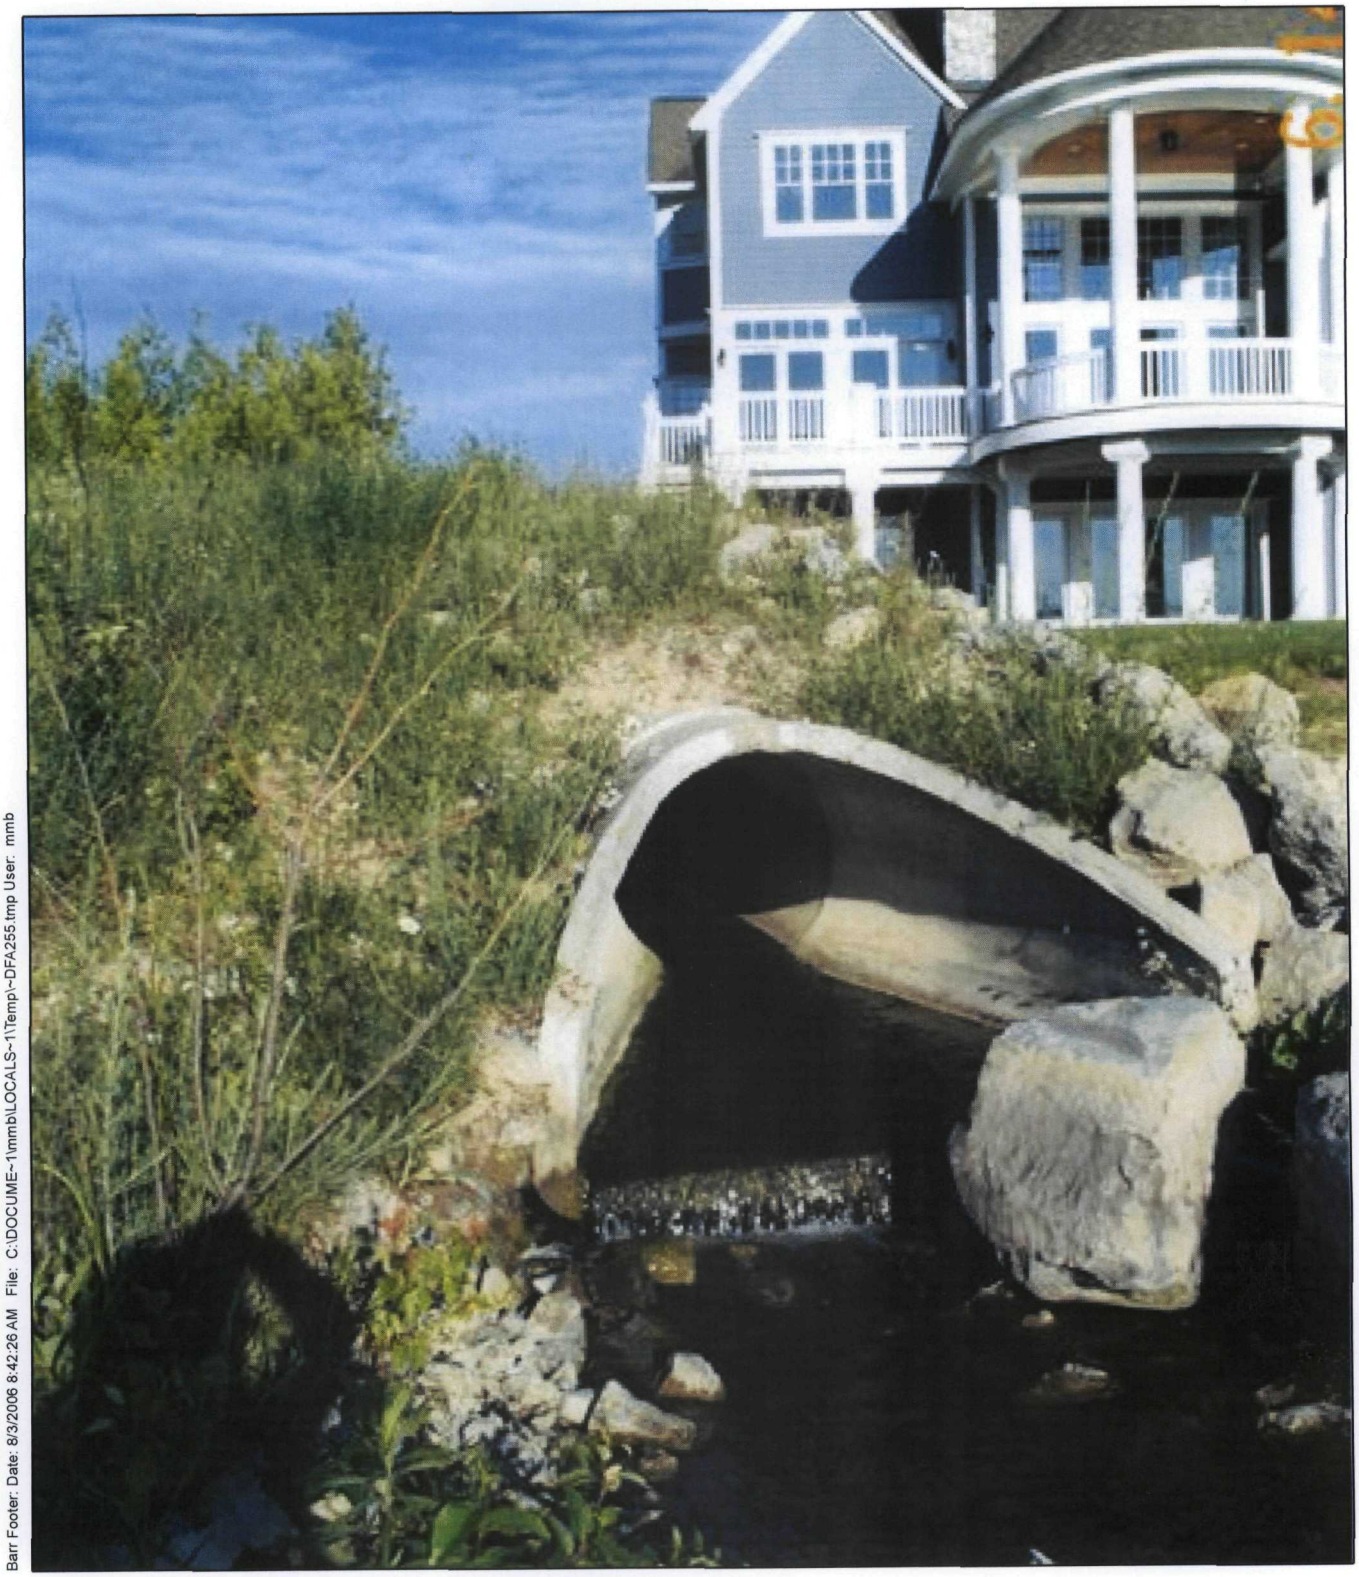
Storm water outflow to southwest corner of Village Harbor.

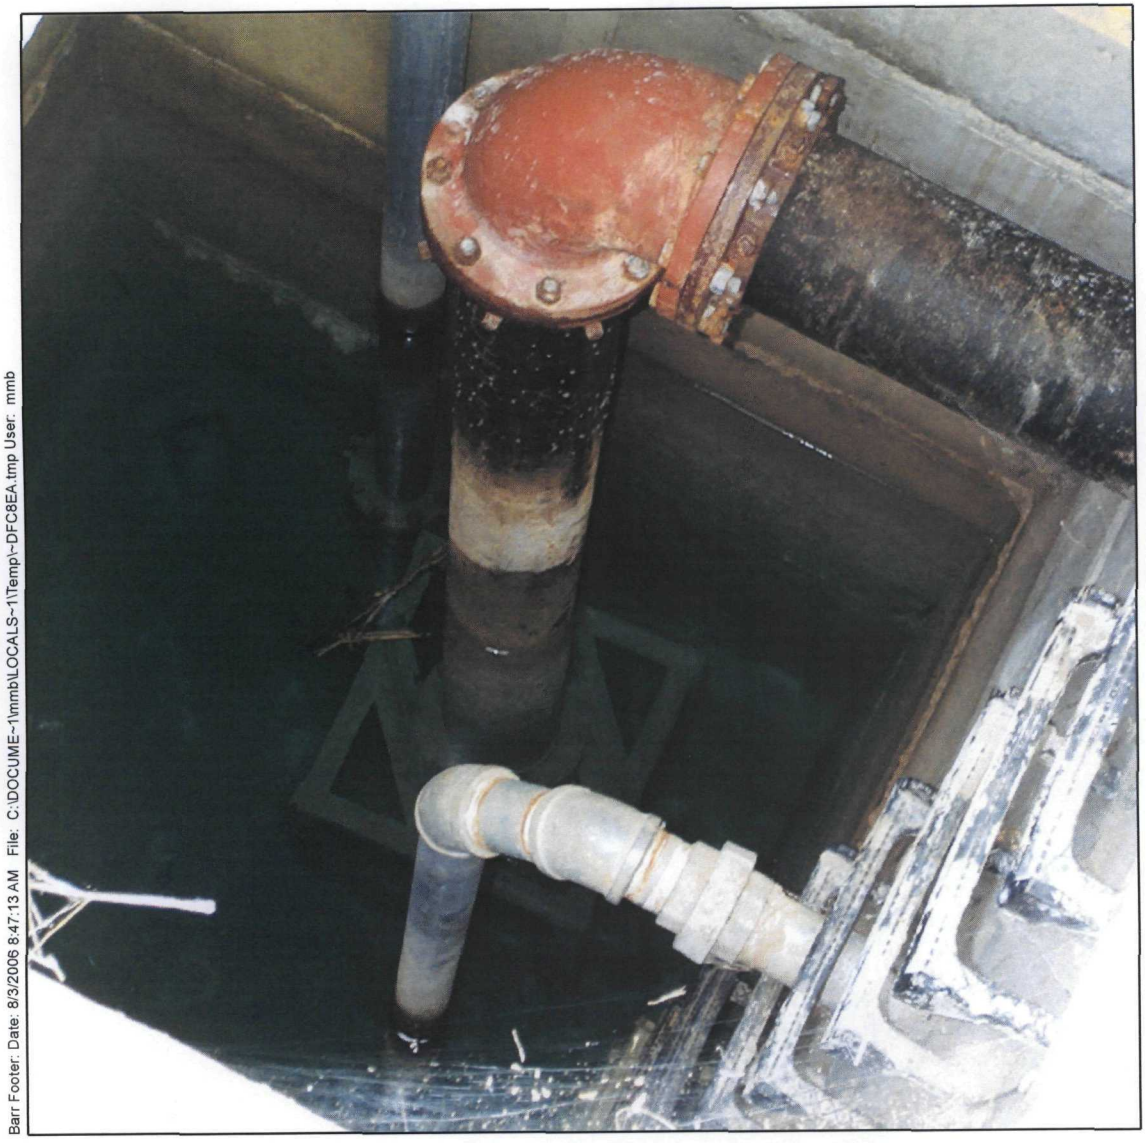
Stormwater utility access located west of the southwest corner of Village Harbor.
