CITY OF CHICAGO
DEPARTMENT OF ENVIRONMENT
PHOTOGRAPHS

Date: 6-7-02
Site: 12601 S. Carondolet
Site Code:

Time: 1:00 P.M. - 2:35 P.M.
Inspector: S. KAEHLER
County: Cook / Chicago

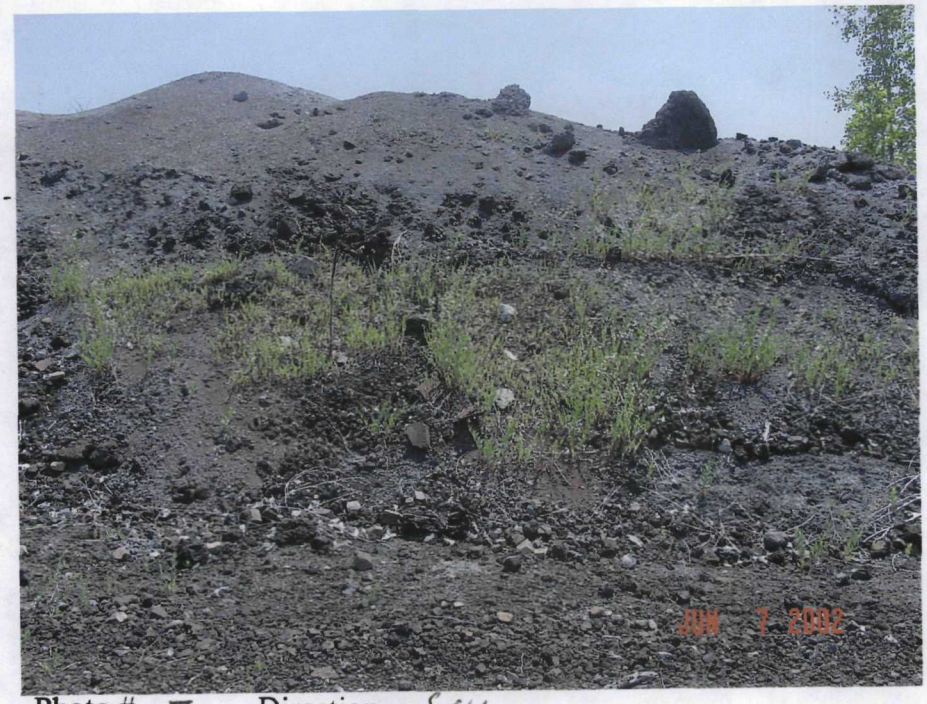
Roll # Photo # 7 Direction SW
Comments: Slag pile mixed with red dust located south of creek.
