LPC 0316005445 Cook Co.
Valspar Paints
ILD 081040107
SF/HRS
Volume 1 of 2

CERCLA
Screening Site Inspection Report

Illinois Environmental Protection Agency
P.O. Box 19276
Springfield, IL 62794-9276

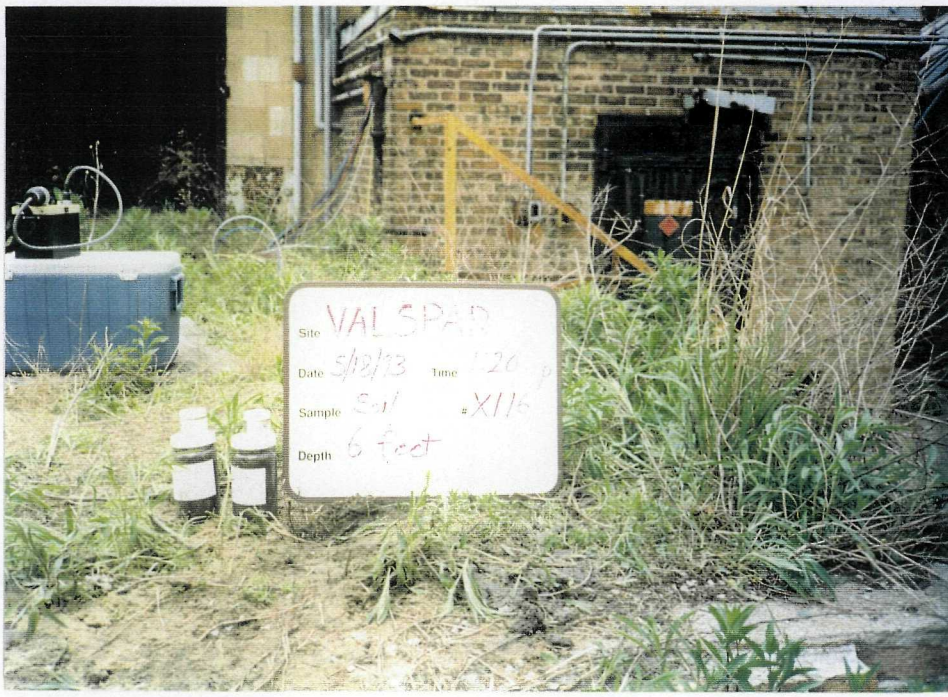
Sample X116 was located 2 feet north of the south concrete wall and 3 feet west from the east concrete wall surrounding the "Cooper's Pit" area which is associated with building 7-C. The sample was taken in an area which contains 15 under-ground storage tanks located under and extending south of building 7-C. The soil boring penetrated the soil south of tank number 290 (Figure 3-6). The purpose of this sample was to determine if any contaminants may have migrated from the under-ground tanks into the soil. Sample was taken at a depth of 6 feet using a stainless steel auger. Air monitoring from the soil boring, prior to sampling, indicated an HNU reading of 20 units. The sample consisted of wet sand with an oily sheen and contained a strong odor.

COMMENTS: Photo taken of sample point X116, located within the concrete vault in the "Cooper's Pit" area

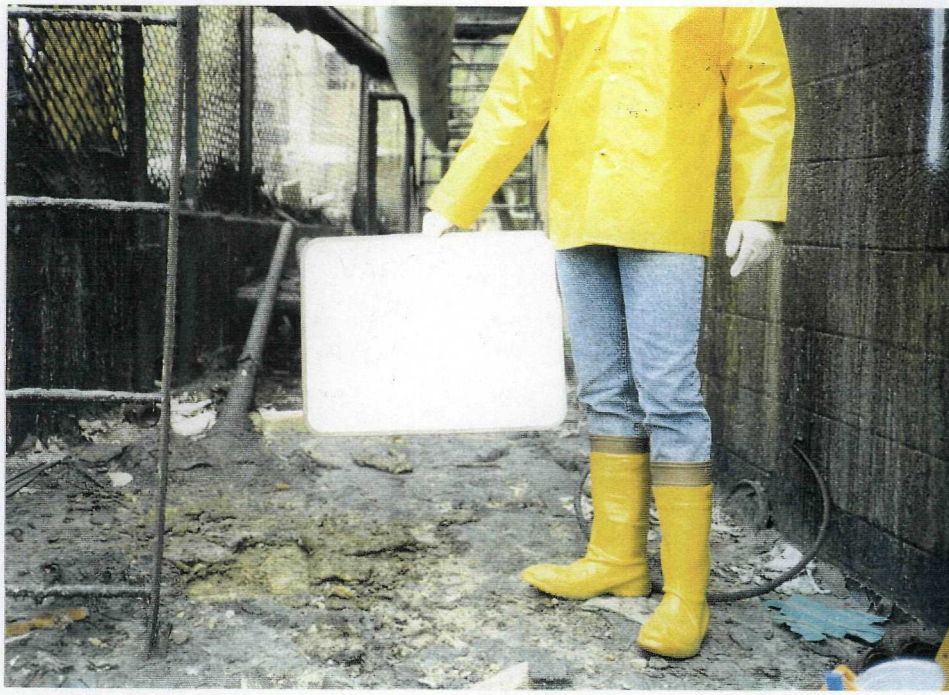
COMMENTS: Photo taken of sample point X111, located between Building 7C and the west property boundary

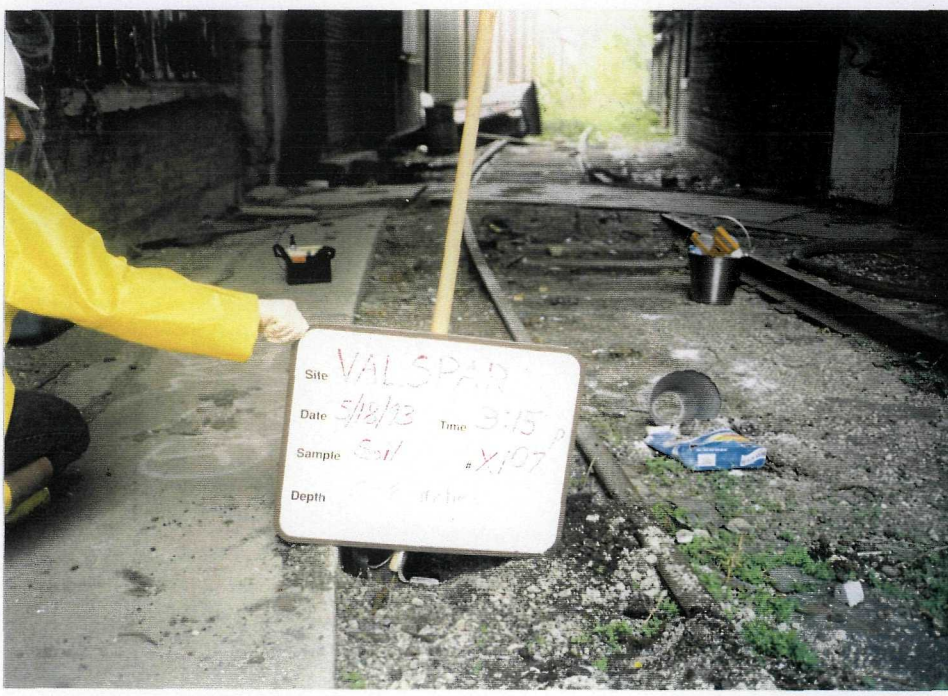
Sample X107 was located 6 feet south of building 8 and 50 feet north-east of an entrance gate located on the north-west area of the site. The sample was collected in an area which was located between a sidewalk and railroad tracks which separate buildings 7 and 8. Sparse vegetation, debris, and a dead dog were found in the proximity of the sample location. This location was chosen because of the potential for contaminants to be released from buildings 7 and 8, or possible spills associated with the adjacent railroad spur. A shovel was used to penetrate the soil and collect the

COMMENTS: Photo taken of sample point X107, located south of Building 8 and north of the railroad tracks

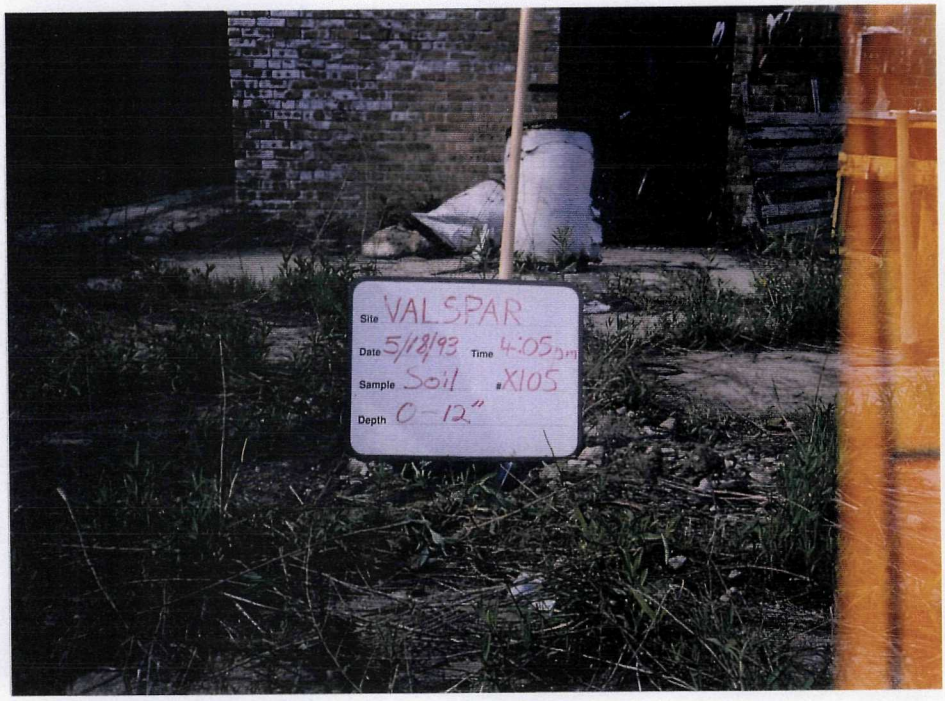
Sample X105 was located 24 feet north of the fence separating Valspar and Armstrong Containers and 20 feet south of building 25. The area surrounding building 25 consisted of a concrete pad which contained several scattered cracks through which vegetation was growing. The sample was taken through a crack in the concrete pad which encompassed the south-east corner of the property. This area was selected due to the potential storage of hazardous materials in this area. A pickax was used to break through an open area in the concrete. The sample was taken at a depth of 0 to 12 inches

COMMENTS: Photo taken of sample point X105, located in a crack in the concrete pad south of Building 25
