L 0316005445
Valspar Paints--Cook Co.
ILD 081040107

CERCLA Preliminary Assessment Report

CERCLA PRELIMINARY ASSESSMENT
VALSPAR PAINT
ILD 081040107

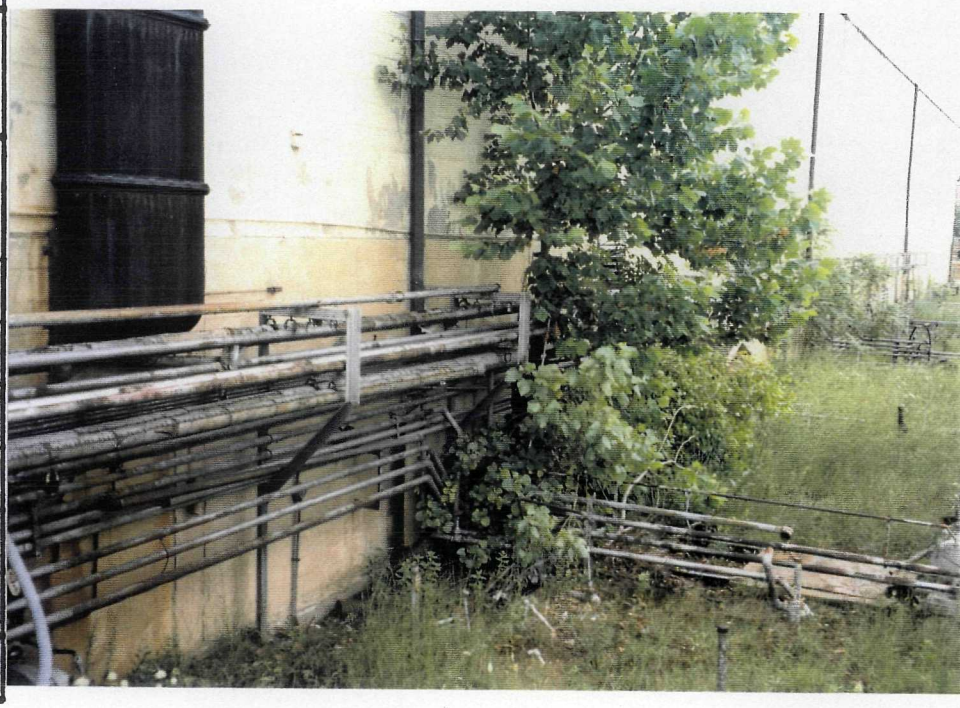
DATE: 8/12/92
TIME: 11:25
PHOTOGRAPH TAKEN BY: Steve Gobelman
COMMENTS: Pictures taken toward: the East. Pipe raceway running along the South Tank Farm.
ROLL #: 1 PHOTO #: 2

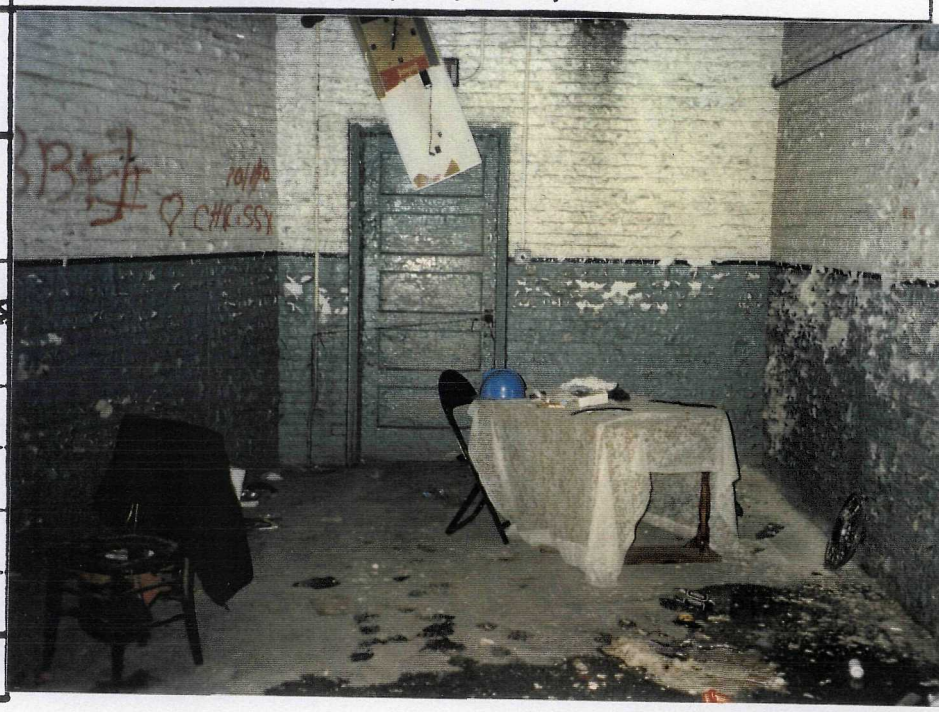
DATE: 8/12/92	SITE #: 0 3 1 6 0 0 5 4 4 5 CO.: COOK
TIME: 12:15	SITE NAME: VALSPAR PAINT
PHOTOGRAPH TAKEN BY: Steve Gobelman	
COMMENTS: Pictures taken toward: Possible living quarters discovered in a small room on the 2nd floor of building #7.	
ROLL #: 1 PHOTO #: 9
