Marvel Engineering
ILD 984837104
L0311860037/Cook Co.
SF/HRS

CERCLA
Integrated Site Assessment

Illinois Environmental Protection Agency

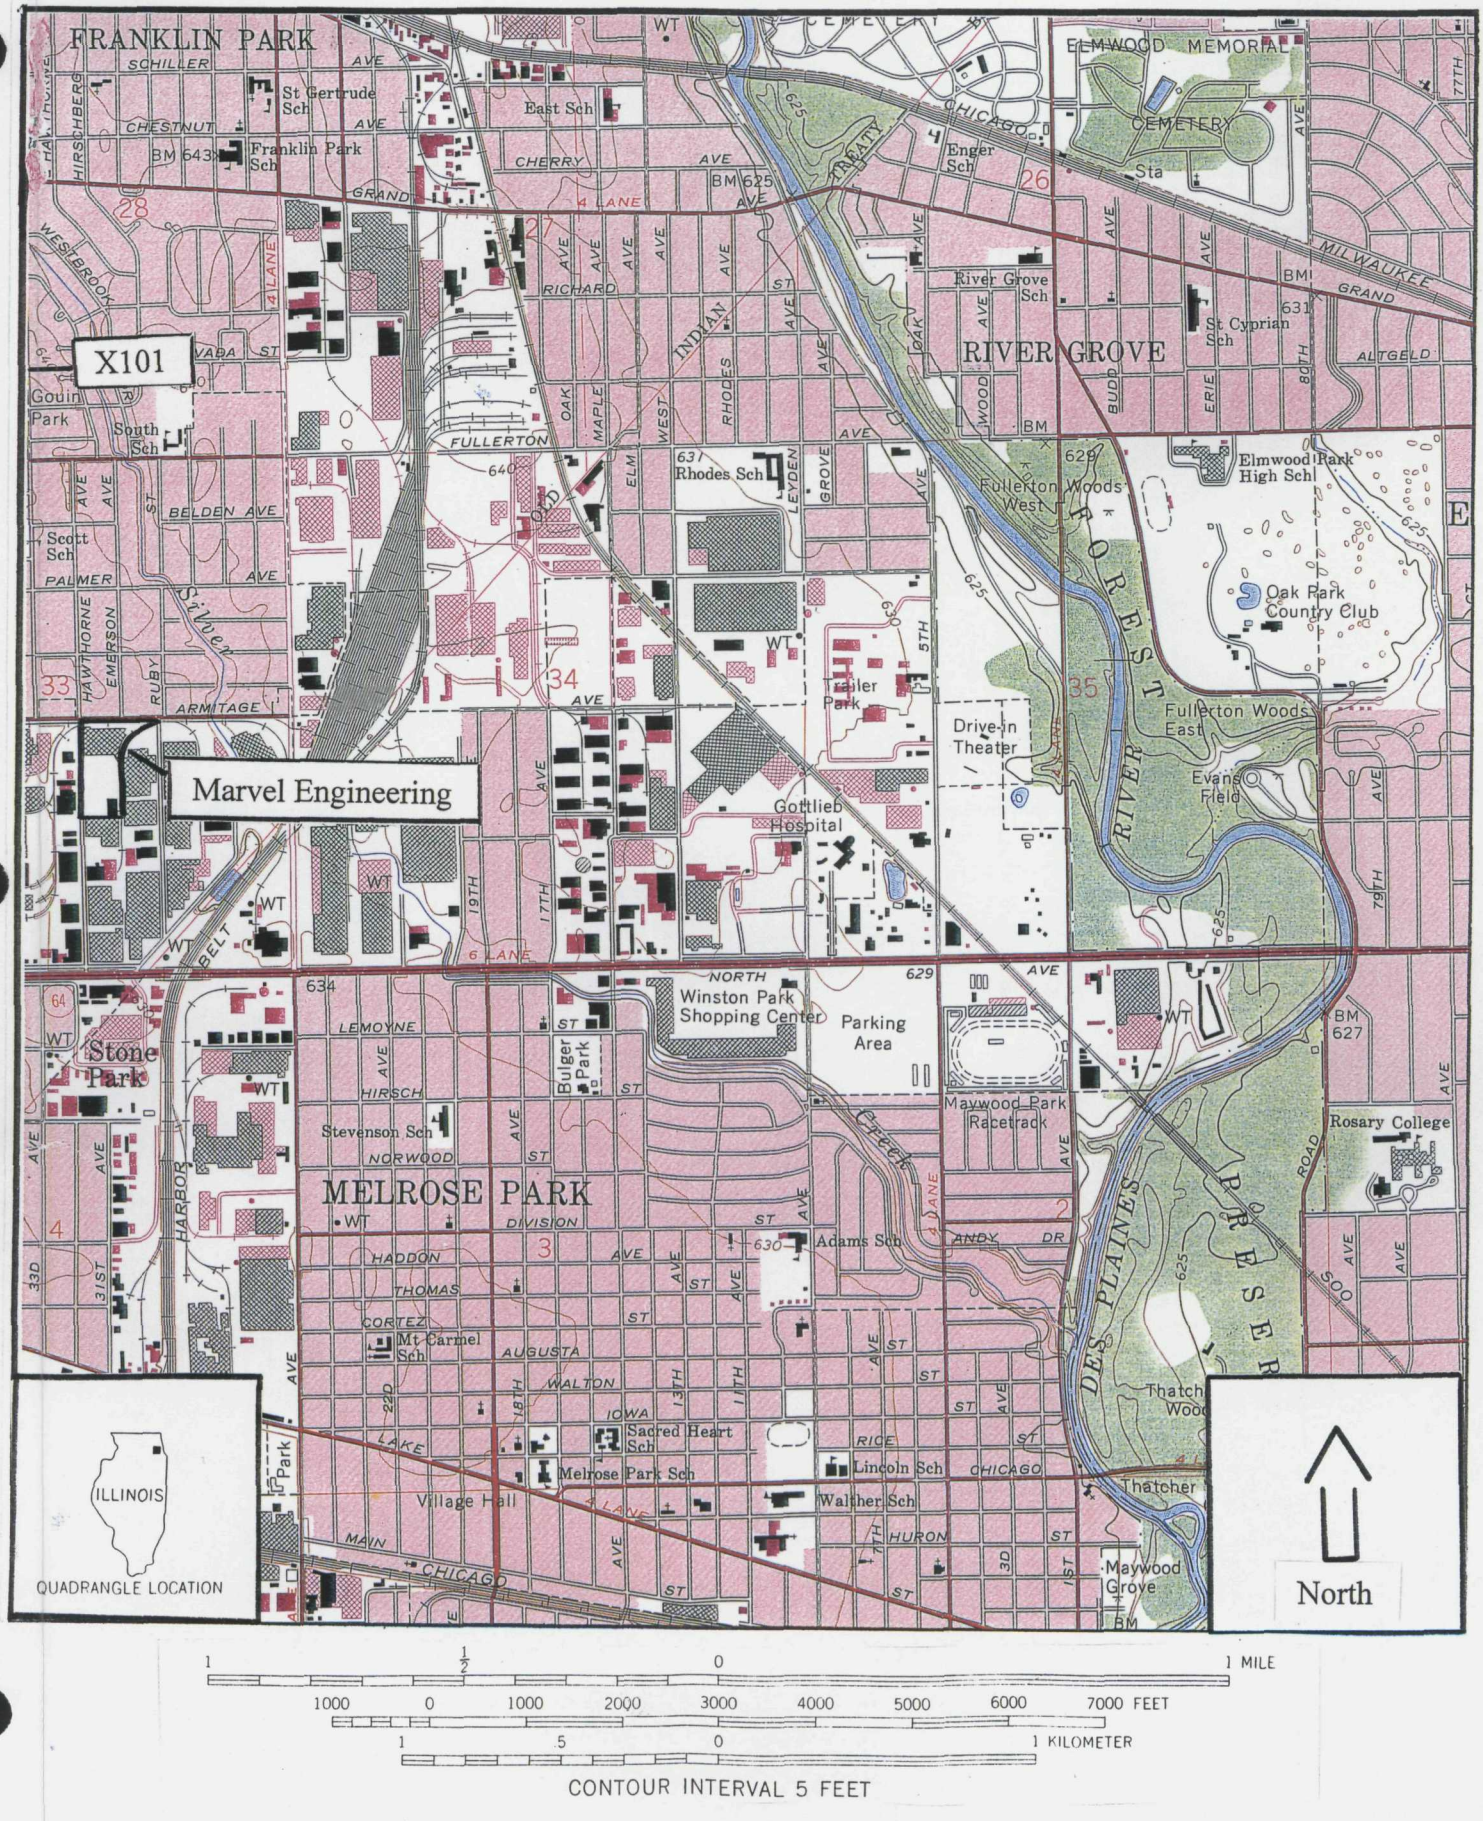
Figure 3. Marvel Egineering 1973 aerial photograph showing Integrated Assessment sample locations.

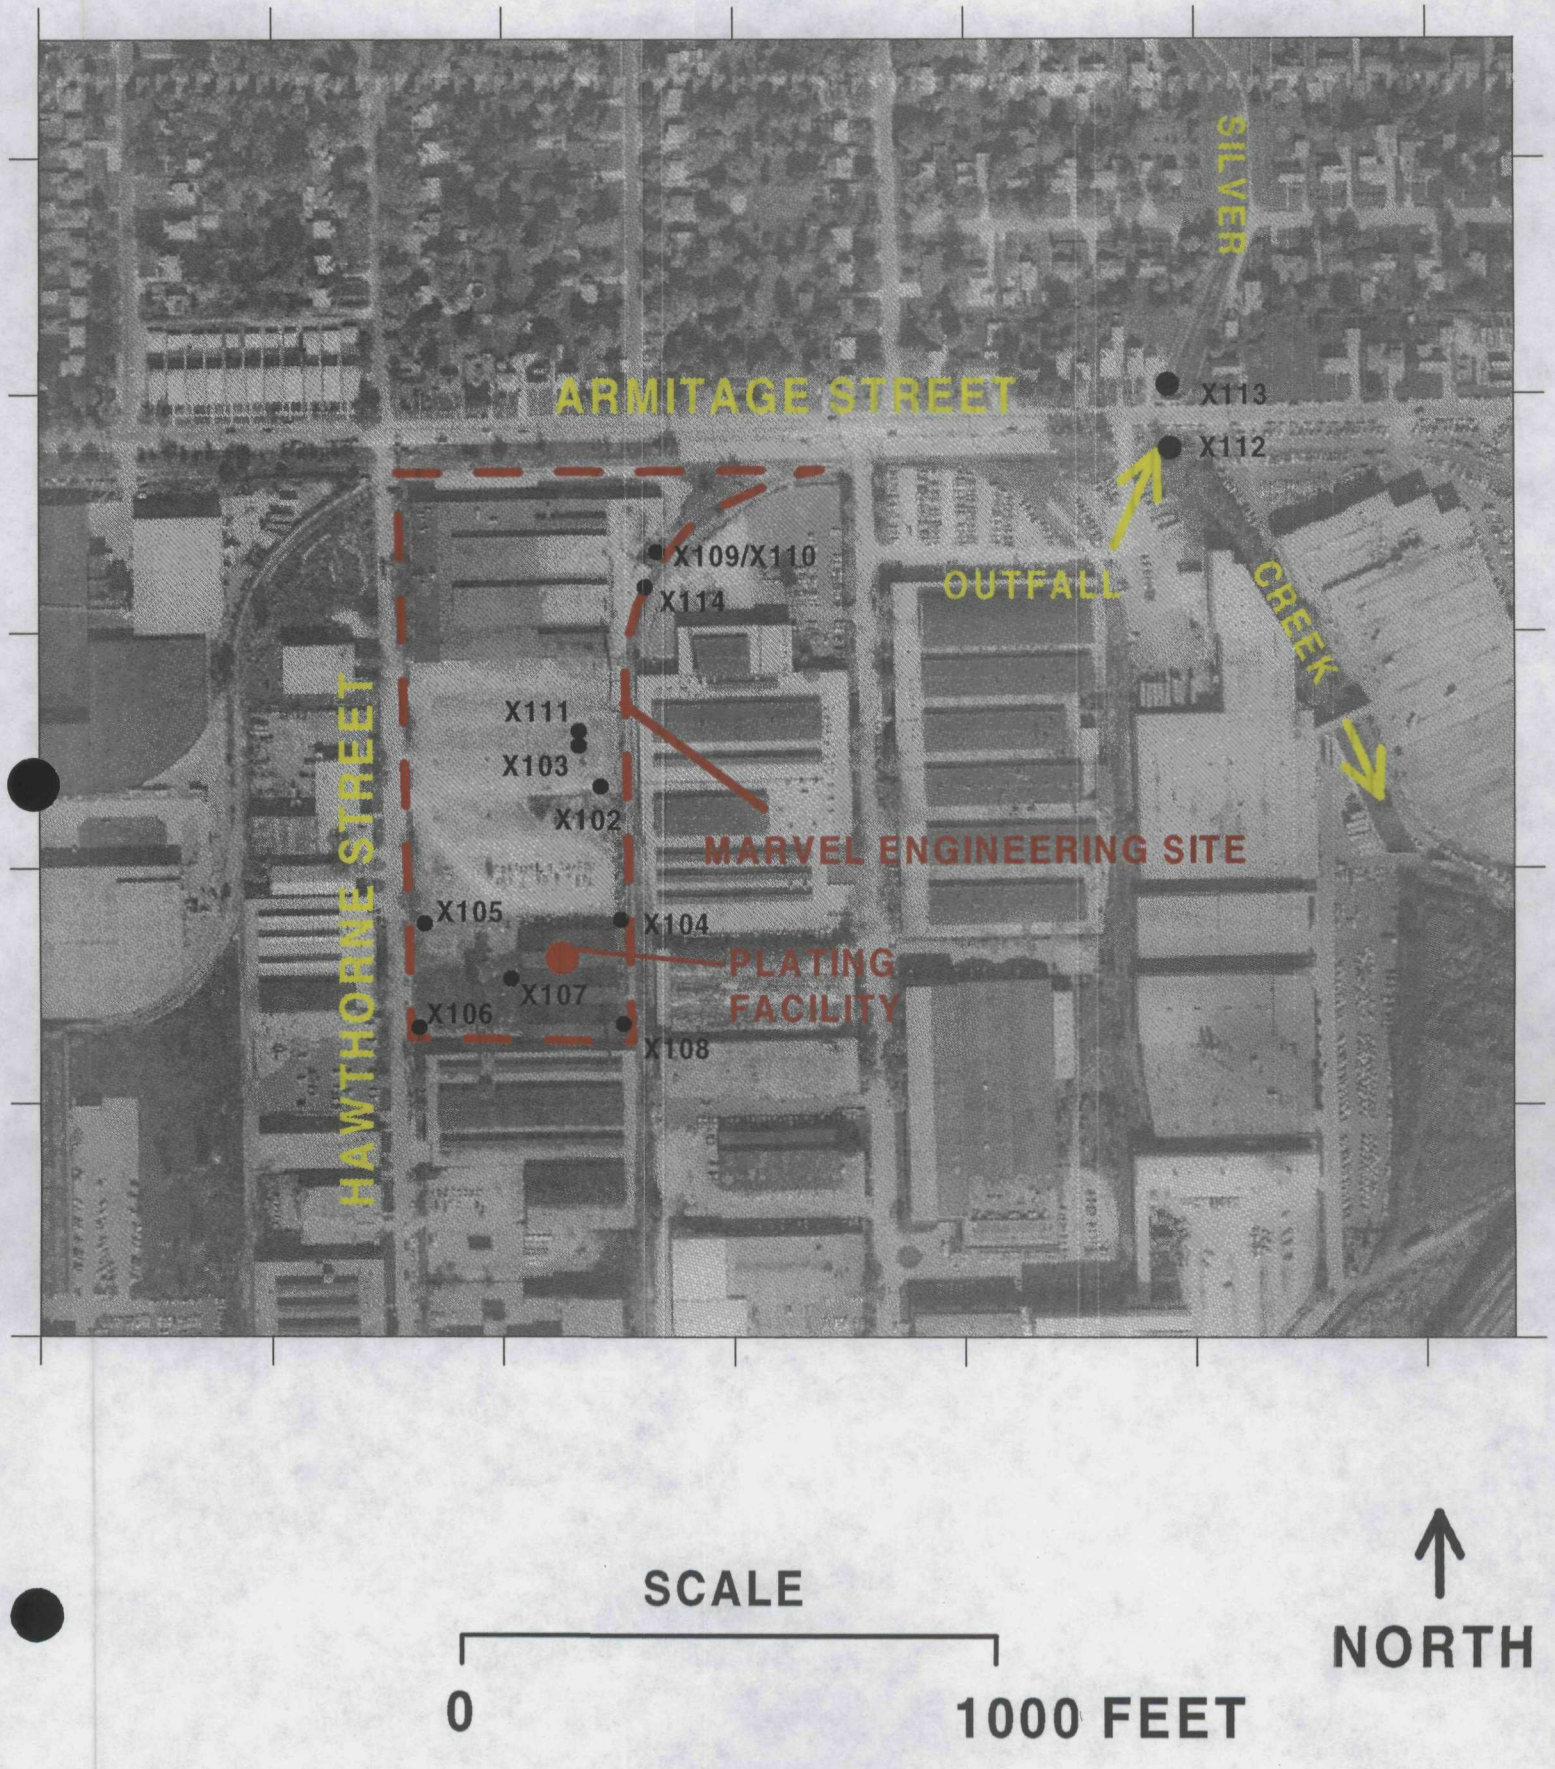
Figure 4. Marvel Engineering 1993 aerial photograph showing Integrated Assessment sample locations.

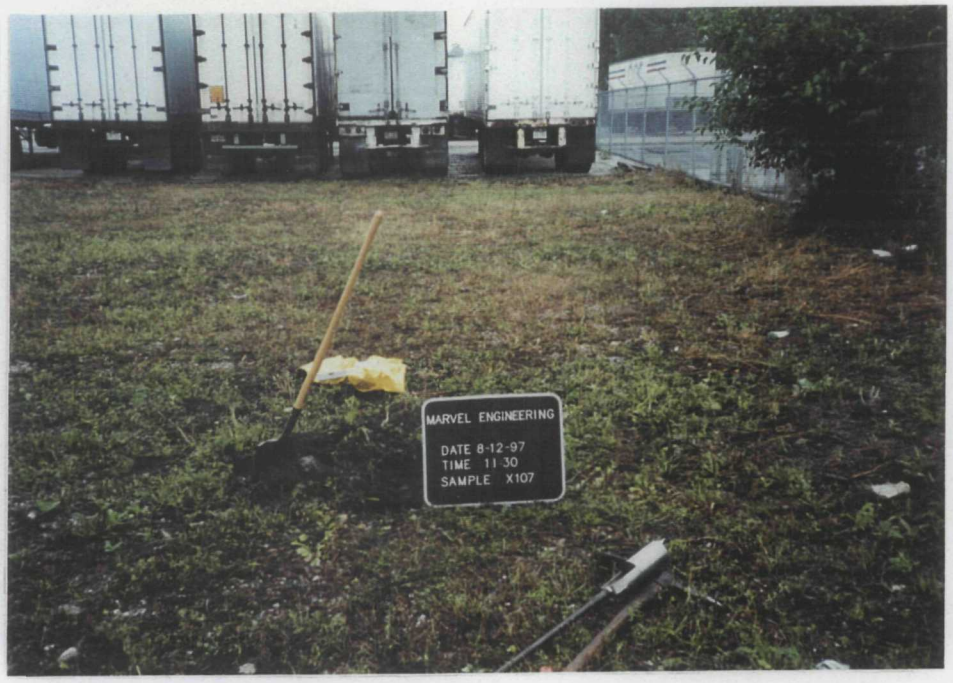
DATE: AUGUST 12, 1997
TIME: 11:30
PHOTO BY: Mark Densmore
SAMPLE: X107
DIRECTION: NORTH
COMMENTS: Photo taken of soil sample located in the south side of the site.

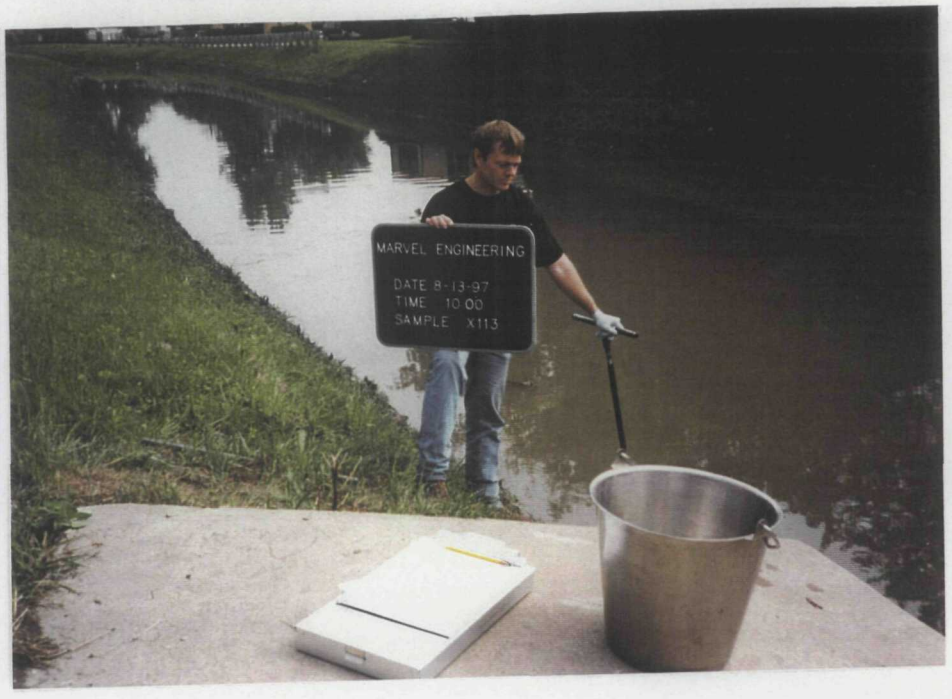
Two samples were taken near an industrial outfall east of the Marvel Engineering site. Sample X113 was taken upstream from the outfall and sample X112 was taken downstream from the outfall. Sample X112 contained elevated levels of semi-volatile organic compounds in comparison to sample X113. The Ontario Sediment guide is used to determine the sediment

quality. The total PAH effect of the sediment quality in Silver Creek based upon sample X112 would be between the lowest effect level and the severe effect level.

The presence of elevated levels of semi-volatile organics were detected in the downgradient sediment sample X112 at levels of more than three times the background sediment concentration. Lead and nickel were also elevated in downgradient sample X112. Section 6.2 of this report includes a discussion of the sediment screening benchmarks.

DATE: AUGUST 13, 1997
TIME: 10:00
PHOTO BY: Mark Densmore
SAMPLE: X113
DIRECTION: NORTH
COMMENTS: Photo taken of sediment sample location upstream of the confluence of the outfall and Silver Creek.

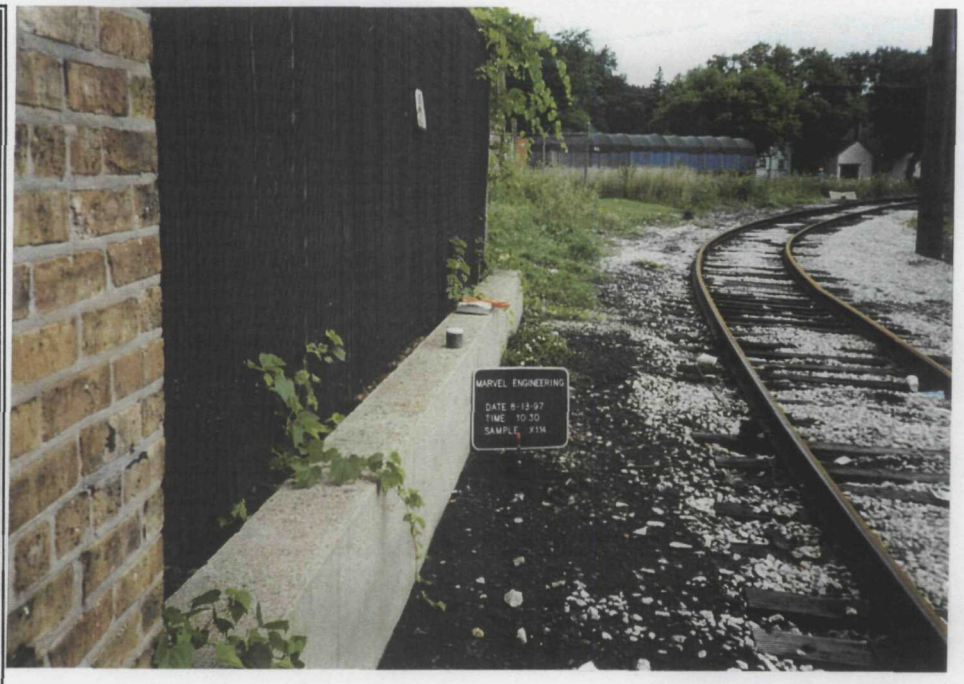
X114	0-2 inches	Soil sample collected along a retaining wall on the east side of the main building. Behind the retaining wall are transformers. Sample located 14 feet north where the retaining wall joins the building near crack in wall. The sample consisted of silty fill.

DATE: AUGUST 13, 1997
TIME: 10:30
PHOTO BY: Mark Densmore
SAMPLE: X114
DIRECTION: NORTH
COMMENTS: Photo taken of soil sample location just outside of a retaining wall with a crack in it. Within the retaining wall are transformers.

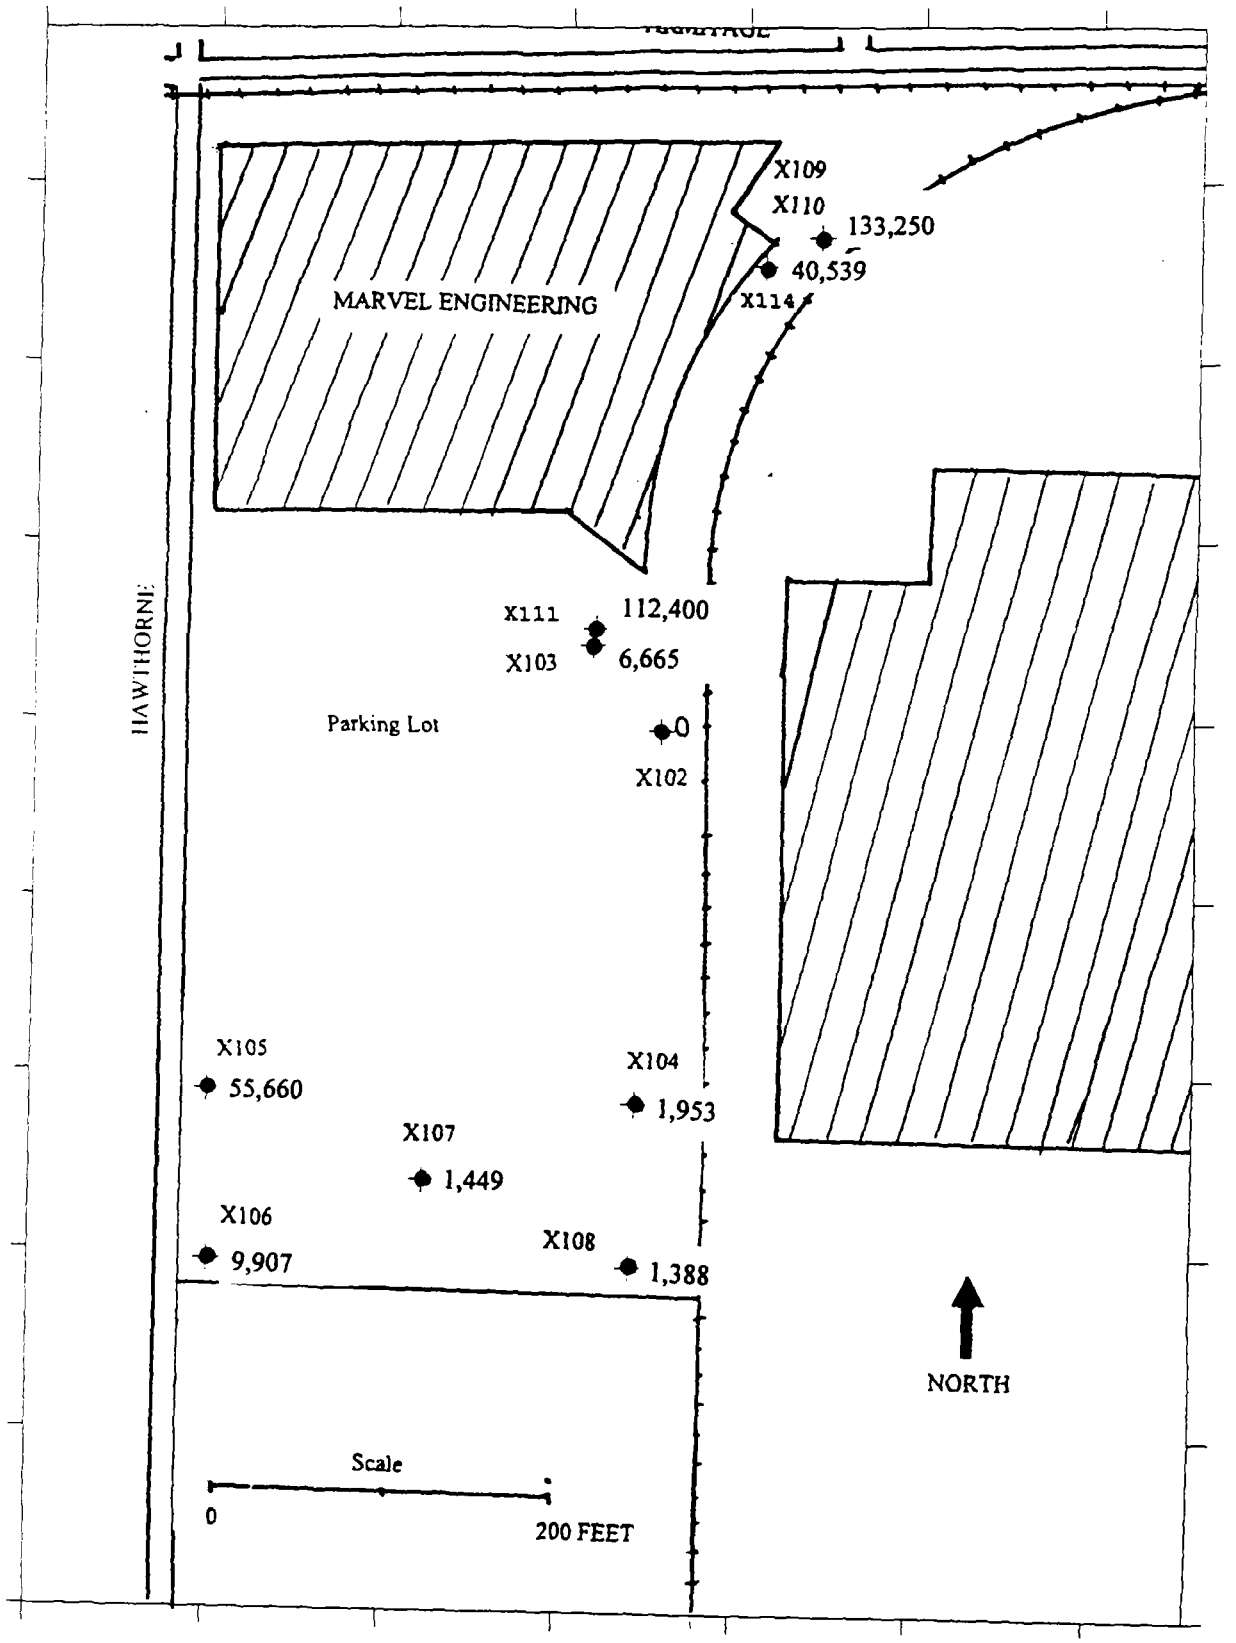
Site map of Marvel Engineering showing total PAH concentrations (ppb) to the right of the sample points.
