EPA Region 5 Records Ctr.
351340

12-7-83
inspection
Dixon, Il.
Green River
Industrial Park

Green River Industrial Park
P.O. Box 326
Dixon, Illinois
(Building 115)

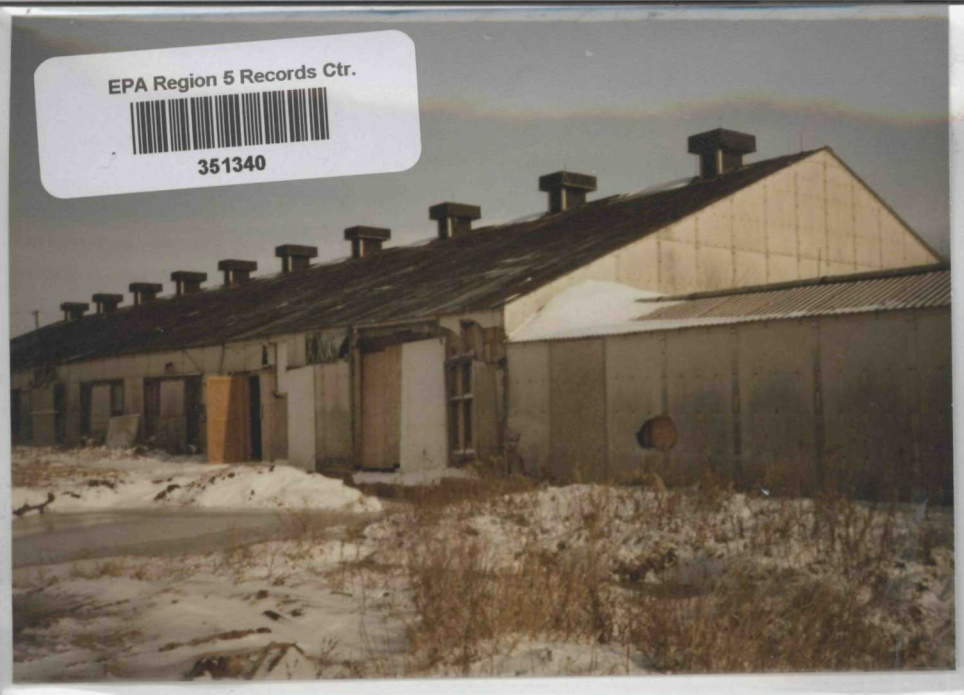
photo 6
Set 1

Building 107
entrance door open

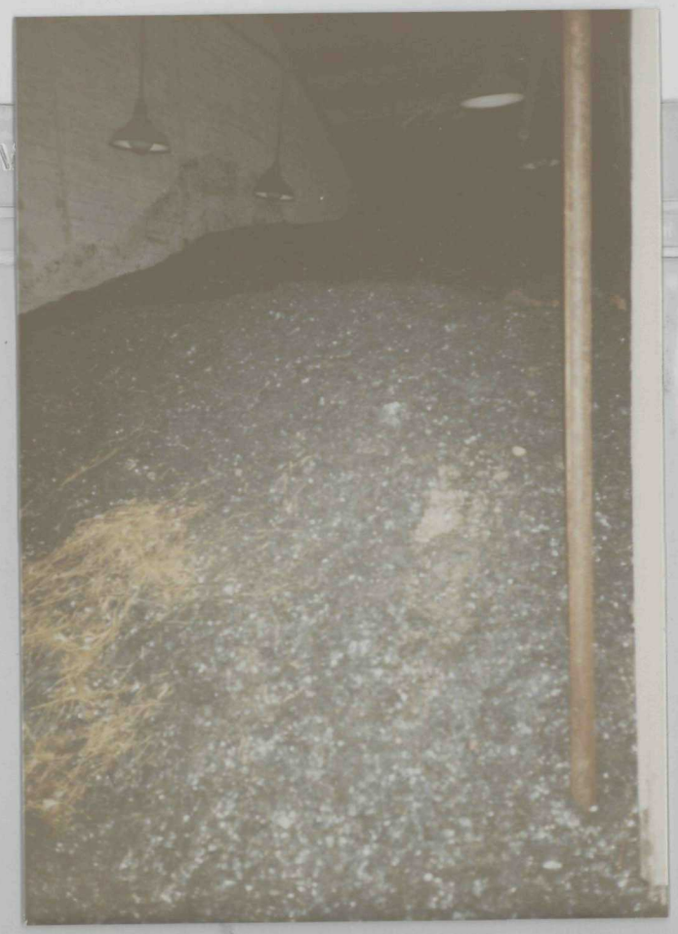
photo #22 Inspection 9/26/83
Set #2

Hallway (right center of photo) connecting to building #115

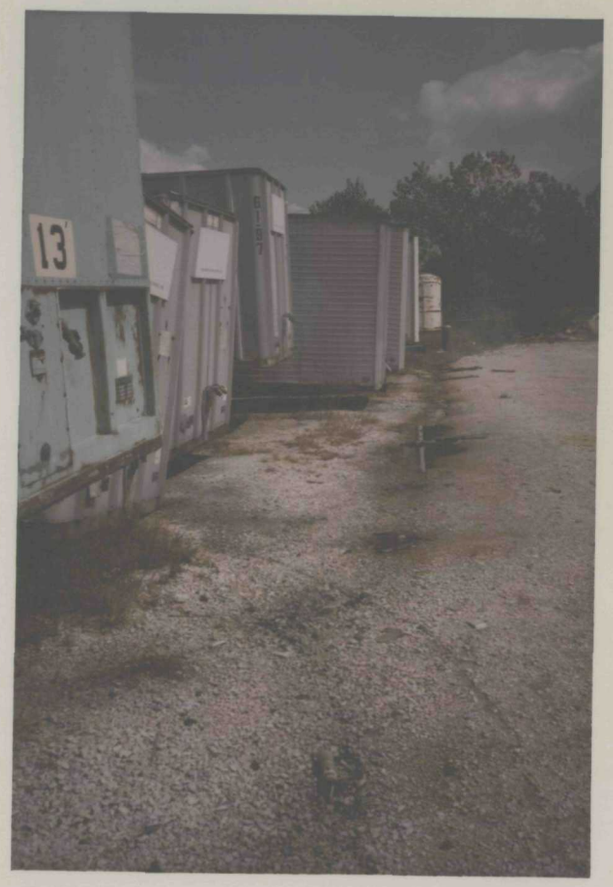
photo #10
Set #1

Trailers at Gemini Leasing Company, Inc. Hodgkins – Trailers have sunk into the soil to some degree. Standing liquid & blue stains in foreground believed to be leachate from the trailers containing "chip"
