6/8/89 Satra Sampling

EPA Region 5 Records Ctr.

Satralloy - ck. Chrome ore fines Catch - ditch in front of plant for EP tox waste

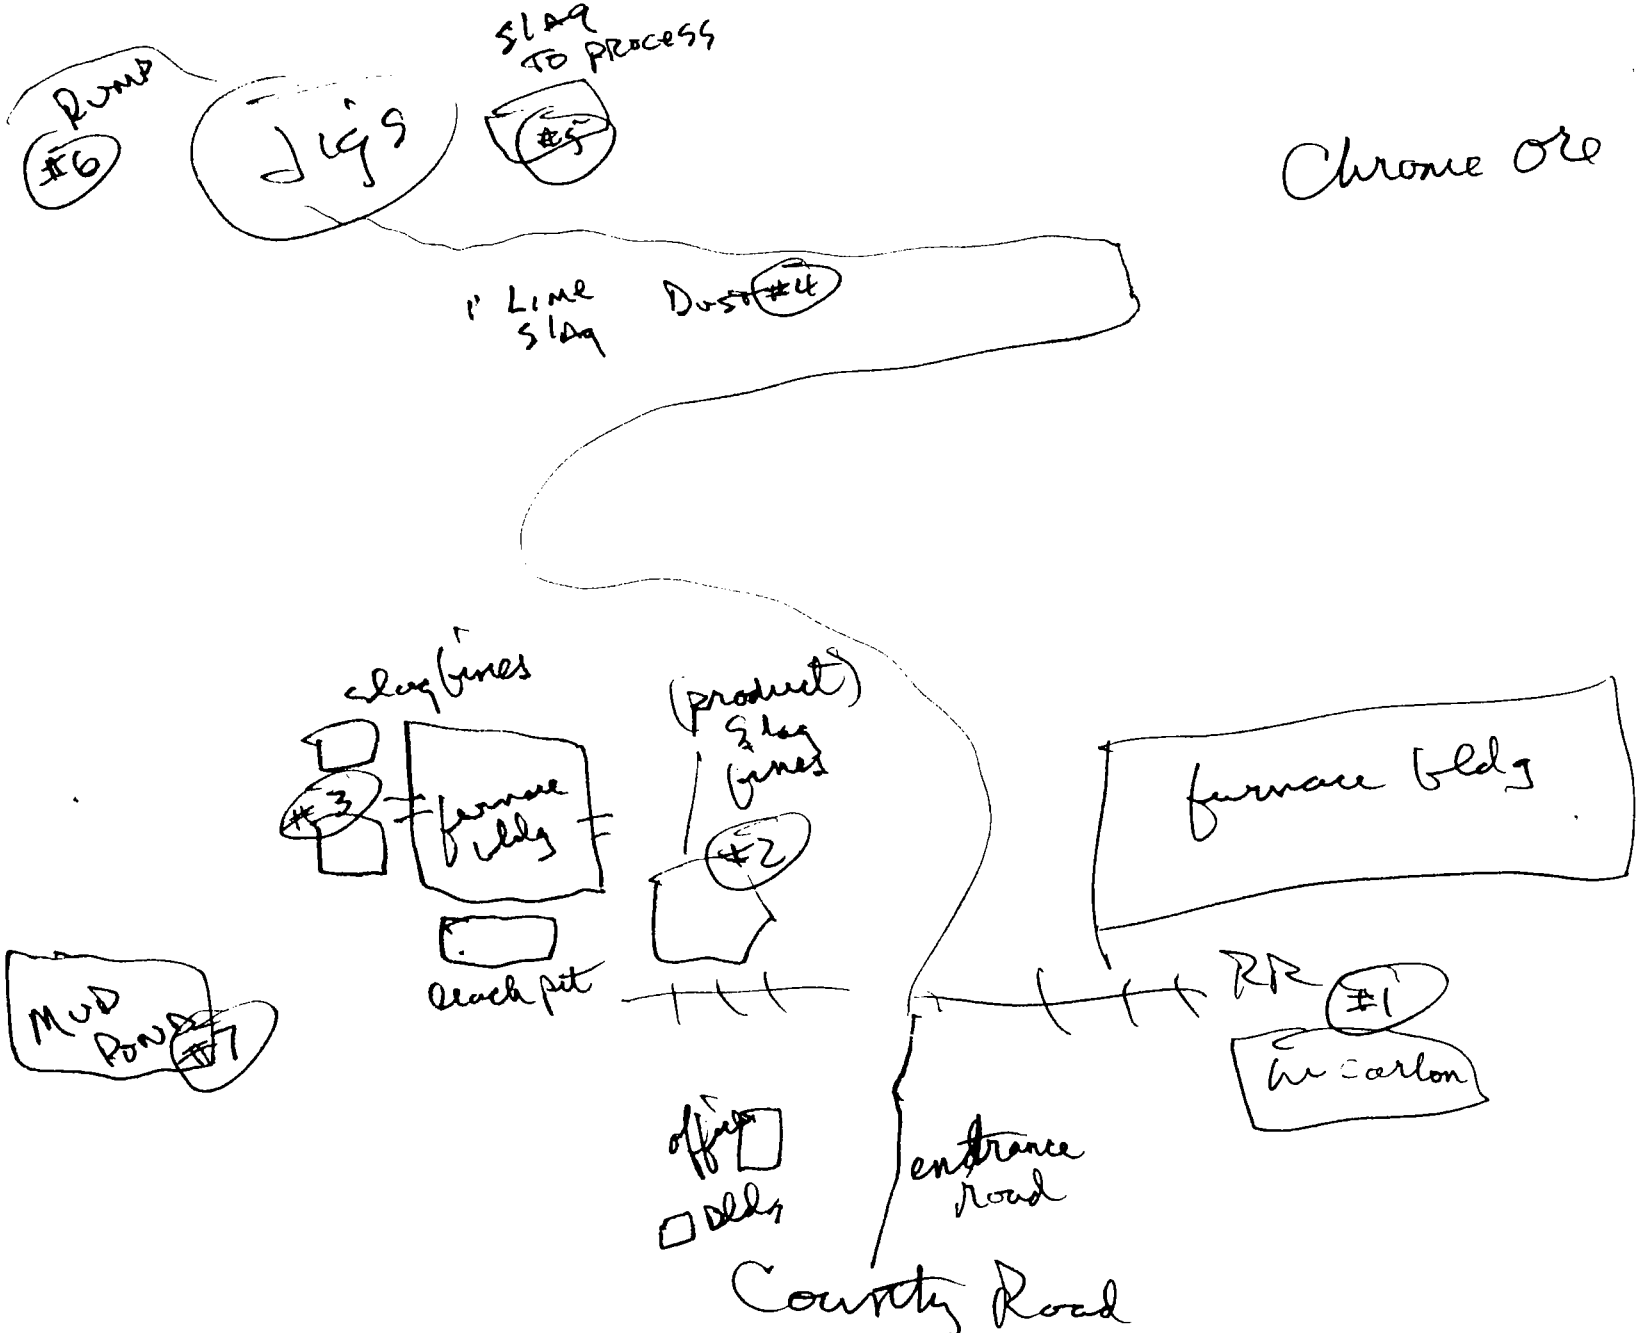
Note - water from concentrate process goes from pipe on side of bldg. into leach pit. Mud settles out, then is bucketed w. F. end loader to pond for drying. pond made of slag material & almost full. Satra plans to construct another, soon.

Chrome Ore
Jigs
Pump
#6
Slag to process
#5
1" Lime Slag
Dust #4
slag fines
#3
furnace bldg
(product) Slag fines
#2
furnace bldg
Mud Pond
#7
Leach pit
RR
#1
in carton
office
bldg
entrance road
County Road
