M&H Zinc
20405.012.001.0729.00

Project M + H Zinc Fund Lead RV
1375 9th Street
LaSalle, IL

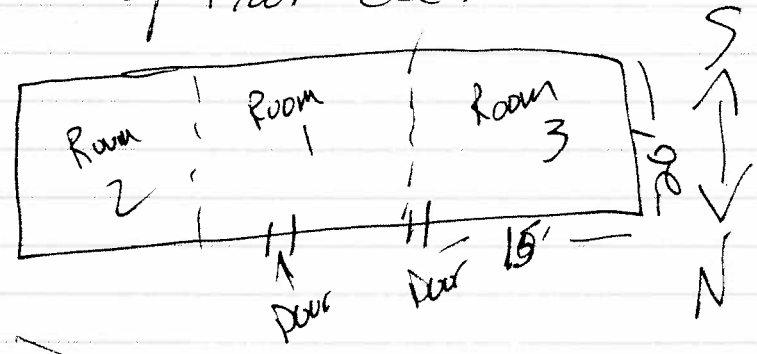
Vestibule to 3rd Room
5' X 8' X 11' high

3rd Room
20' wide (building
25' X 20'

Room1 ~~20' X 25'~~ X 12' high
Room2 30' X 20 12

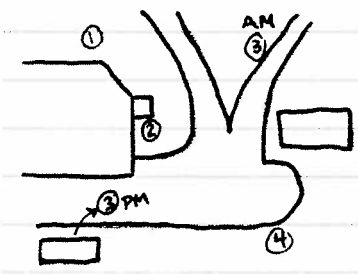
①-④ = Air pump locations
