SITE ASSESSMENT REPORT
FOR THE
BLISSFIELD CANNERY SITE
BLISSFIELD, LENAWEE COUNTY, MICHIGAN

Date Prepared:	June 20, 2011
Technical Direction Document No.:	S05-0001-1012-005
Document Control No.:	1294-2A-ANOA
Contract No.:	EP-S5-06-04
START Project Manager:	Lori Kozel
Telephone No.:	(248) 658-5012
U.S. EPA On-Scene Coordinator:	Jon Gulch

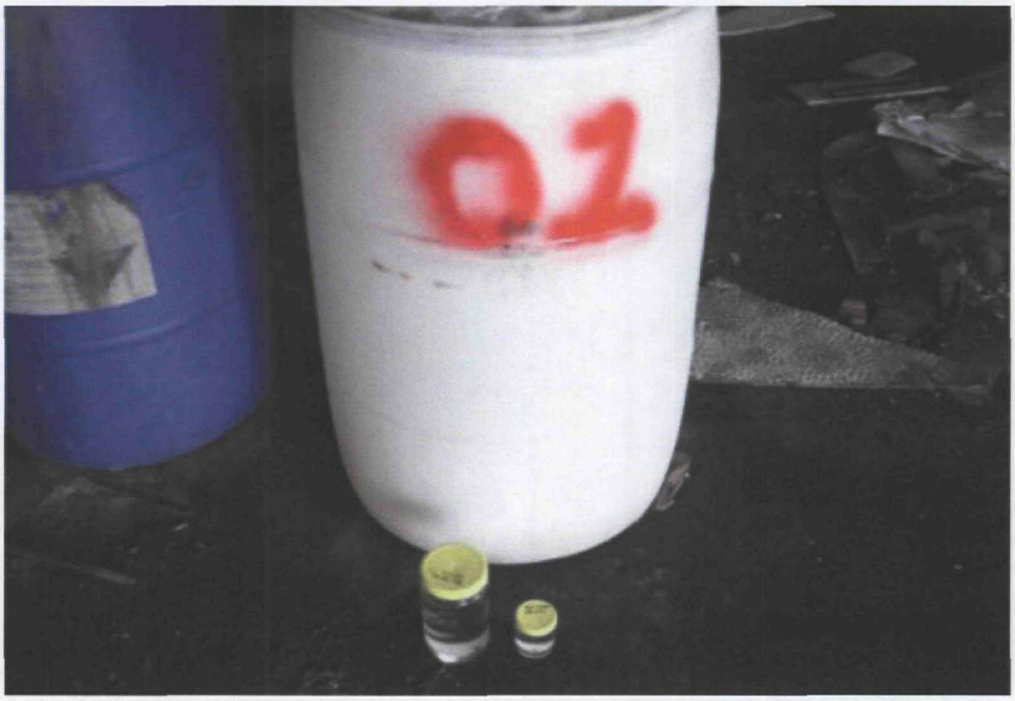
Site: Blissfield Cannery Site
Photograph No.: 5 **Date:** 5/17/11
Direction: Down **Photographer:** Matthew Beer
Subject: Liquid sample BC-WL01-051711 and its container

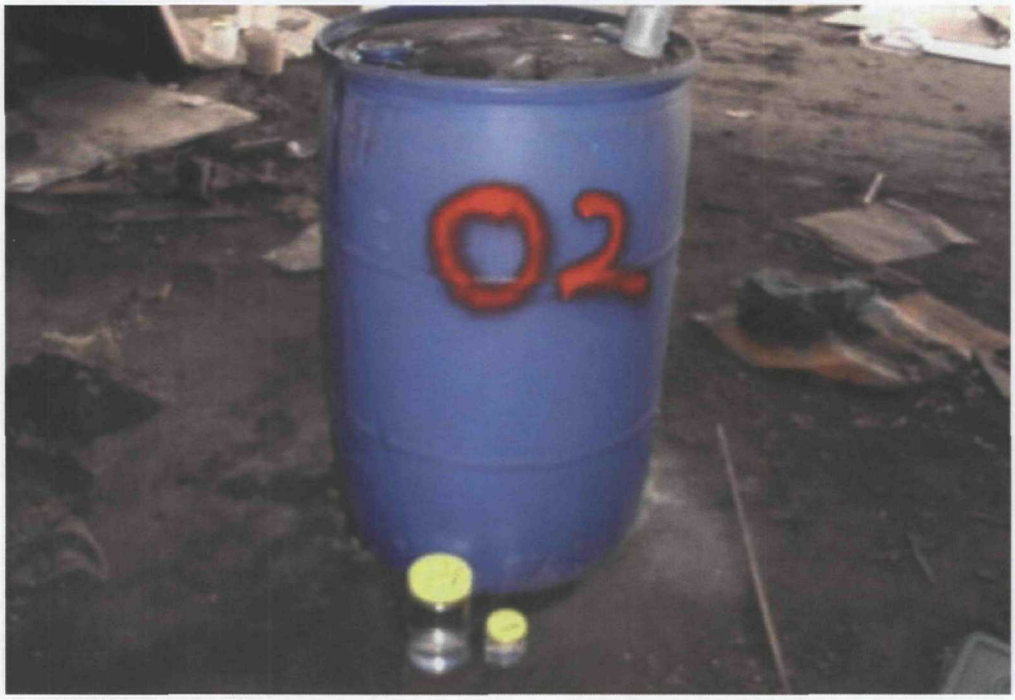
Site: Blissfield Cannery Site
Photograph No.: 6 **Date:** 5/17/11
Direction: Down **Photographer:** Matthew Beer
Subject: Liquid sample BC-WL02-051711 and its container

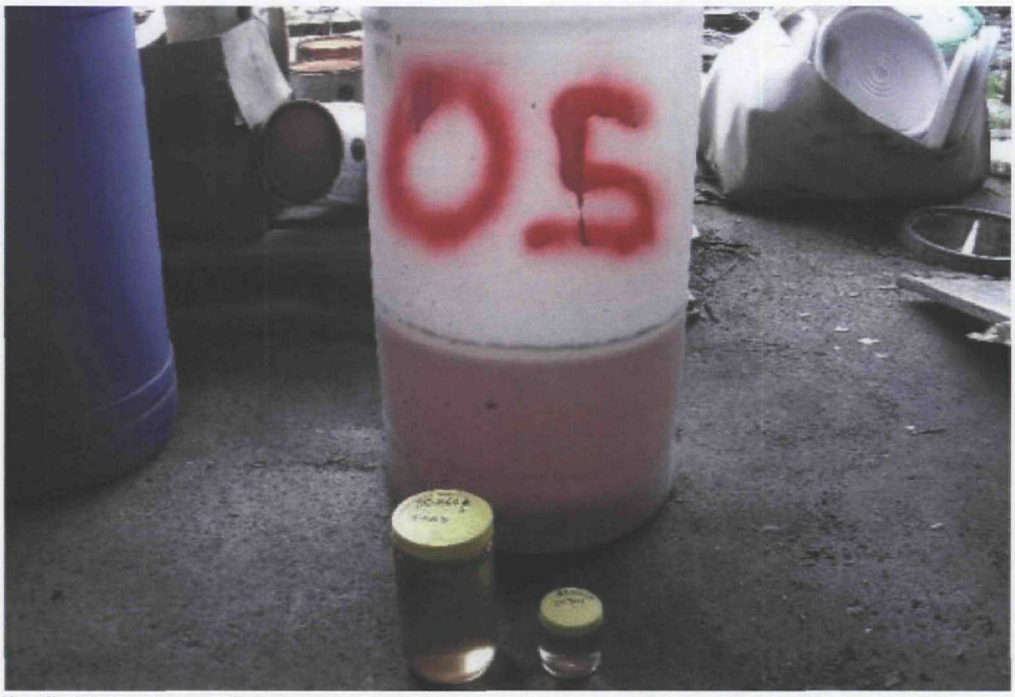
Site: Blissfield Cannery Site
Photograph No.: 009 **Date:** 5/17/11
Direction: Down **Photographer:** Matthew Beer
Subject: Liquid sample BC-WL05-051711 and its container

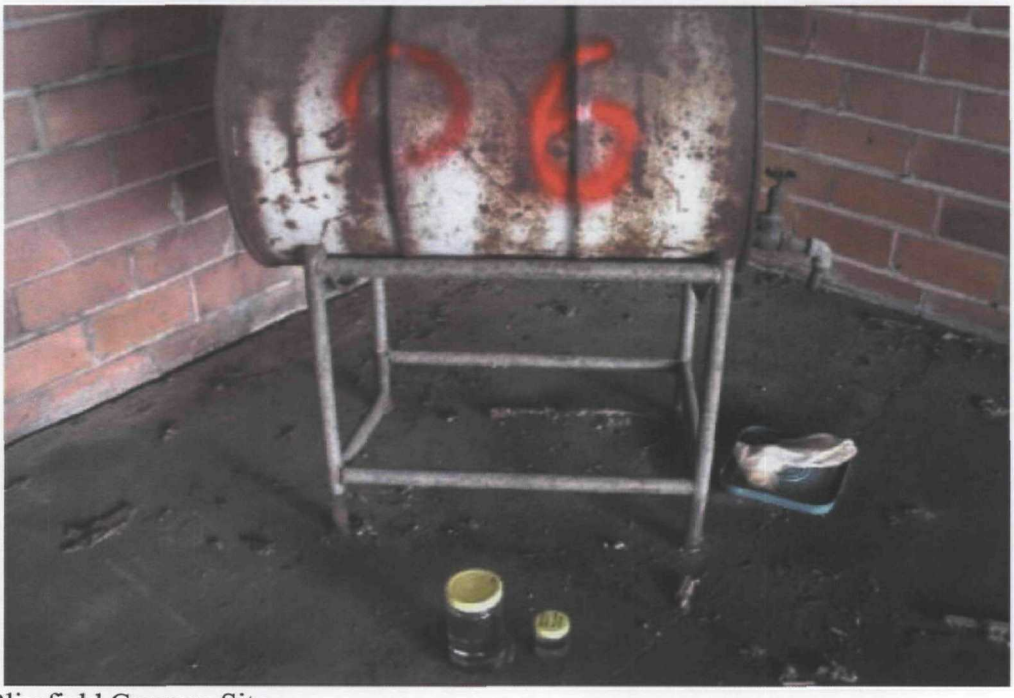
- **TCLP Metals:** Liquid sample BC-WL08-051711 contained chromium at 450 milligrams per liter (mg/L), which exceeds the 40 CFR 261.2 criterion for chromium of 5 mg/L. Therefore, this sample represents a hazardous waste by virtue of the characteristic of toxicity.
- **TCLP VOCs:** Liquid sample BC-WL06-051711 contained 1,4-dichlorobenzene at 220,000 mg/L, which exceeds the 40 CFR 261.2 criterion for 1,4-dichlorobenzene of 7.5 mg/L. In addition, sample BC-WL06-051711 also contained chlorobenzene at 2,900

mg/L, which exceeds the 40 CFR 261.2 criterion of 100 mg/L. Therefore, this sample represents a hazardous waste by virtue of the characteristic of toxicity.

Site: Blissfield Cannery Site
Photograph No.: 10 **Date:** 5/17/11
Direction: Down **Photographer:** Matthew Beer
Subject: Liquid sample BC-WL06-051711 and its container
