US EPA RECORDS CENTER REGION 5
422296

DATE 2/16/72

Lucas County

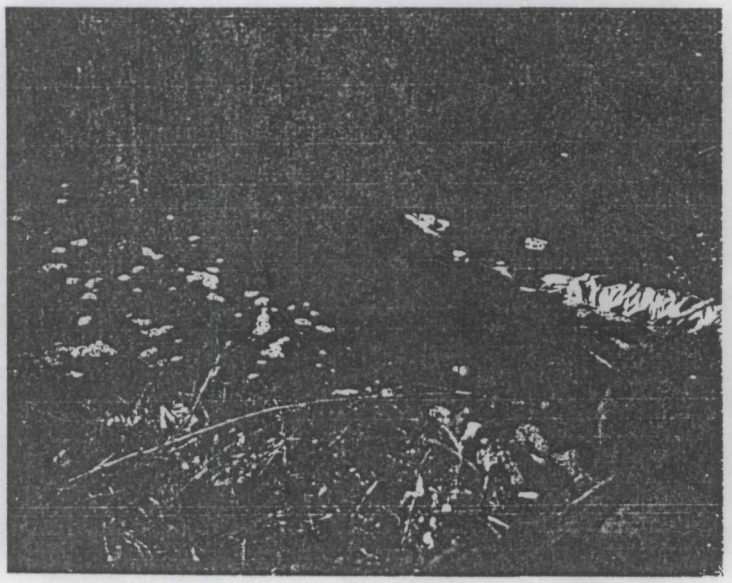
12:30

NAME drainage from Municipal

ADDRESS Services & Treasure Isle dumps as it enters Ditch #1139; drainage was black & odorous (H_2S) & the D.O. ≅ 0.6 mg/l

flow was 100 - 200 gpm

NAME Ditch #1139 upstream from

ADDRESS the Central Ave. dump site; D.O. ~60' upstream from trash = 4.0 mg/l

D.O. in ditch from Donovan = 6.3
" " " " Inland = 8.8
(strong chemical odor at this location)

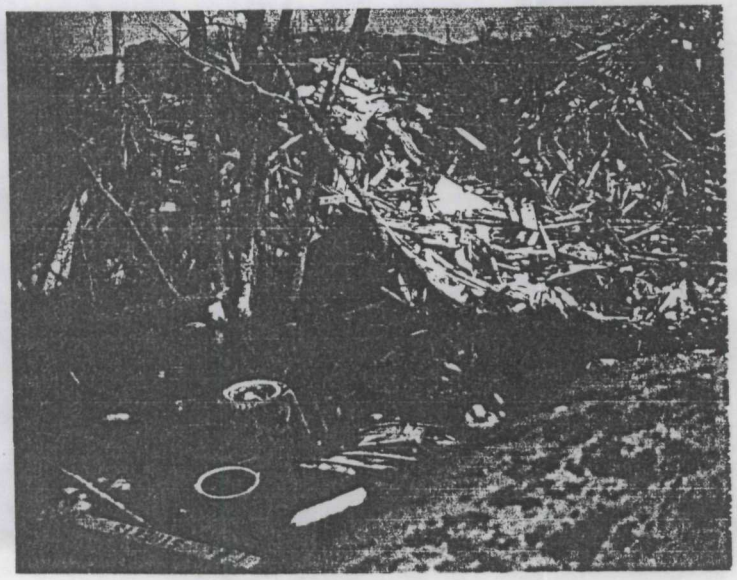
2:00

NAME looking at drainage ditch

ADDRESS along Municipal Services dump into which the storm sewer from Booth Rd. discharges (sewer can be seen in picture); wastewater in ditch is black & odorous, & probably septic

NAME Ditch #1139 as it leaves the

ADDRESS Central Ave. Dump site; great deal of sludge deposited in the ditch (3' deep in one spot)
