Subject: **Multi-Service Site Assessment Report**
Dayton, Montgomery County, Ohio
Technical Direction Document No.: S05-0001-1101-003
WESTON START Contract No.: EP-S5-06-04
Document Control No.: 1344-2A-ALVJ

SITE ASSESSMENT REPORT
FOR THE
MULTI-SERVICE SITE
DAYTON, MONTGOMERY COUNTY, OHIO
SITE ID NO. C508

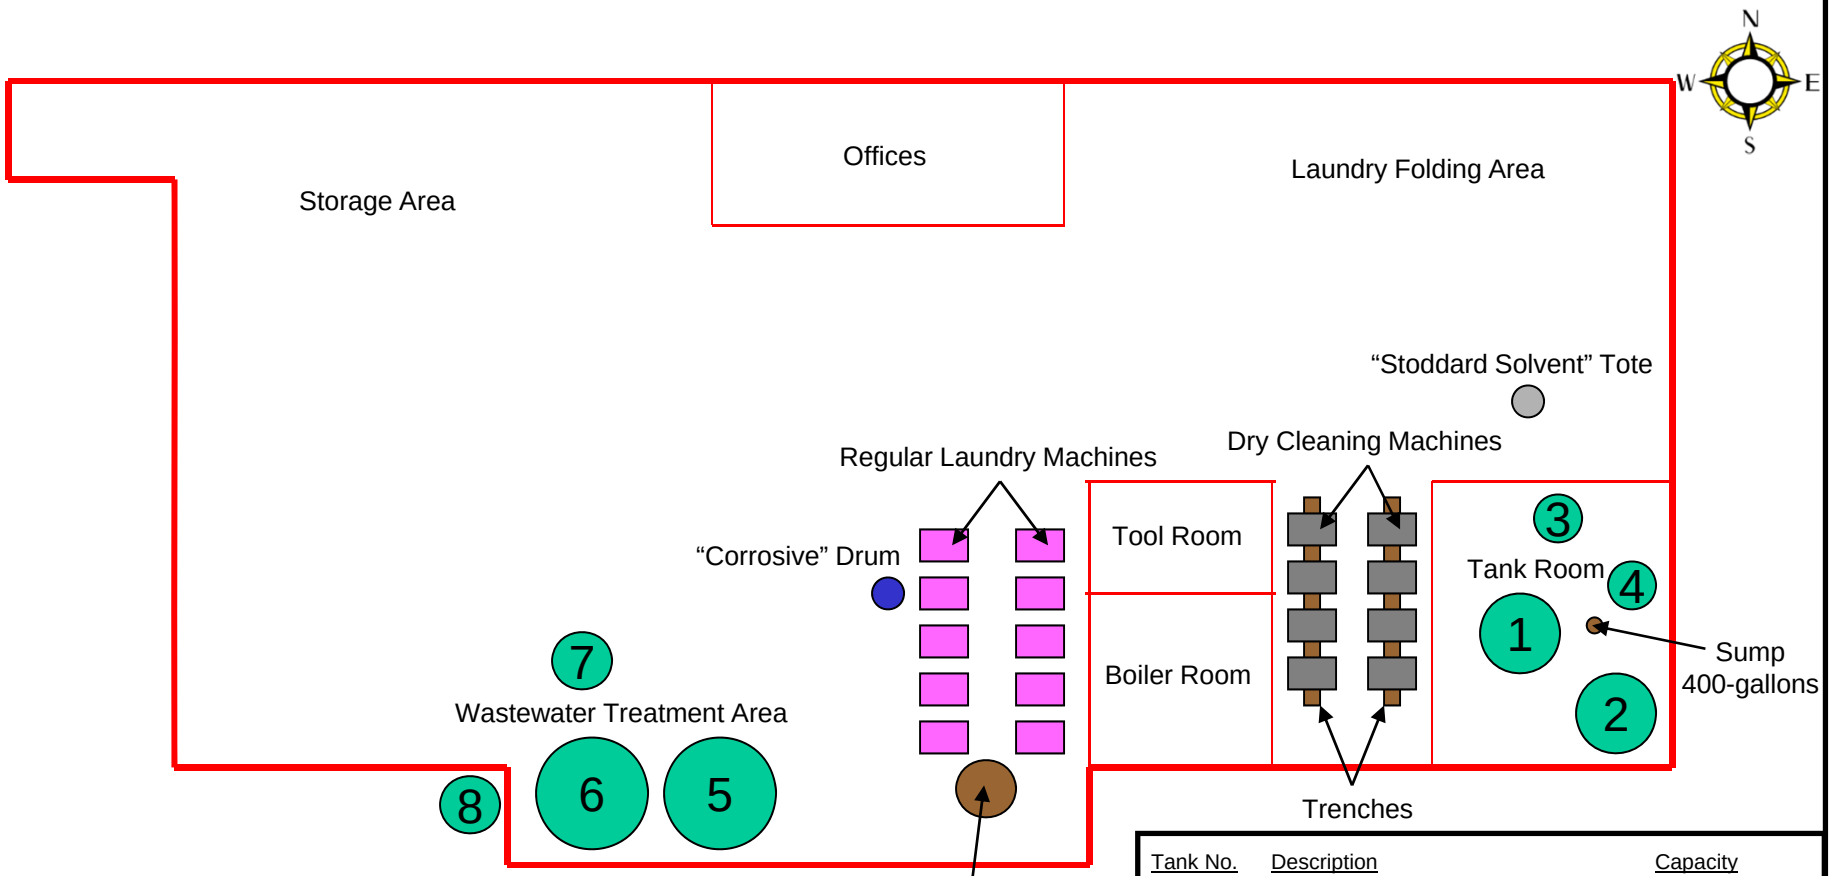
Figure 3-1

During the site assessment, WESTON START observed a total of eight tanks (see **Figure 3-1**). Approximately 50 55-gallon drums, totes, and containers having volumes of 5 gallons or less also were observed throughout the building. Numerous tanks, drums, totes, and containers were uncovered and deteriorating, with contents spilled onto the floor. WESTON START observed that a few of the drums, totes, and containers were labeled as “Stoddard Solvent,” “Corrosive,” and “Flammable Liquid.” The Tool Room also contained aerosol spray paint cans.

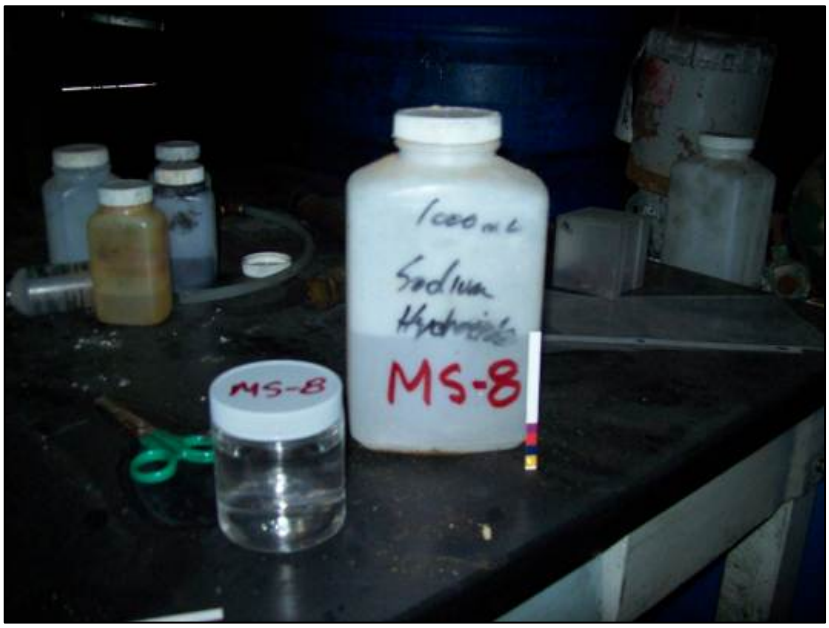
Site: Multi-Service Site
Photograph No.: 7 **Date:** 1/27/11
Direction: Down **Photographer:** John Sherrard
Subject: Container from which investigative waste liquid sample MS-8 was collected; sample had a pH of 12 SUs
