RE: METAL FINISHING COMPLIANCE STATUS REPORT;
GOODYEAR METAL PRODUCTS DIV., AKRON, OHIO

Re: Metal Finishing Compliance Status Monitoring and Analysis Program; Metal Products Plant

GOODYEAR TIRE & RUBBER COMPANY
METAL PRODUCTS DIVISION

COMPARISON OF SEIBERLING STREET OUTFALL
EFFLUENT QUALITY
WITH REGULATORY CRITERIA

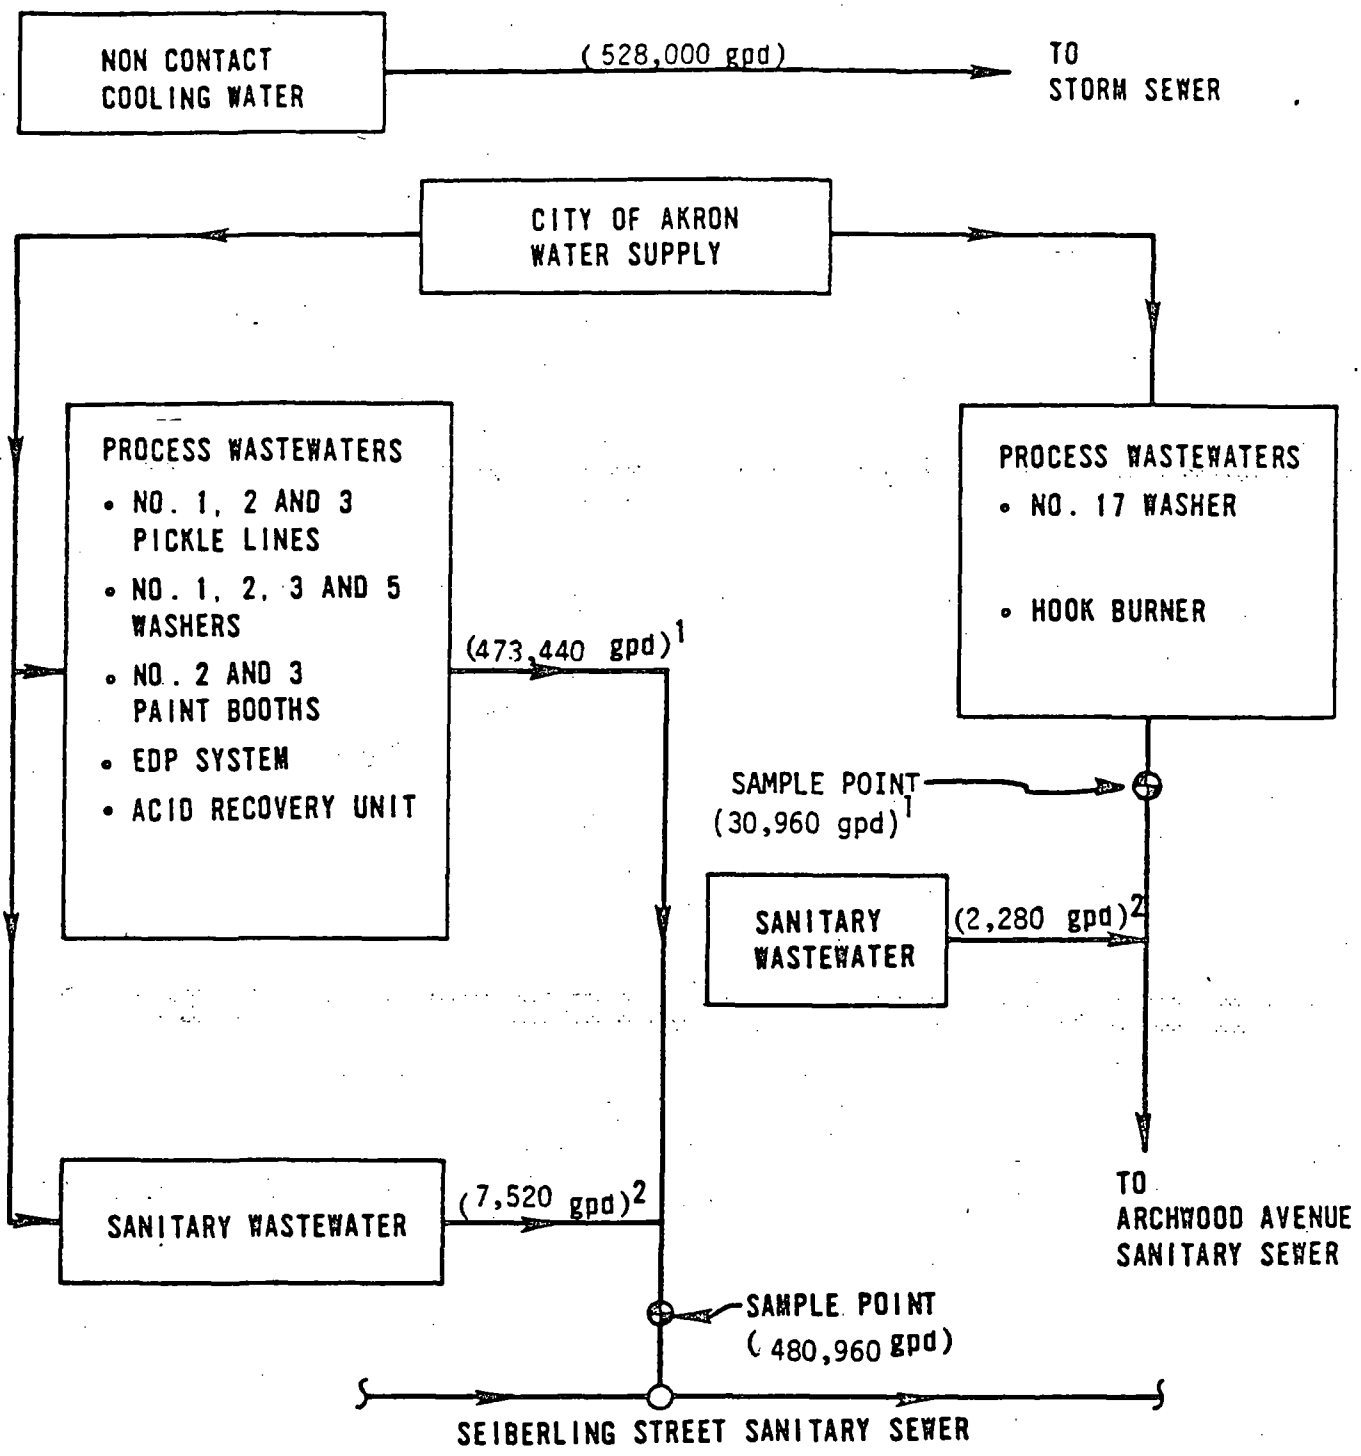
Figure 1

1 Current three shift operation flow rate
2 Based on 20 gallons per person per day
( ) Average Flow Rate
