ENVIRONMENTAL PROTECTION AGENCY STATE OF ILLINOIS

OBSERVATION REPORT - SITE INVENTORY NO. 1 4 3 8 0 8 0 1
(11) (18)

PEORIA CO. - L.P.C. Region # C Date 11/27/79
(20) (25)

PEORIA / JANSON
(Location) (Responsible Party)

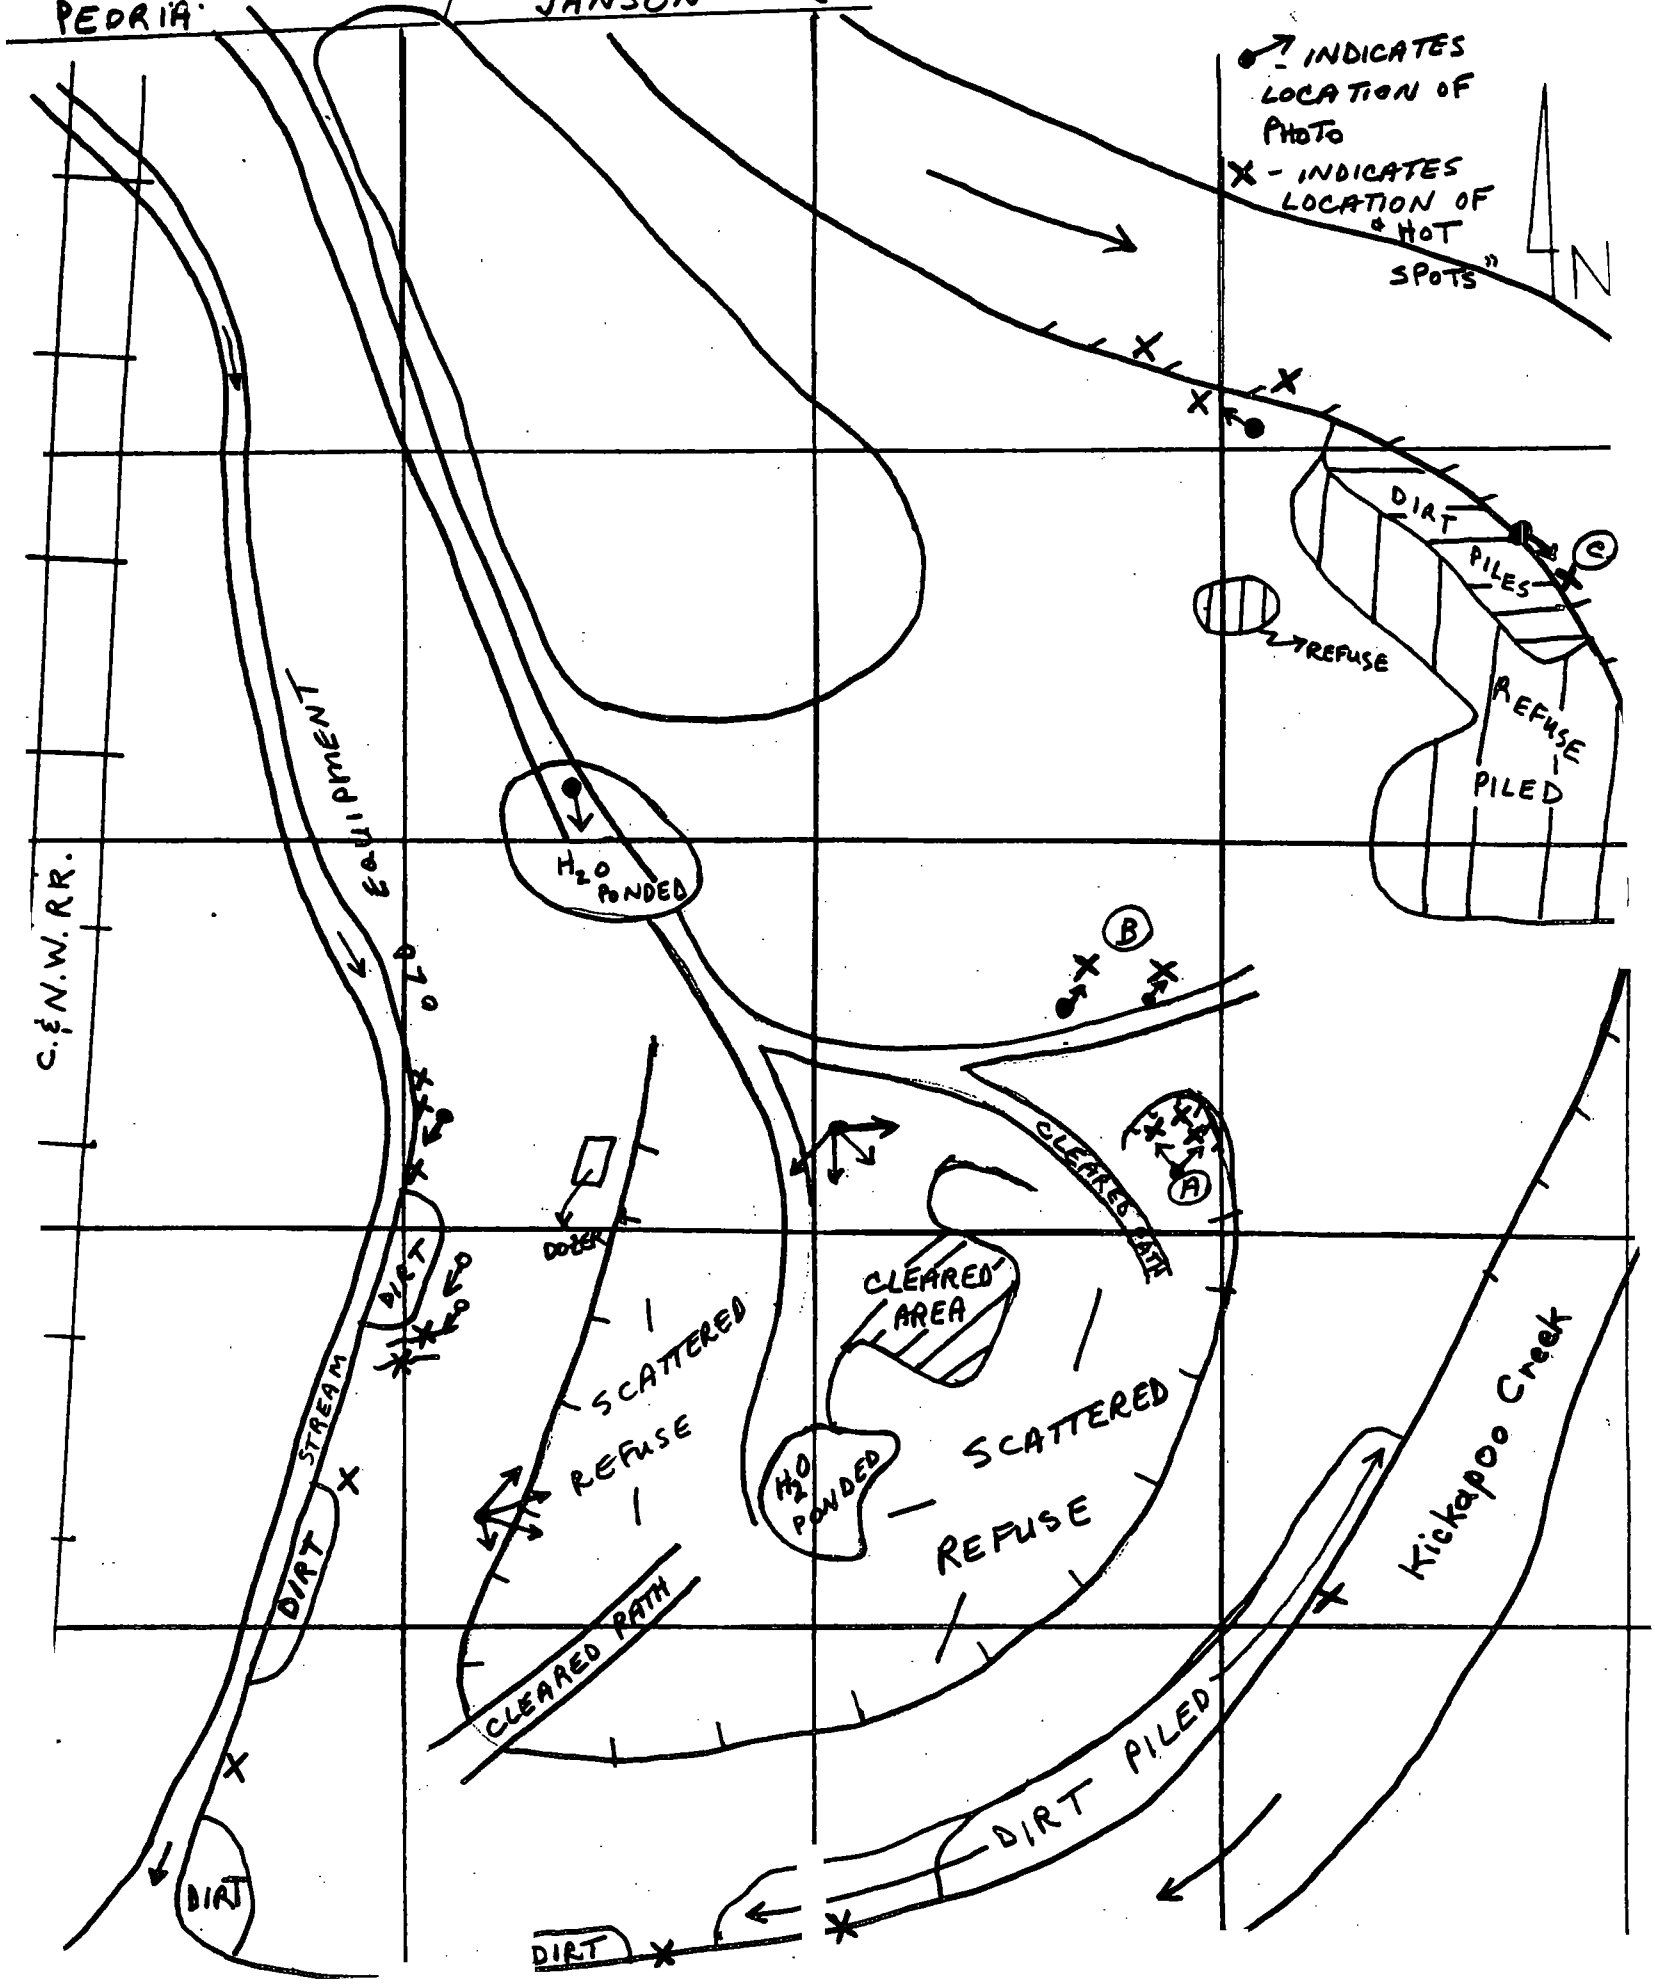
DIAGRAM:

GENERAL REMARKS: Inspection of this illegal site revealed it to be very wet from rain +/or snow on Sun. and today. H_2O was standing in the access road + the center low area. Size of ponds were not measured but a rough estimate is that neither was larger than 10yds².
Little work has been done at this site since last inspection. Approx 2 additional loads had been removed from the "cleared area" (see site sketch) in the center low area.
Smoke vents were noted in the same locations (see site sketch). They were

INTERVIEW: "vigorously spewing" smoke today. Smoke was visible from a distance of 50-80yds. New vents were noted in 2 areas: (A) in the E-central area and (C) in the NE area (see site sketch).
