ENVIRONMENTAL PROTECTION AGENCY STATE OF ILLINOIS

**OBSERVATION** REPORT - SITE INVENTORY NO. 1 4 3 8 0 8 0 1
(11) (18)

Peoria CO. - L.P.C. Region # C Date 10/30/79
(20) (25)

Peoria / Janson Letter Sent (Yes or No) N
(Location) (Responsible Party) (26)

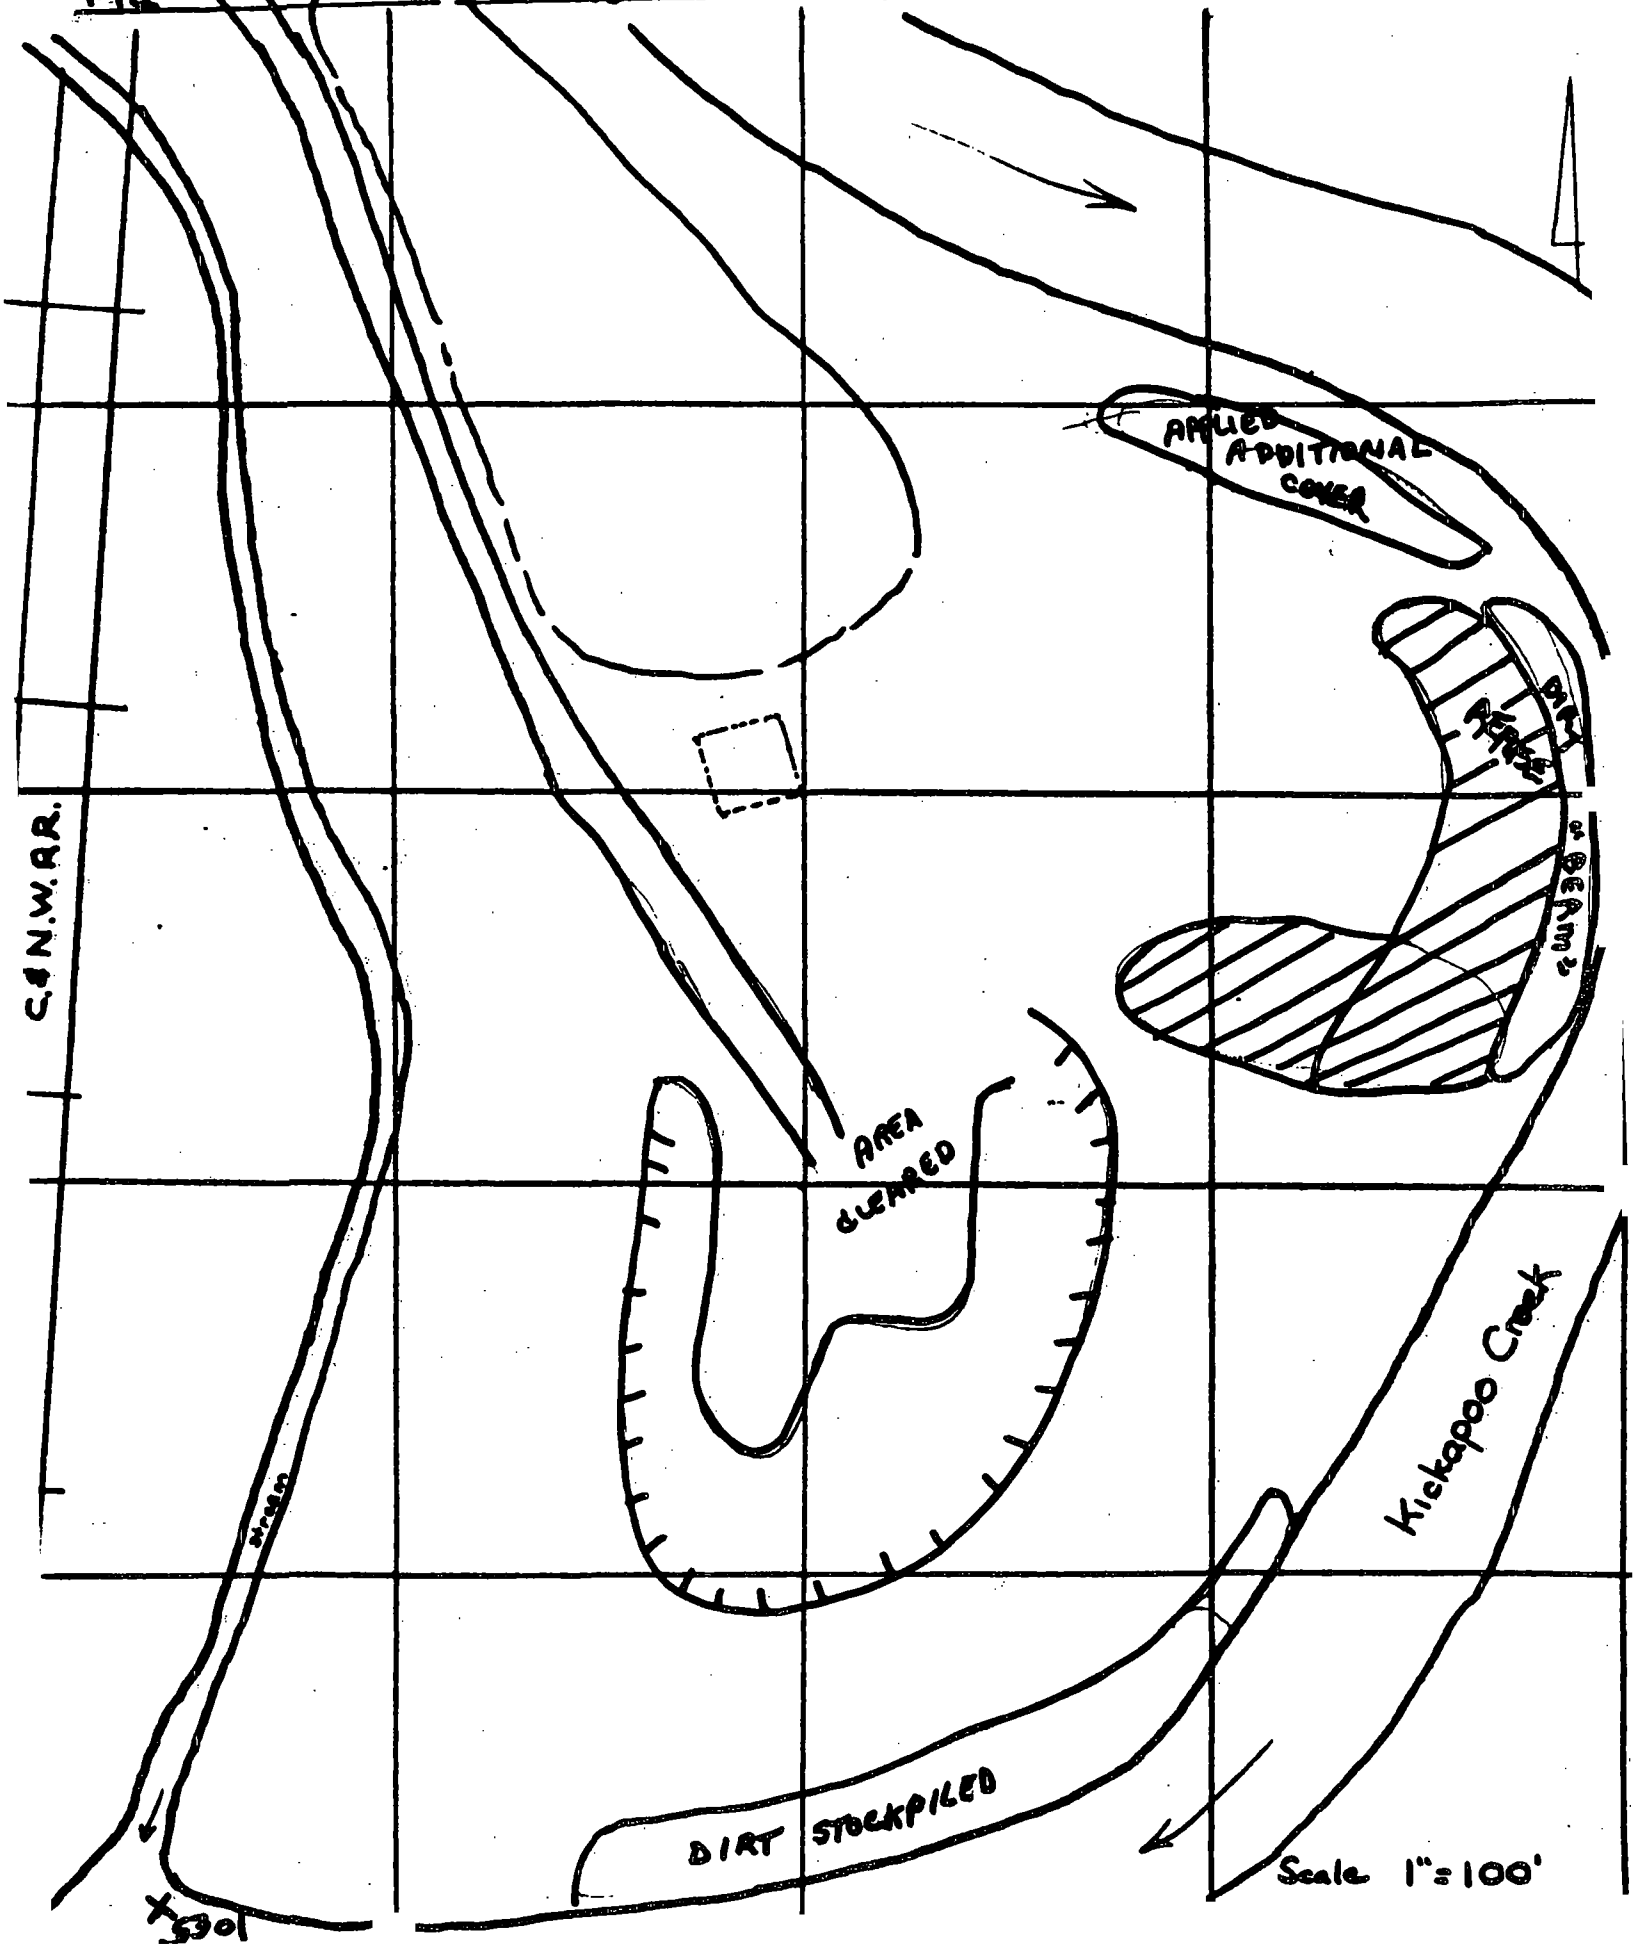
DIAGRAM:

GENERAL REMARKS: Observation of this ~~illegal~~ CMJ site revealed that work was being done to clear out the center area of refuse. The refuse that was removed was dumped in the NE part of the site. Dirt was stockpiled between the refuse + the edge of the slope in this area.
Dirt was also stockpiled in the SE part of the site on top the berm.
Additional cover had been applied to the slopes bordering Kickapoo Ck in the NE area beyond where the refuse was piled.
Refuse was removed so that "virgin" ground was observed in the N part of the center.
