ENVIRONMENTAL PROTECTION AGENCY STATE OF ILLINOIS

**OBSERVATION** REPORT - SITE INVENTORY NO. 1 4 3 8 0 8 0 1
(11) (18)

PEORIA CO. - L.P.C. Region # C Date 1 1/16/79
(20) (25)

PEORIA / JANSON Letter Sent (Yes or No) N
(Location) (Responsible Party) (26)

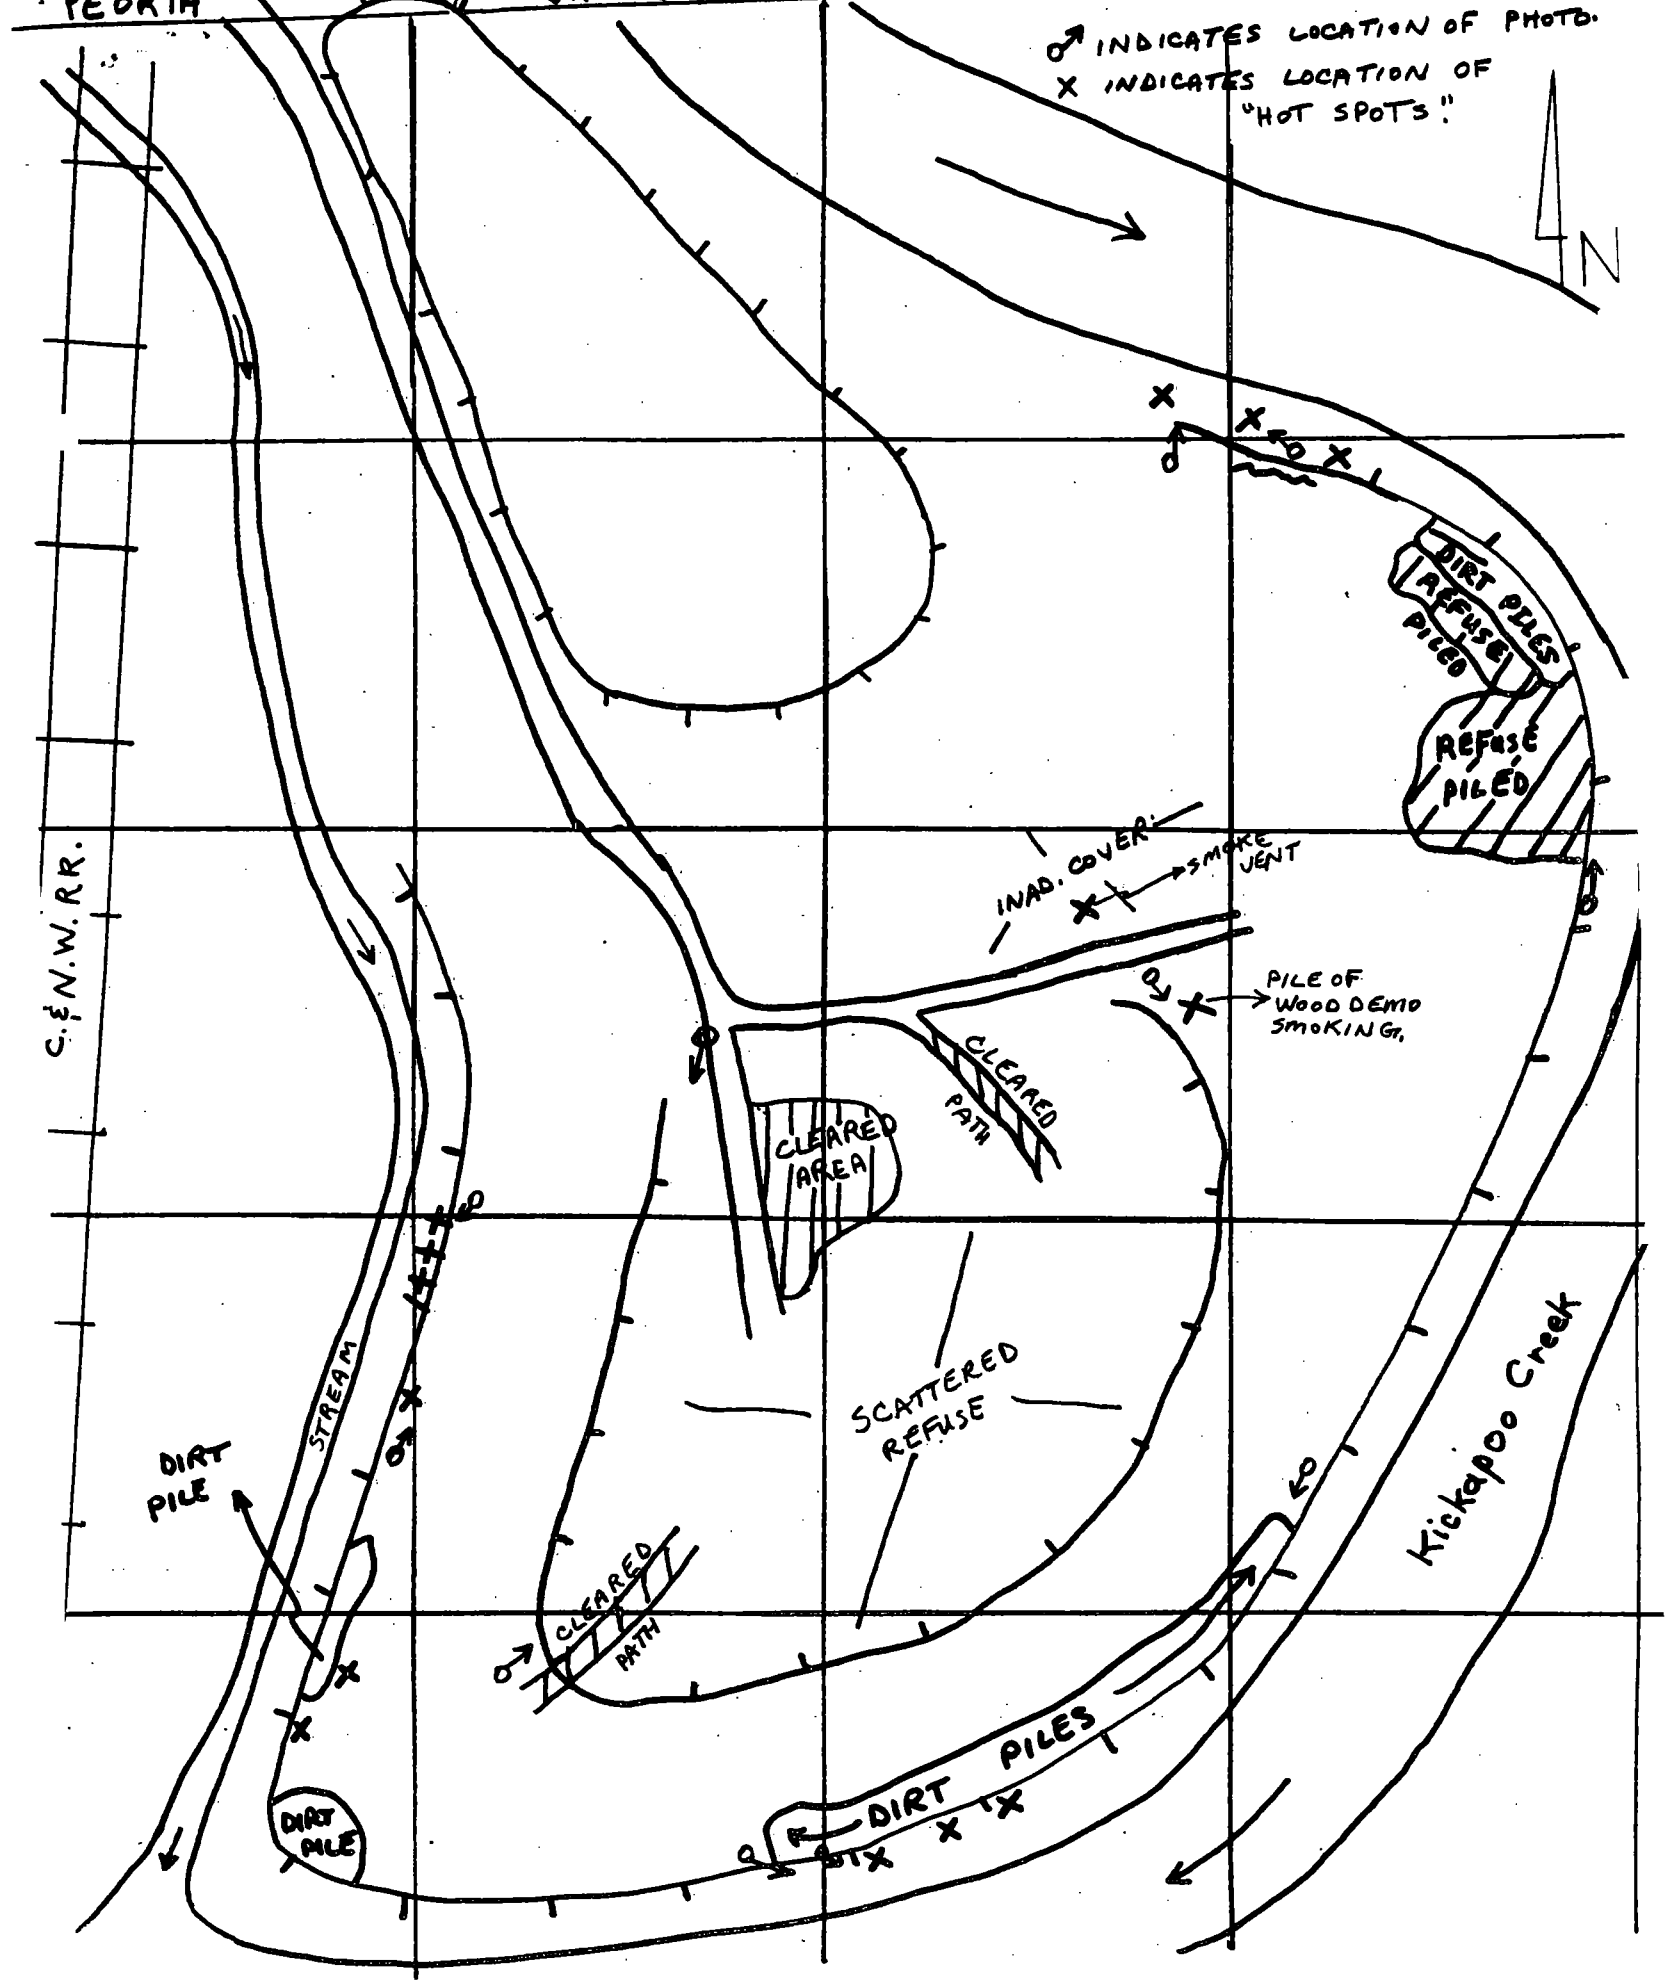
DIAGRAM:

GENERAL REMARKS: Observation of this illegal site just before going to the Peoria Co. Court House revealed that the site was still on fire. Evidence of the underground fire surfaced at the points indicated on the site sketch by X. Evidence of the underground fire consisted of smoke rising from vents or cracks in the soil, soil charred around these vents + cracks, the temperature of the soil in the cracks + vents was hotter than normal. Also noted some small areas of subsidence as if the subsurface material had collapsed causing the ground surface to sink.
The site appeared the same as my last inspection on Oct. 30, 1979. Evidence of

INTERVIEW: the fire occurred in 3 general areas: N-NE; S-SE; and SW-W. Refuse removed from the center remained piled in the NE part of the site. Dirt was piled along the berm's outer edge in the SE, SW and part of the W and NE. Approx. 15% of the center area was cleared of refuse.
Photos were taken.
No one was at the site initially. Mr. Janson and another fellow arrived as we ~~wer~~ waited for a train to clear the RR tracks, so we could enter the site.
~~No~~ photos were taken.
Walked the site w/ J. Taylor. While Ann Carr spoke w/Mr. Janson. According to A. Carr ~~said~~ C. Janson said his equipment was broke down claiming that it had been vandalized.
