STETZER ROAD
LANDFILL
4676 STETZER ROAD
BUCYRUS, OHIO

Tetra Tech EM Inc.

12/17/03 Stetzer Road Landfill

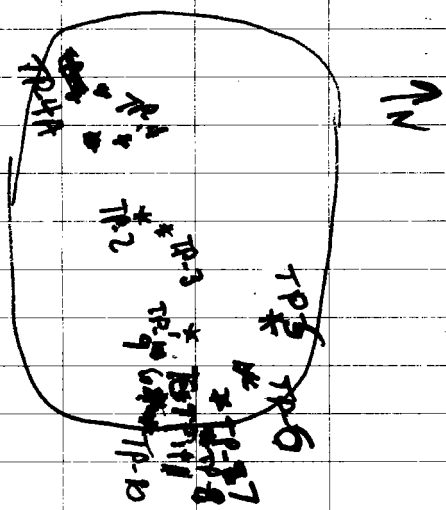
TEST PIT #1

FID = 2.38 ppm over leaking

Drum photo 1 showing leaking

Drum FID reading 95 ppm
