DNAPL Investigation Status Summary

Detrex Site – Ashtabula, Ohio

APRIL 2012

Prepared by
URS Corp.
Cleveland Office

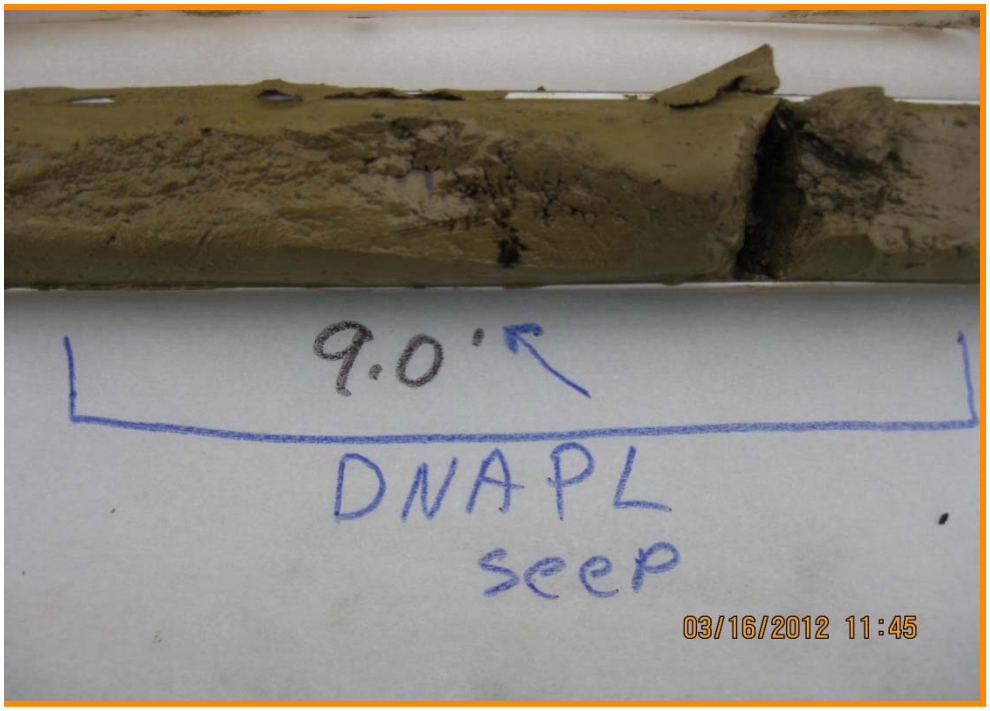
GP-15 Photos

8.0'
GP-15
9.0'
GP
DNAPL
seep
03/16/2012 11:44

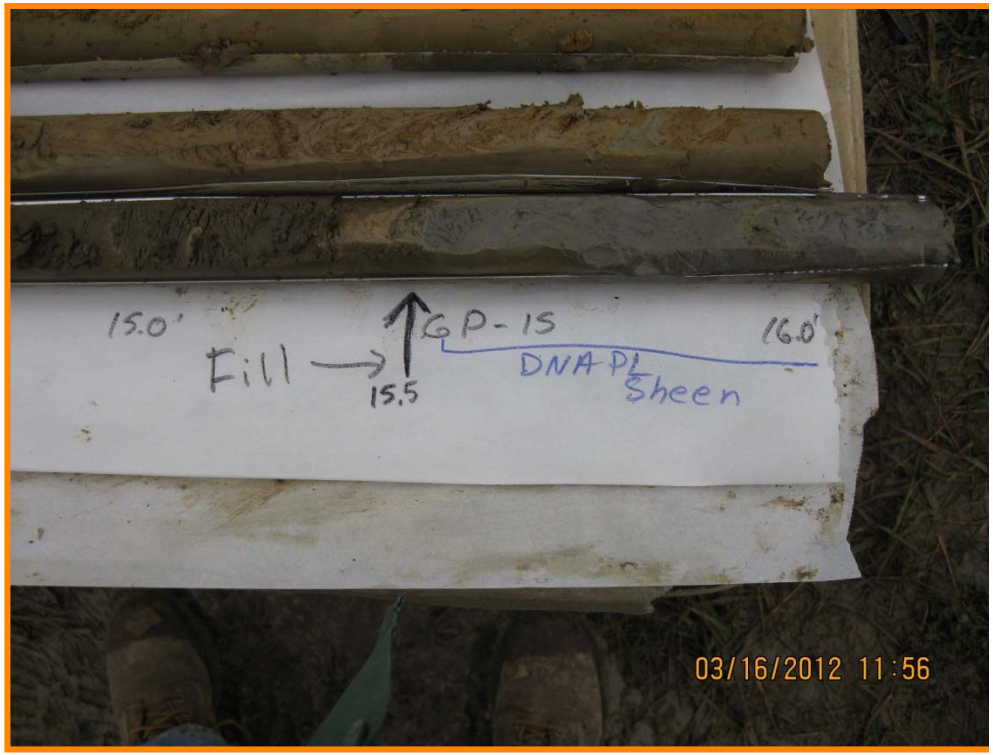
GP-15 Photos

14.0
GP-15
15.0'
Fil
03/16/2012 11:56

15.0'
Fill
15.5
GP-15
16.0'
DNAPL
Sheen
03/16/2012 11:56

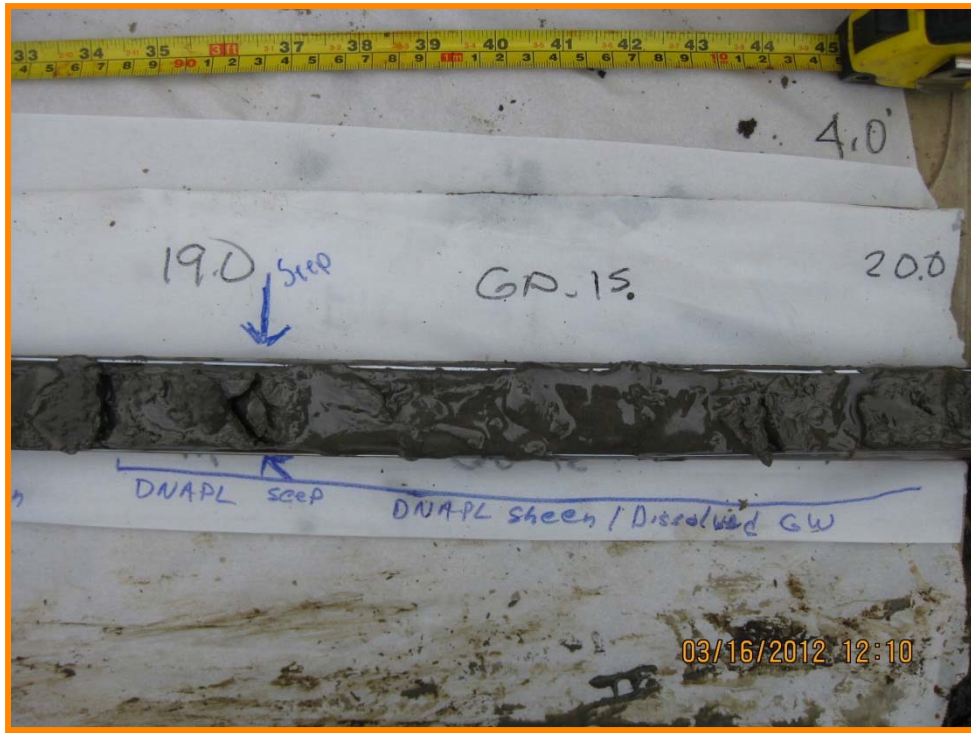
GP-15 Photos

18.0
GP-15
19.0
Seep
DNAPL Sheen
DNAPL seep
03/16/2012 12:09

4.0
19.0
Seep
GP-15
20.0
DNAPL seep
DNAPL sheen / Dissolved GW
03/16/2012 12:10
