1615 - START Summers on-site. Acme Galvanizing Fire, 2730 S. 19th Street, Milwaukee, WI. Level D PPE. 66° Cloudy NNE wind 19 mph USEPA Kathy Halbur on-site. Milwaukee Fire Department on-site. Representatives from Acme on-site. Wisconsin DNR on-site.

ACME GALV. E.R.

Monday, March 16, 2015

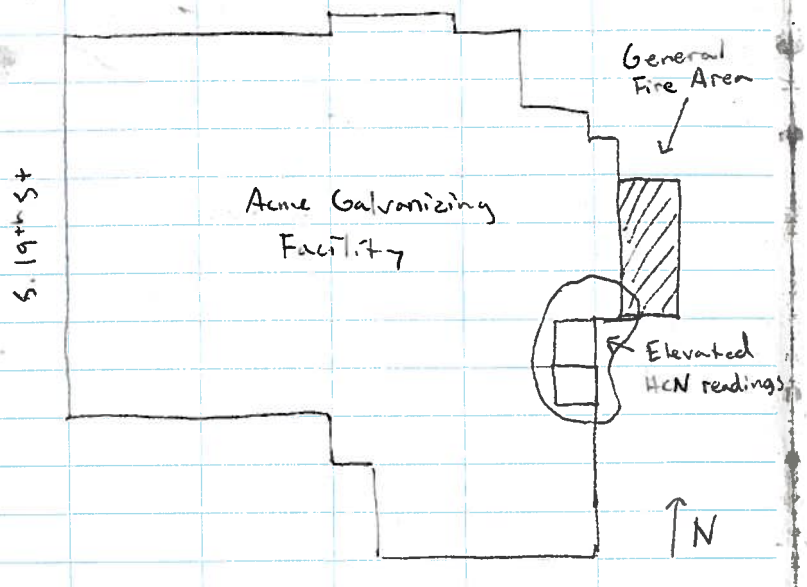
630 - Fire occured/began at approximately 0830 on eastern end of building.

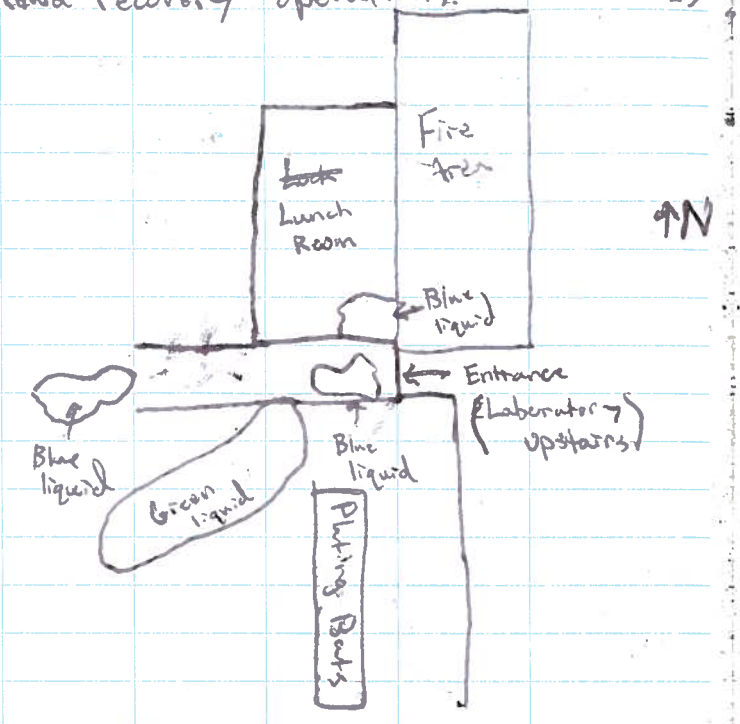
1330 - Remediation Contractor will be conducting fluid recovery operations. ——— LS

1430 - Remediation Contractor finishes liquid recovery operations. Level B air monitoring range during recovery operations 0-7ppm for HCN. ——— LS
