SUMMIT COUNTY GENERAL HEALTH DISTRICT

October 2, 1998

Well Samples
August 18 and 20, 1998
Coventry Township
Buckley Auto Wrecking Investigation

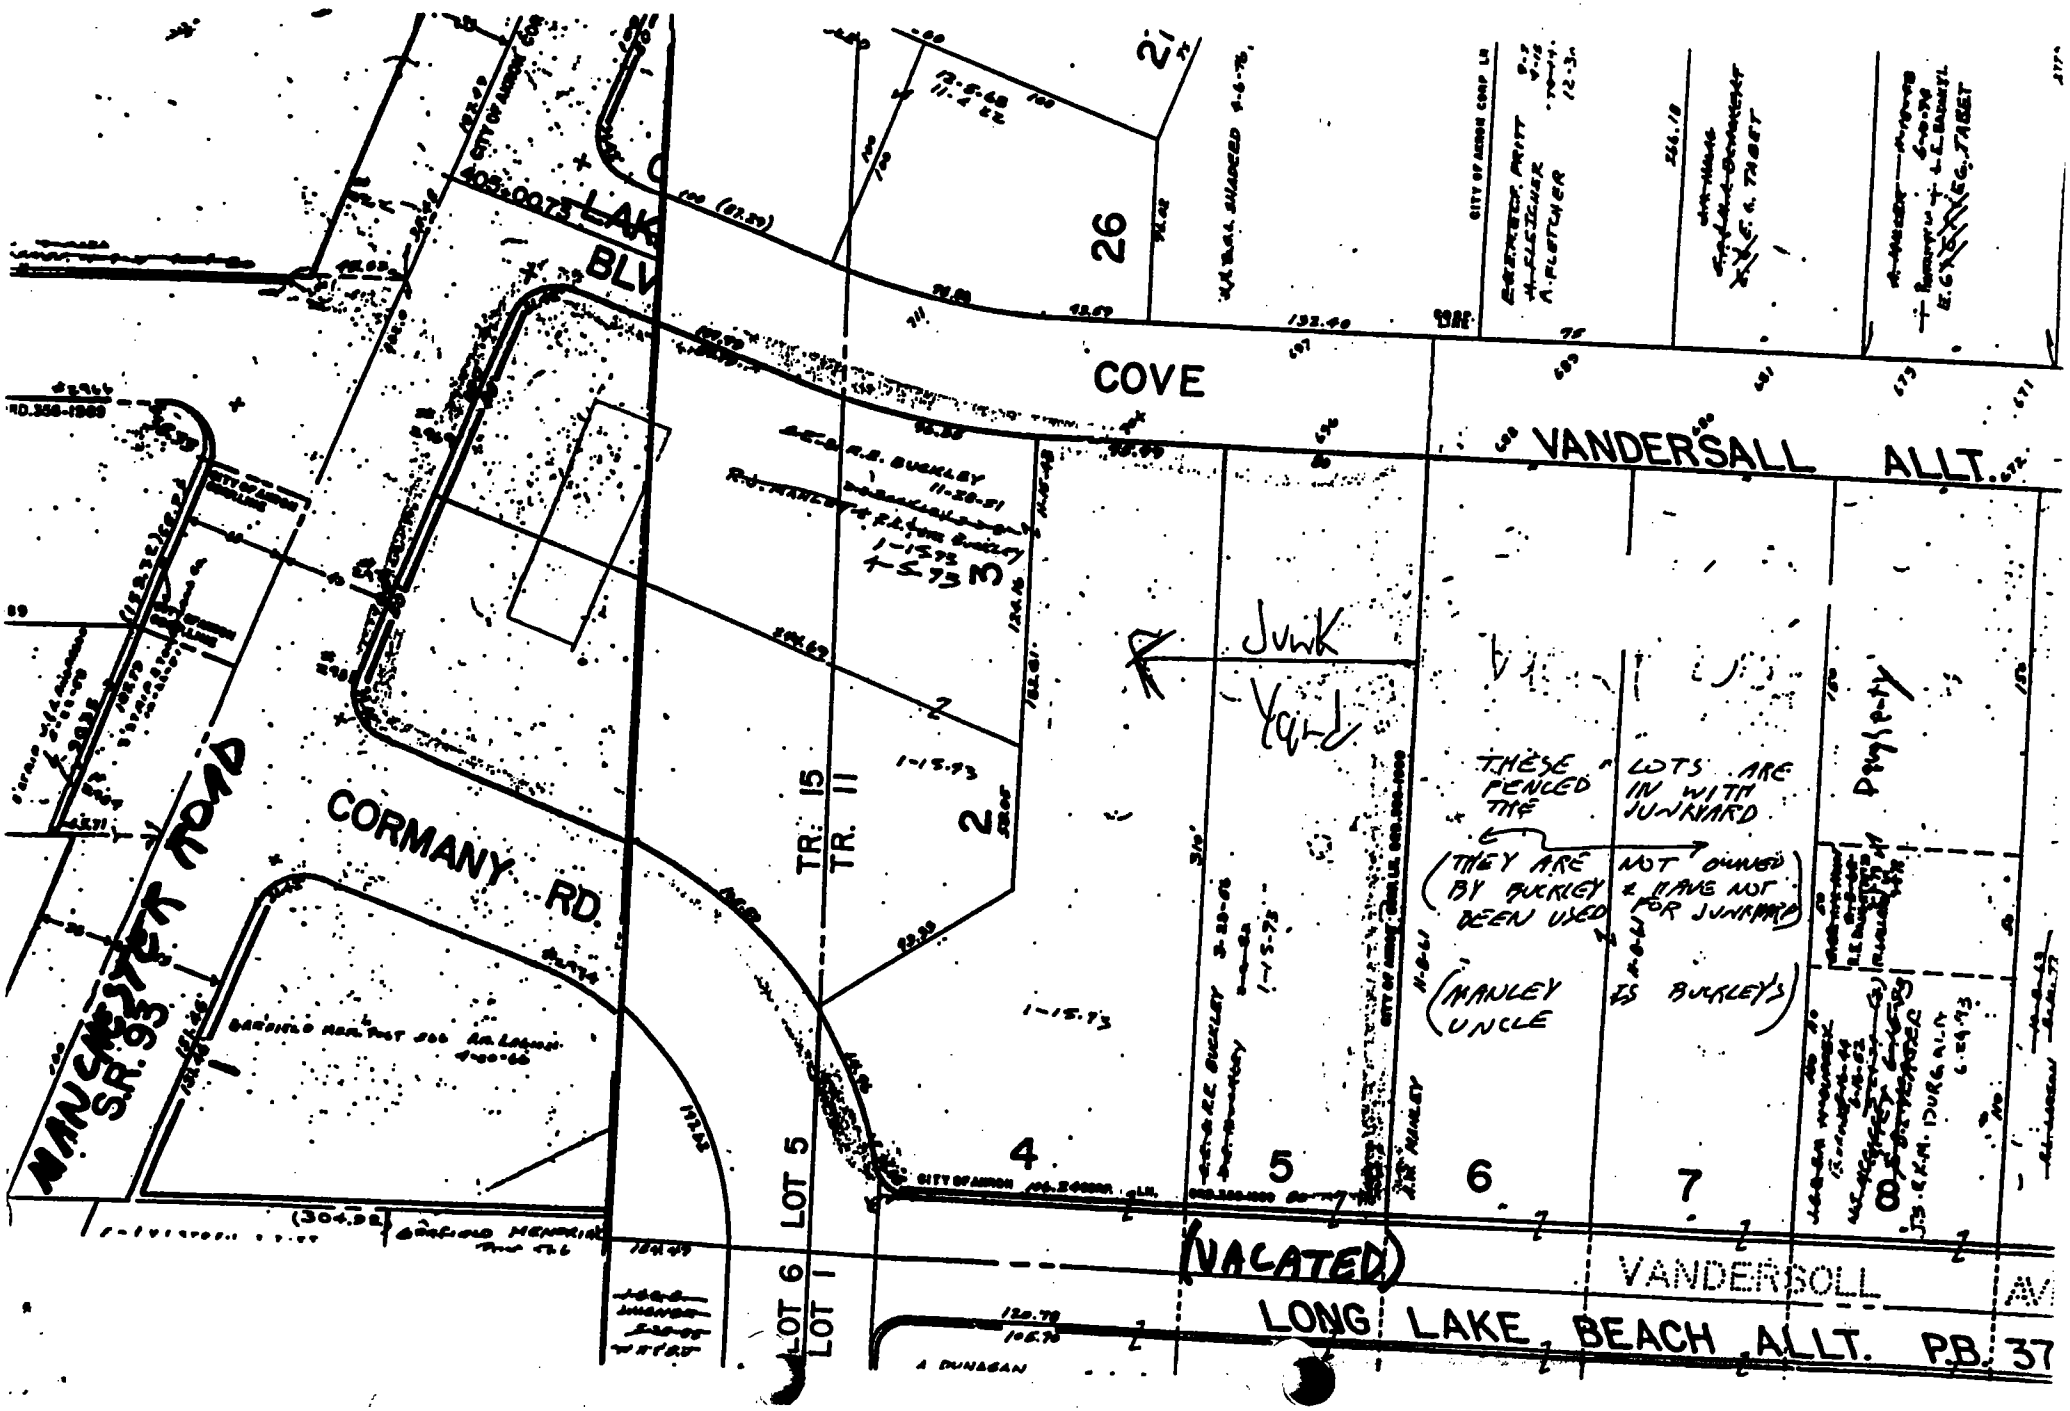
On Recently, I spoke with you regarding private water wells which I sampled for metals and voc's on August 18 and 20, 1998. I expressed concern to you regarding the finding of Trichloroethene in two wells at a level of 11 ppb in the well at Non-Responsive and 0.6 ppb at Non-Responsive, both in Coventry Township, Summit County. In all, 11 wells were sampled (see the enclosed map and list for locations).

Address	pH	TCE	THM	Ba	Well log found?	Depth of Well
Non-Responsive	6.3				yes	28'
Non-Responsive	6.6				no	35' ?
Non-Responsive	6.1				no	?
Non-Responsive	6.2	0.6 ug/l			no	65' ?
Non-Responsive	6.1	11 ug/l			yes	20'
Non-Responsive	6.2				no	?
Non-Responsive	6.4		3.3ug/l		yes	36'
Non-Responsive	6.2				no	20' ?
Non-Responsive	8.1			730ug/l	yes	120'
Non-Responsive	8.3			100ug/l	no	?
Non-Responsive	6.6				yes	51'

TCE = Trichloroethene, mcl standard is 5 ug/l = 5 ppb.

THM = Total Trihalomethanes, Bromoform 0.7 and Chloroform 2.6. The resident of this address chlorinates their well twice per year. This would explain the presence of the THM's.
