Reference: *Radon Test Results*
300 South Barclay and 139 East Oregon Street
Milwaukee, Wisconsin

KEY ENGINEERING GROUP, LTD.
File No. 1701-0785-0008

The purpose of this letter is to document the results of radon testing performed at the above referenced site (herein after called The Barclay) by Key Engineering Group, Ltd. (KEY).

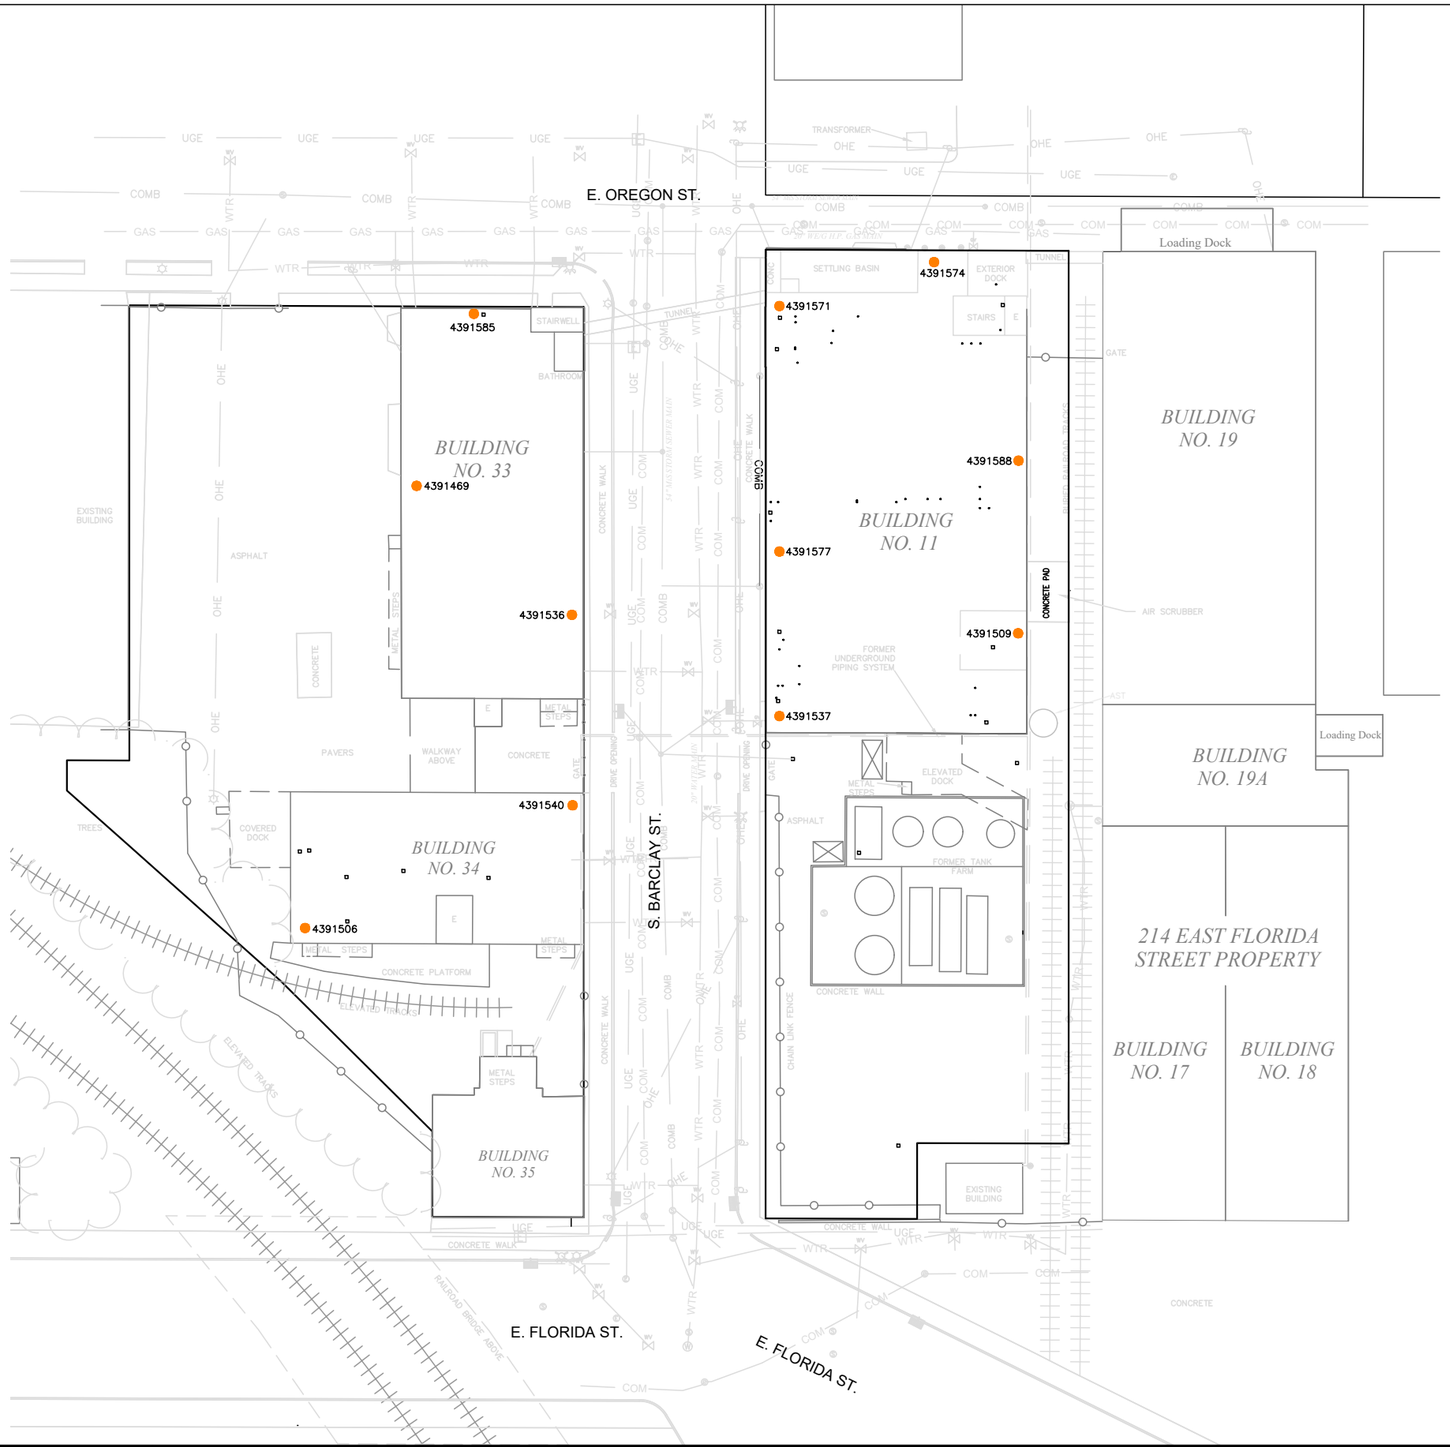
FIGURE 2
SITE LAYOUT MAP
WAYNE PIGMENT CORPORATION
300 SOUTH BARCLAY STREET
MILWAUKEE, WISCONSIN

The location of the site in shown in Figure 1. Sampling locations are shown in Figure 2.

Sample ID	Result (pCi/L*)	Building Location
4391509	1.0	11
4391537	1.3	11
4391471	1.4	11
4391588	1.2	11
4391577	1.2	11
4391574	1.2	11
4391540	<0.4	34
4391506	<0.4	34
4391585	<0.4	33
4391469	damaged	damaged
4391536	damaged	damaged

All samples taken at The Barclay building complex were considerably less than the EPAs' action level, as such, no further action is recommended. On average, all samples taken below ground in building #11 were higher. One sample exceeded the average indoor concentration for radon, sample 4391471, but was still well below the EPA action limit. Buildings #33 and #34 did not have basements, as such, the samples were collected on the first floor.

Based upon laboratory analytical results, it is KEY's opinion that the buildings at The Barclay do not require any further investigation or mitigation action in regards to radon assessment.
