U.S. Environmental Protection Agency
Region 7

Superfund Technical Assessment and Response Team (START) 2 Contract

Agromac-Lockwood Operable Unit 2
Gering, Nebraska

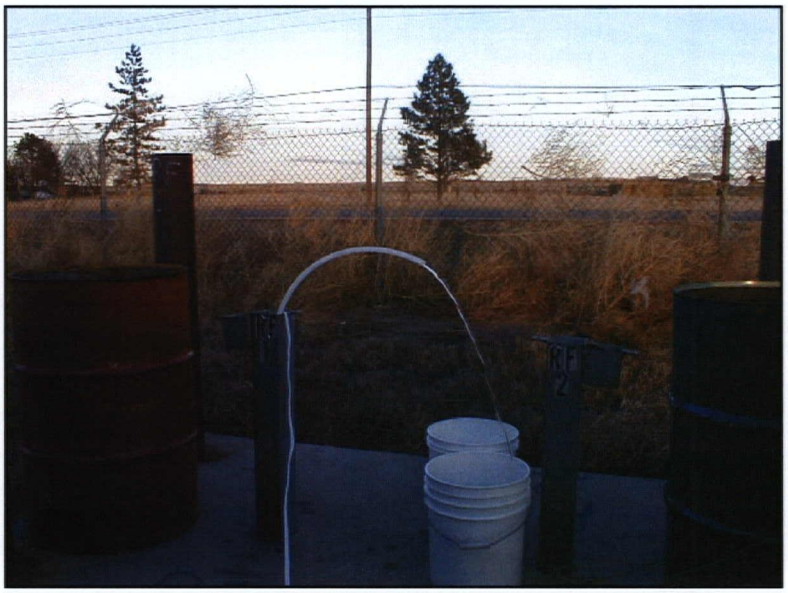
TETRA TECH PROJECT NO. G9011.01.0008.10	DESCRIPTION	Purging of monitoring well RF-1	11
	CLIENT	U.S. Environmental Protection Agency Region 7	Date
Direction: NE	PHOTOGRAPHER	Crystal Roberts	01/14/02

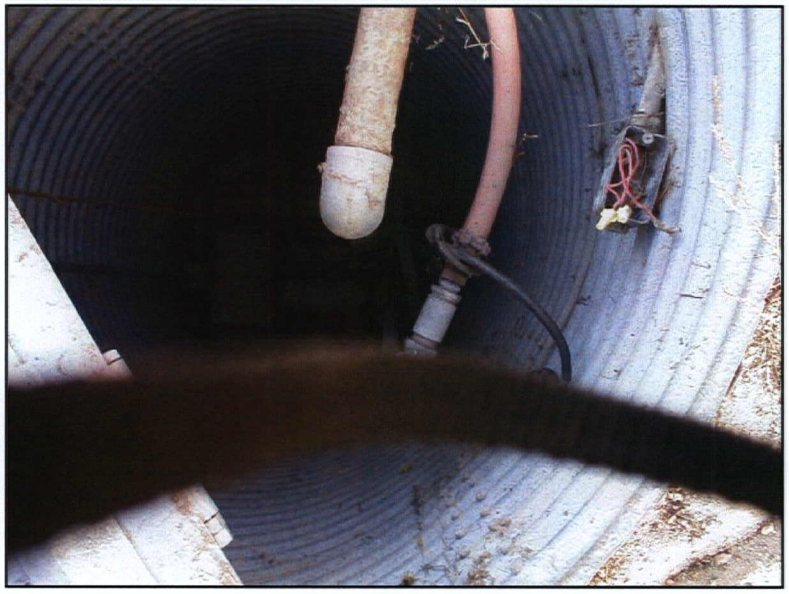
TETRA TECH PROJECT NO. G9011.01.0008.10	DESCRIPTION	Monitoring well LW-6, formally used as a water supply well	16
	CLIENT	U.S. Environmental Protection Agency Region 7	Date
Direction: Down	PHOTOGRAPHER	Crystal Roberts	01/15/02

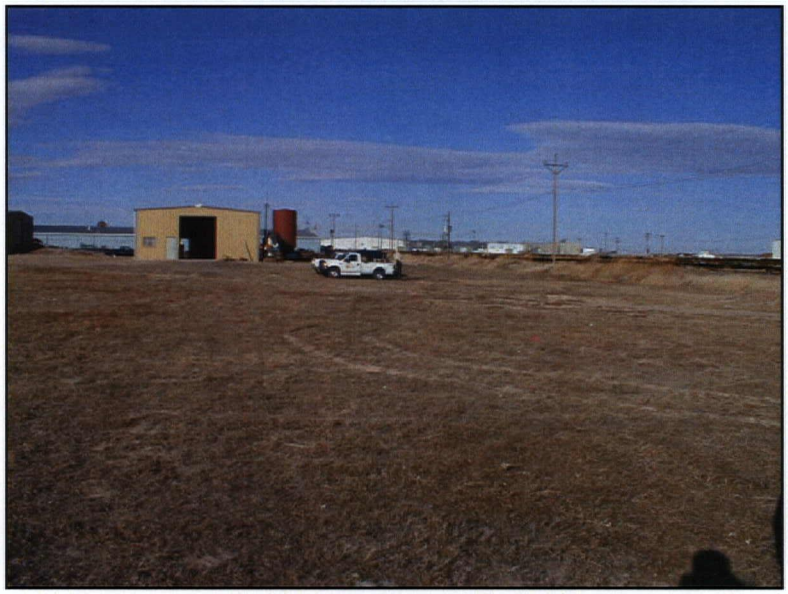
TETRA TECH PROJECT NO. G9011.01.0008.10	DESCRIPTION	Background 3 and 4 soil sample collection locations, located on property adjacent to west side of site, just west of surface impoundment	38
	CLIENT	U.S. Environmental Protection Agency Region 7	Date
Direction: N	PHOTOGRAPHER	Jeff Hodge	01/21/02

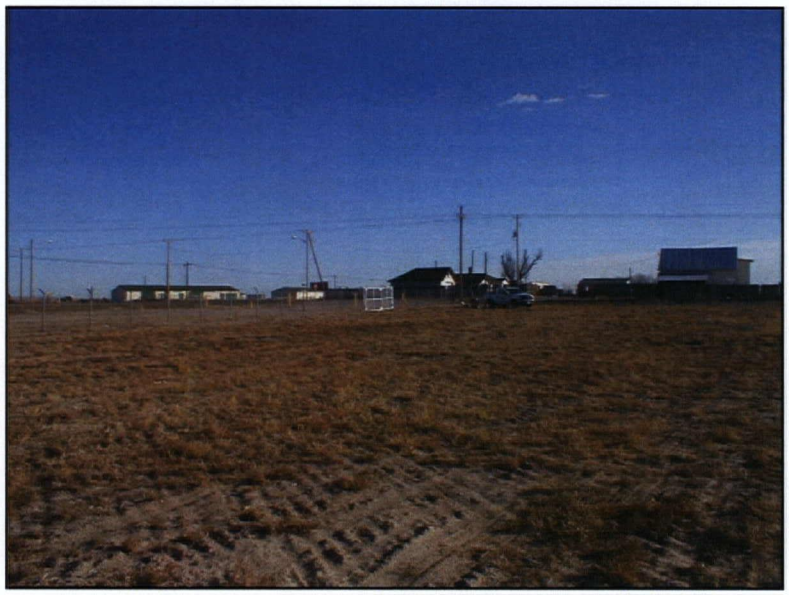
TETRA TECH PROJECT NO. G9011.01.0008.10	DESCRIPTION	Northeastern corner of the scrap storage area in which the Geoprobe ™ is collecting groundwater sample SA-GGW-1	49
	CLIENT	U.S. Environmental Protection Agency Region 7	Date
Direction: NE	PHOTOGRAPHER	Jeff Hodge	01/22/02

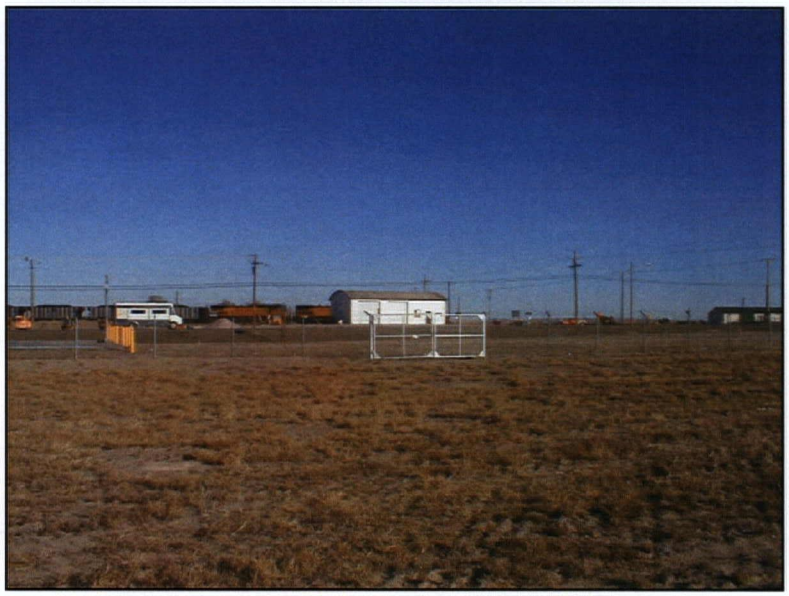
TETRA TECH PROJECT NO. G9011.01.0008.10	DESCRIPTION	Private well sample location OS-PW-8, located north of site and Hwy 92	50
	CLIENT	U.S. Environmental Protection Agency Region 7	Date
Direction: NNE	PHOTOGRAPHER	Jeff Hodge	01/22/02
