Navajo Abandoned Uranium Mine Site Screen Report

Haystack Mines AUM Site

Navajo AUM Eastern Region

May 2009

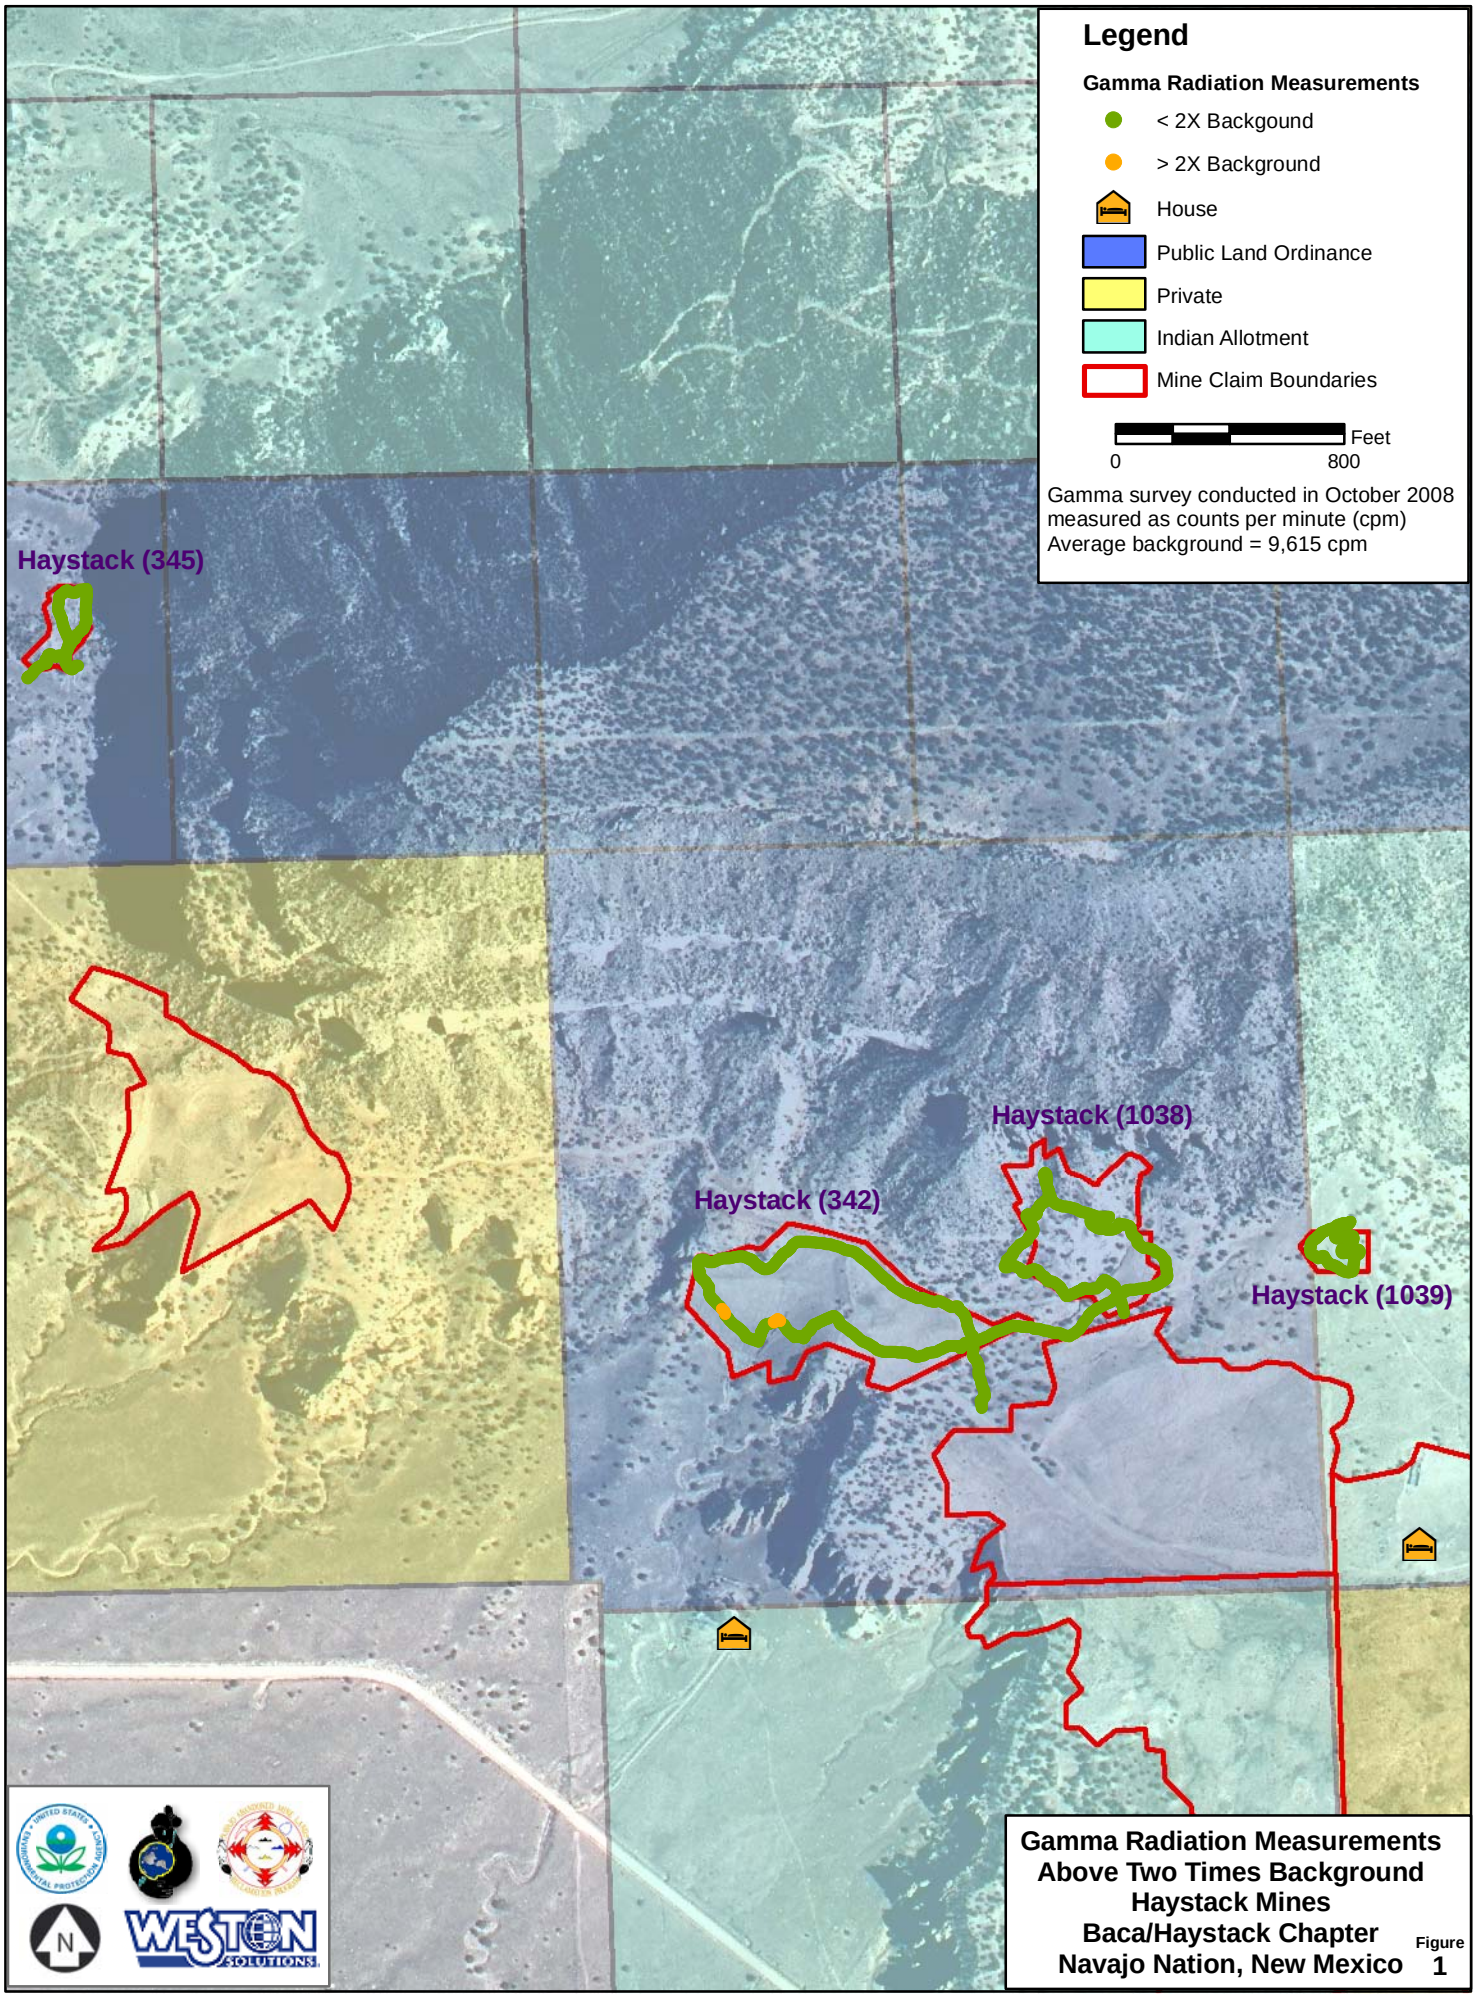
Figure 1

A total of 2,223 gamma radiation measurements were collected from the mine sites, ranging from 6,074 cpm to 33,870 cpm. The measurements are represented in Figures 1 and 2.

Gamma Radiation Measurements Above Two Times Background
Haystack Mines
Baca/Haystack Chapter
Navajo Nation, New Mexico

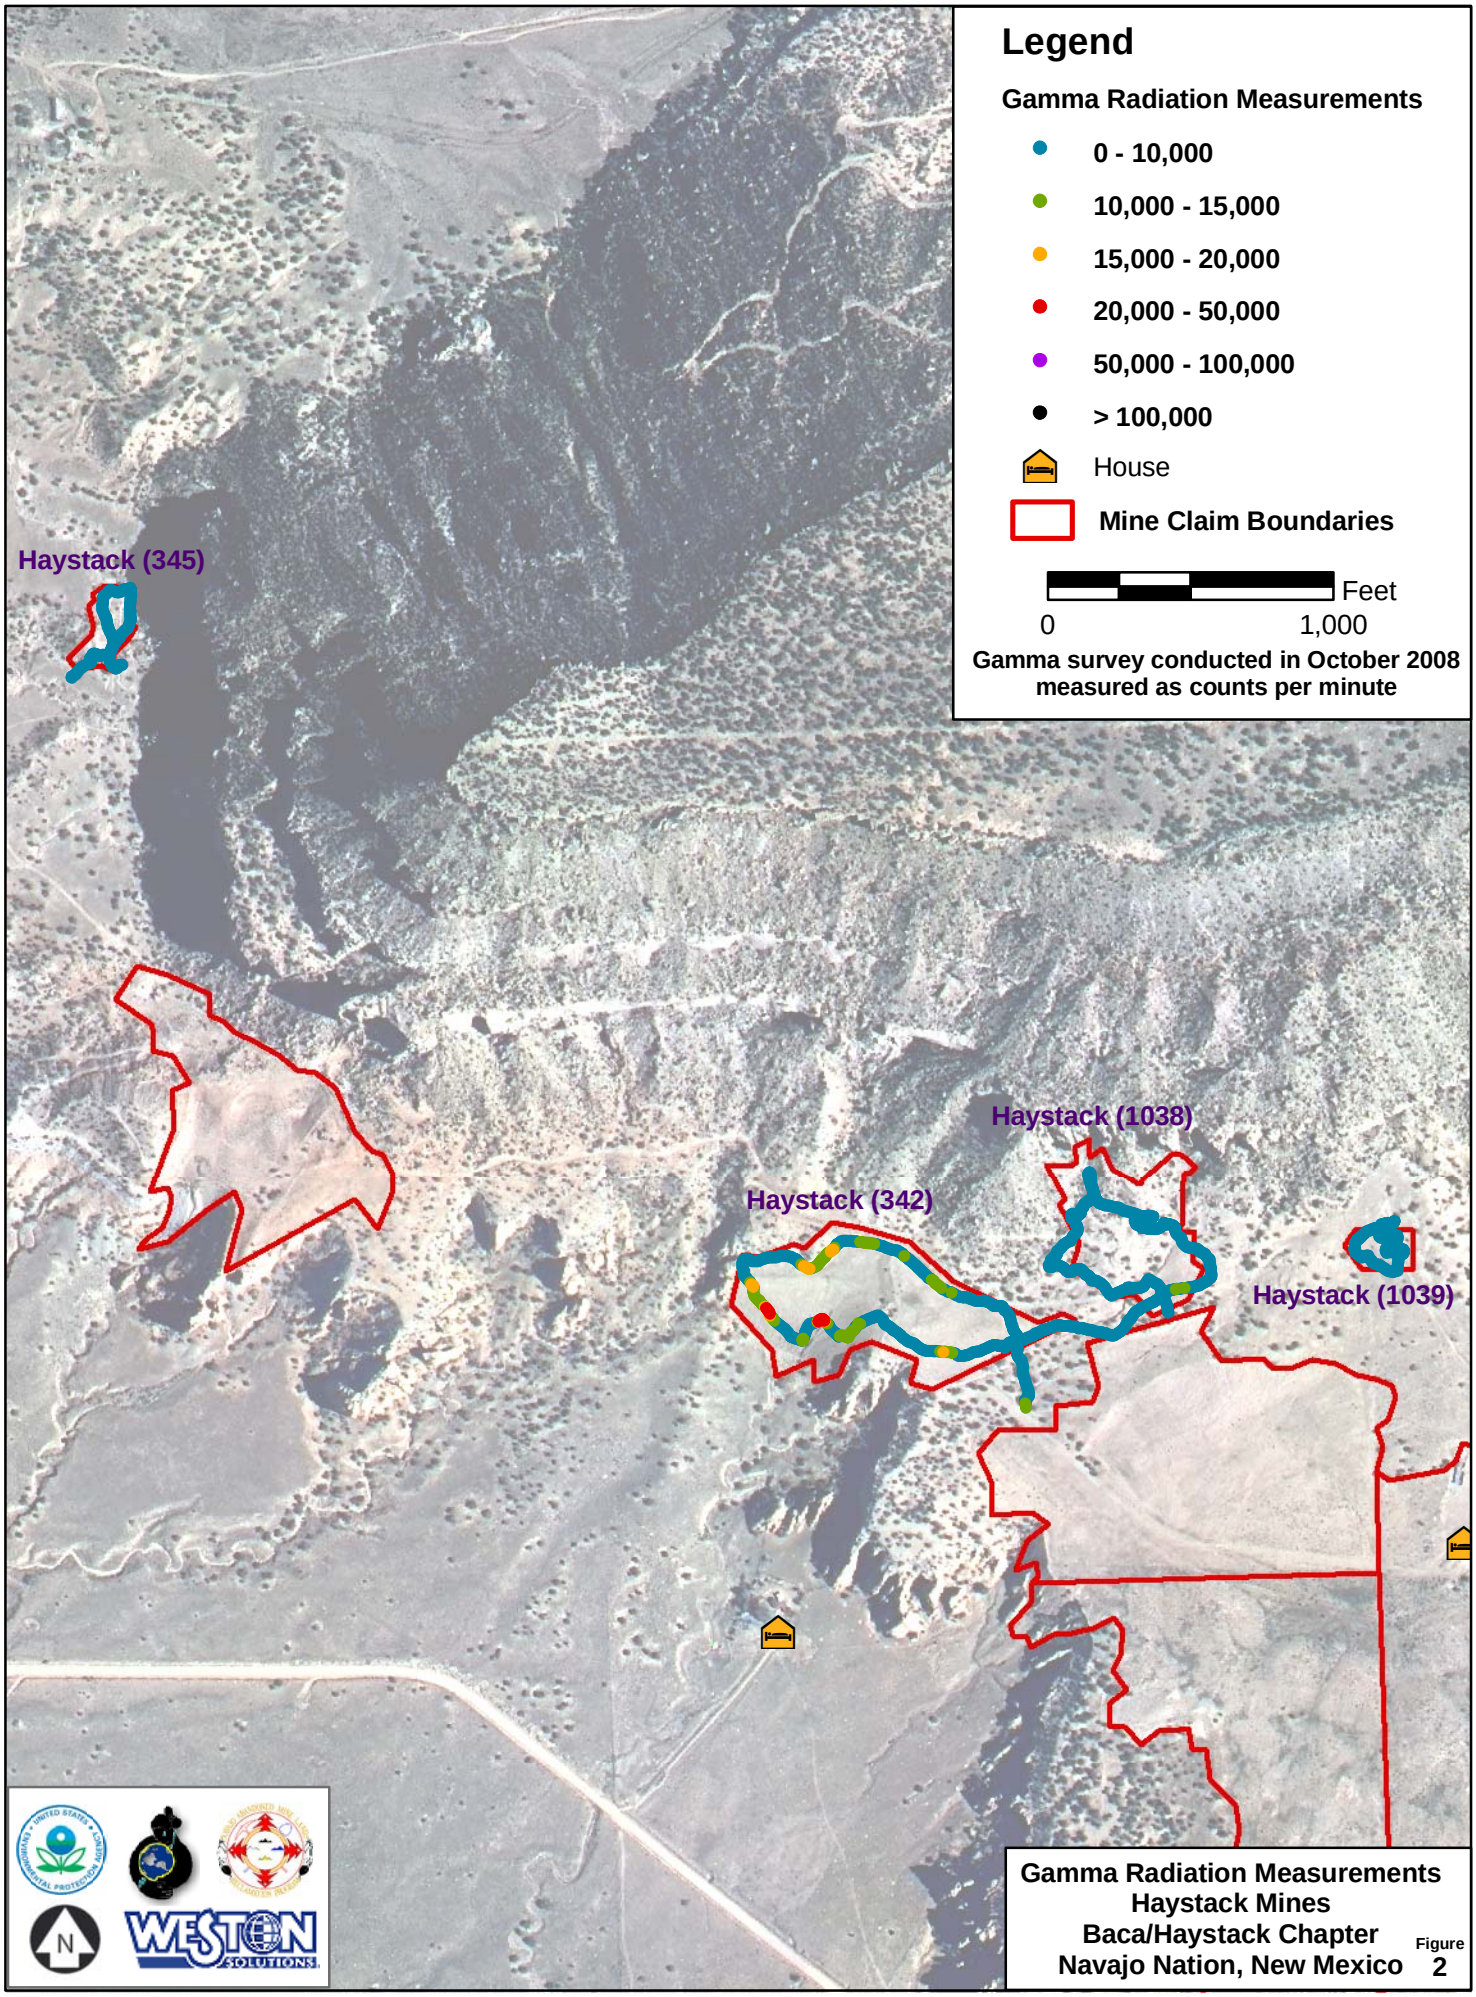
Figure 2

Gamma Radiation Measurements
Haystack Mines
Baca/Haystack Chapter
Navajo Nation, New Mexico
