Navajo Abandoned Uranium Mine Site Screen Report

Haystack No. 1 AUM Site

Navajo AUM Eastern Region

May 2009

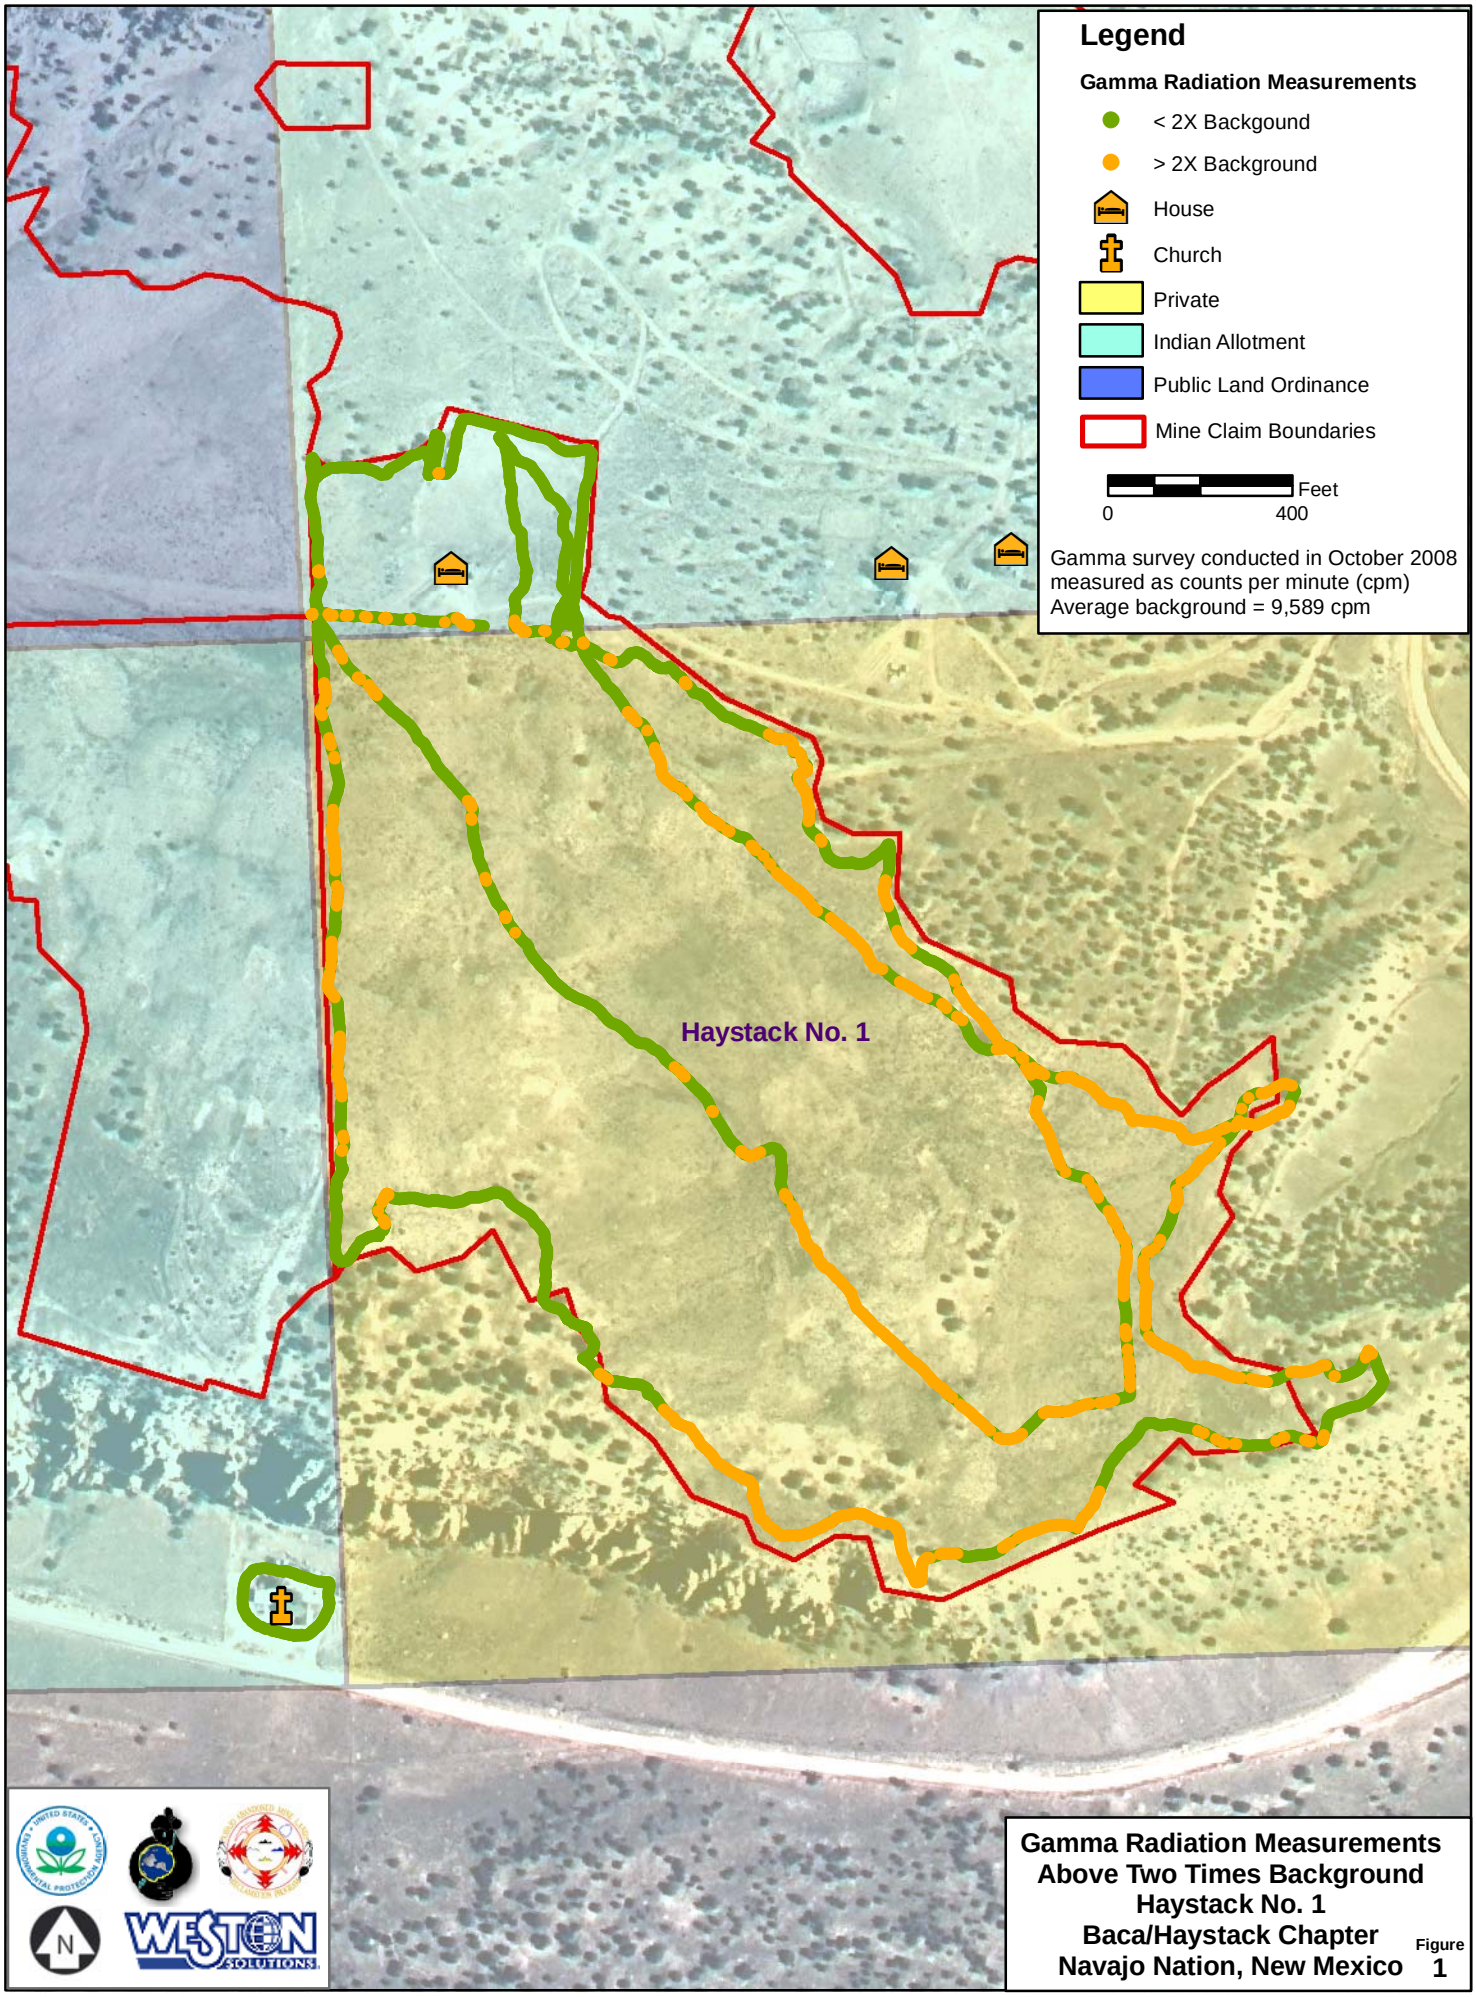
Figure 1

A total of 7,045 gamma radiation measurements were collected from mine sites, ranging from 5,965 cpm to 626,434 cpm. The measurements are represented in Figures 1 and 2.

Gamma Radiation Measurements Above Two Times Background
Haystack No. 1
Baca/Haystack Chapter
Navajo Nation, New Mexico

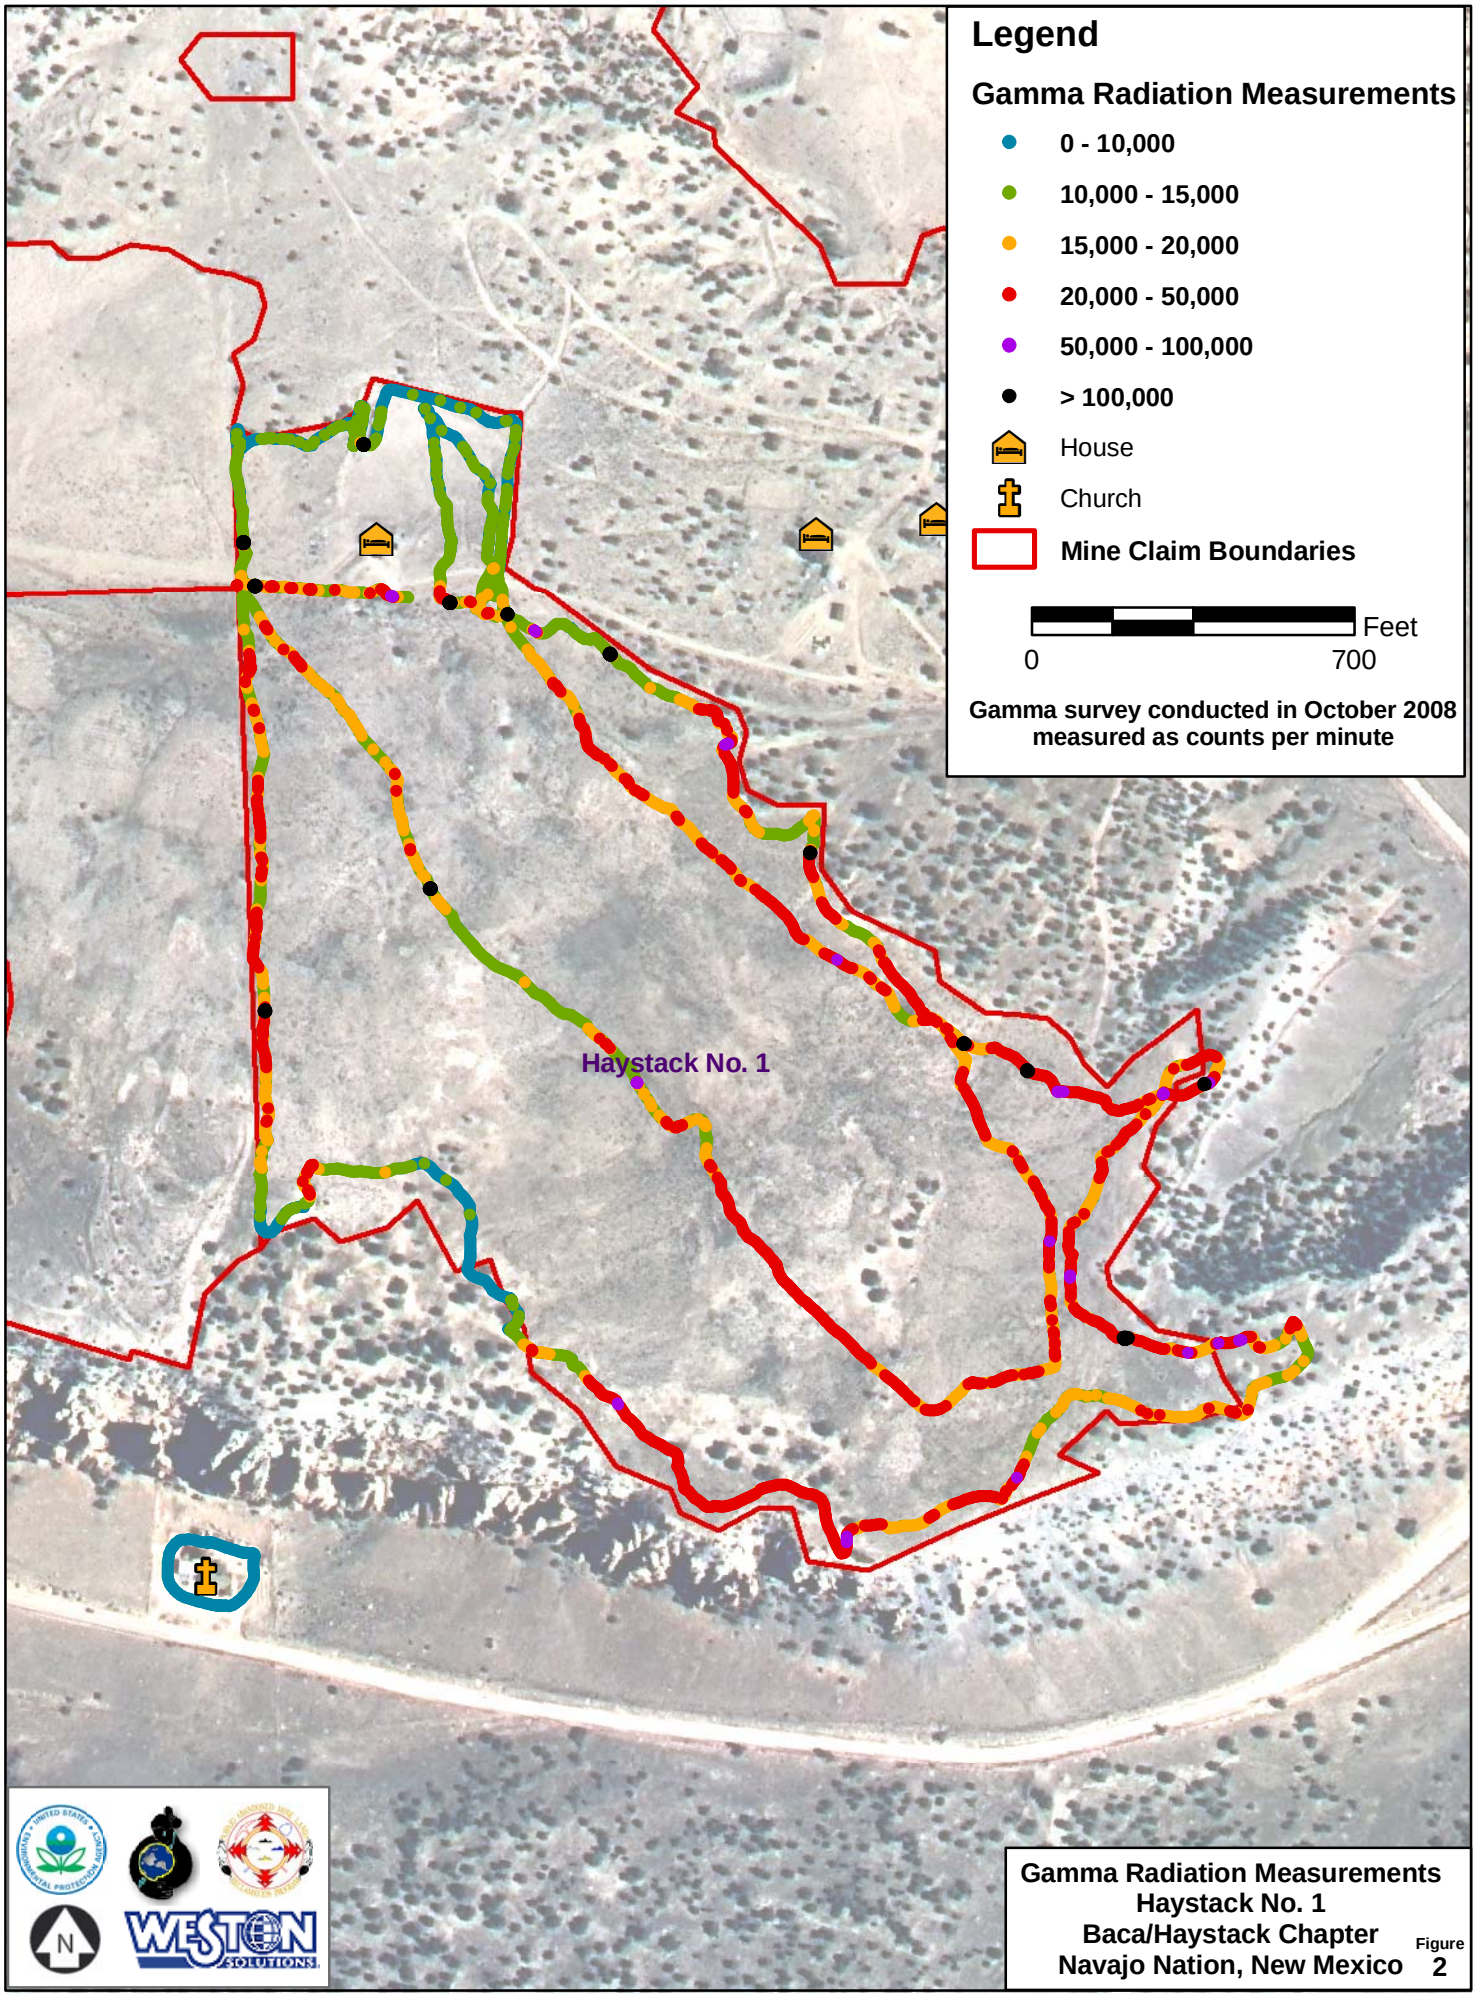
Figure 2

Gamma Radiation Measurements
Haystack No. 1
Baca/Haystack Chapter
Navajo Nation, New Mexico
