Navajo Abandoned Uranium Mine Site Screen Report

Haystack No. 2 AUM Site

Navajo AUM Eastern Region

May 2009

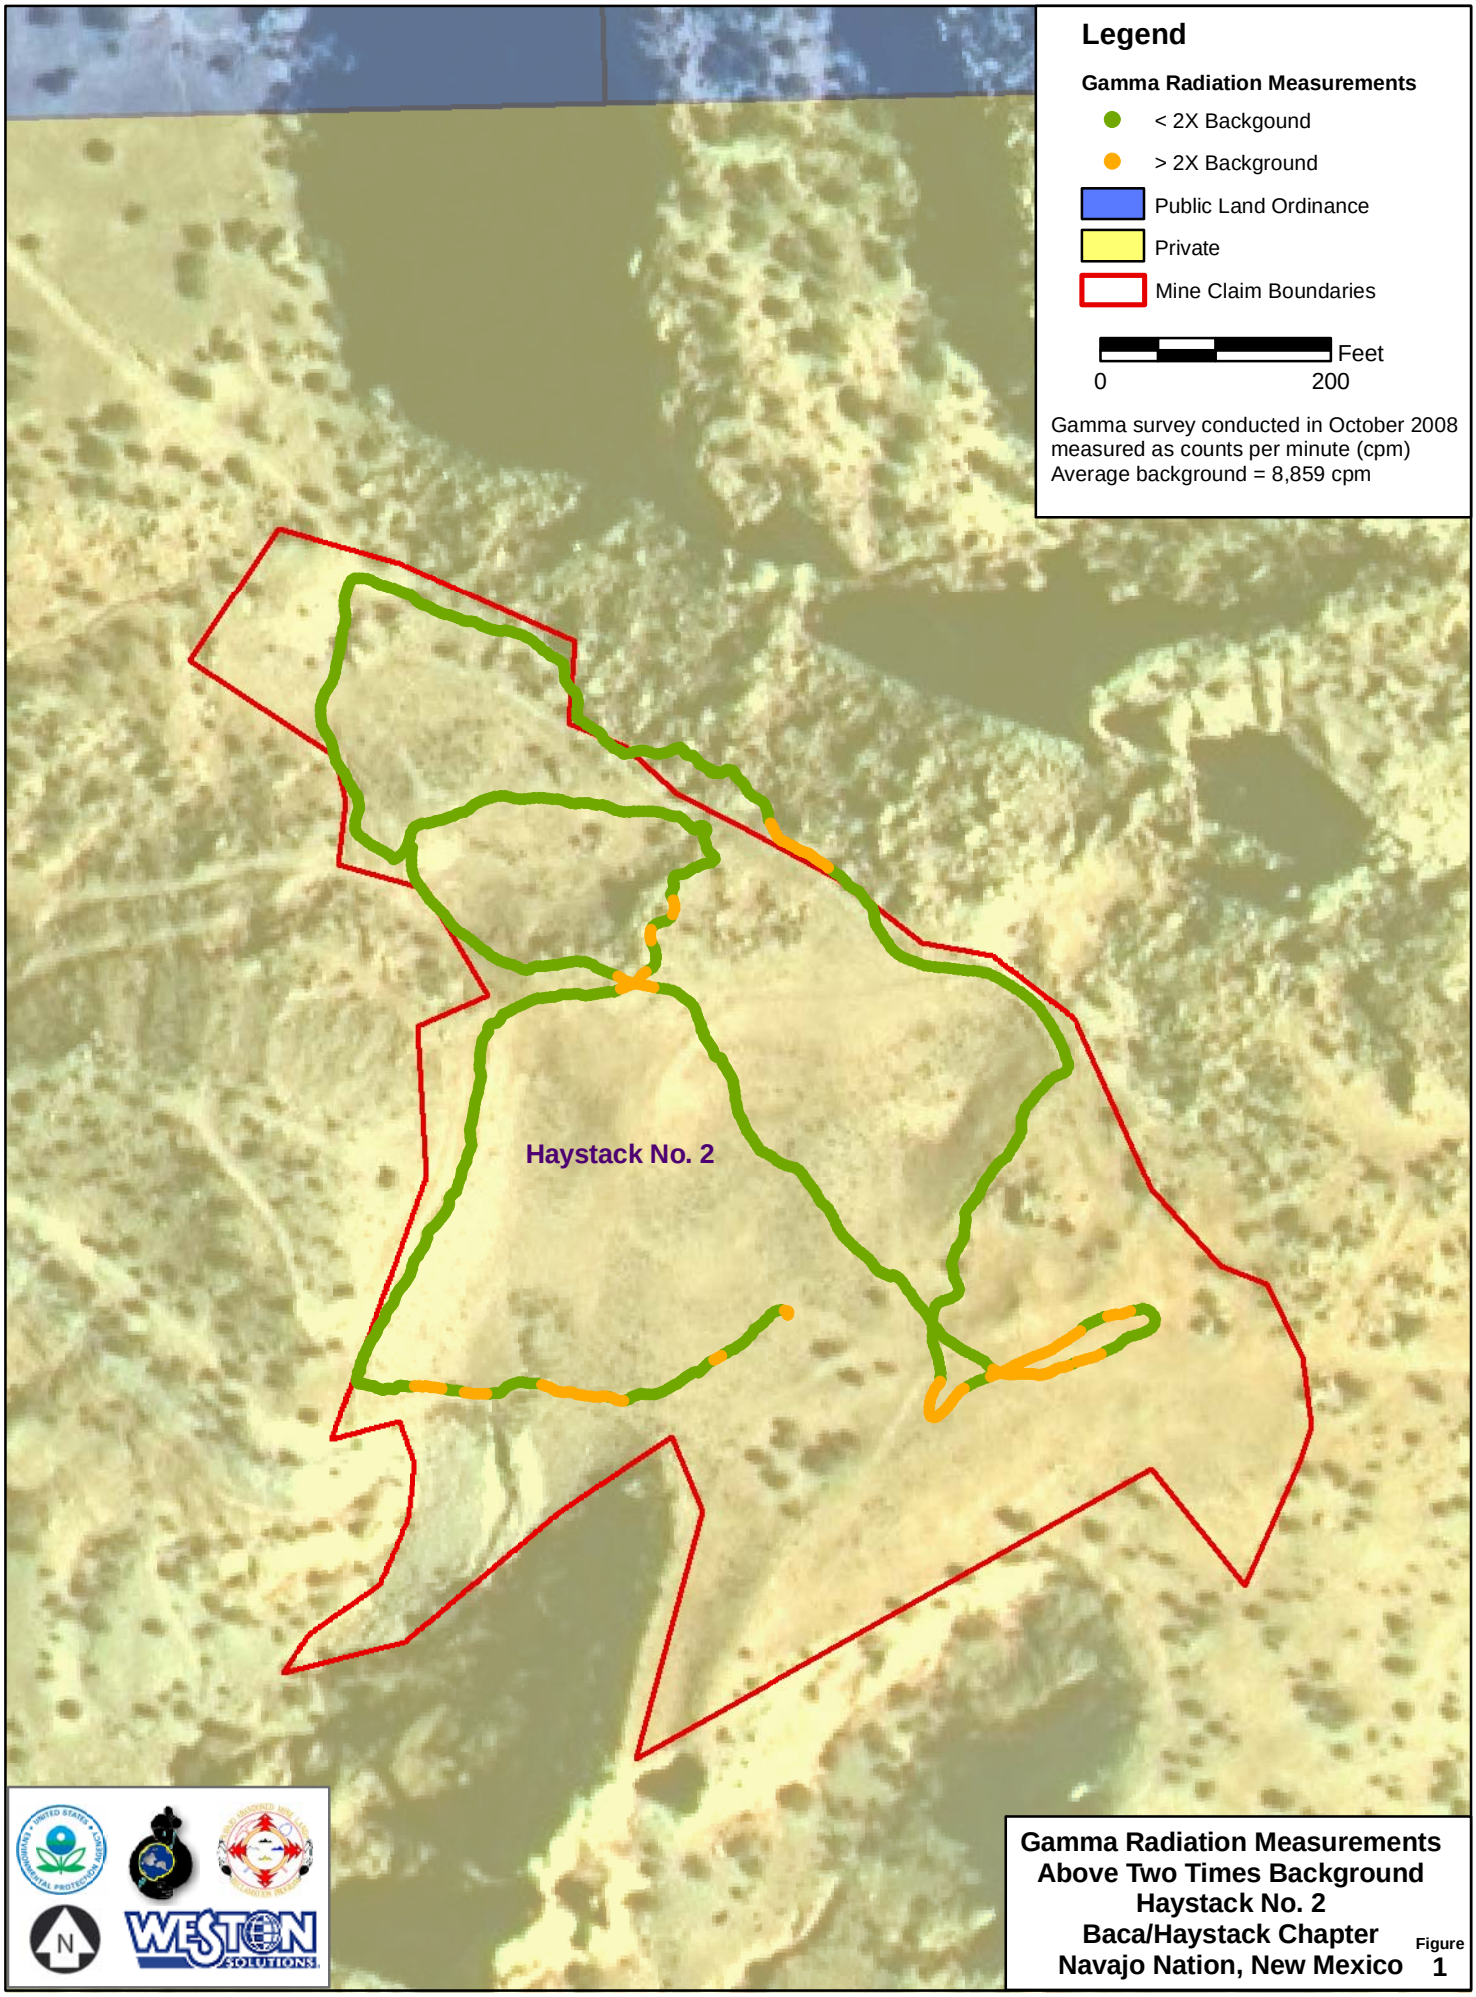
Figure **1**

A total of 1,210 gamma radiation measurements were collected from the mine site, ranging from 6,155 cpm to 32,732 cpm. The measurements are represented in Figures 1 and 2. Radiological measurements collected for the New Mexico Mining and Minerals Division during a 2008 field screening survey found gamma radiation levels near the ground surface with a maximum of 90 micro Roentgen per hour (µR/hr) and a minimum of 10 µR/hr, levels at the 4-foot elevation with a maximum of 60 µR/hr and a minimum of 9 µR/hr, and background levels of 10 µR/hr.

Gamma Radiation Measurements Above Two Times Background
Haystack No. 2
Baca/Haystack Chapter
Navajo Nation, New Mexico

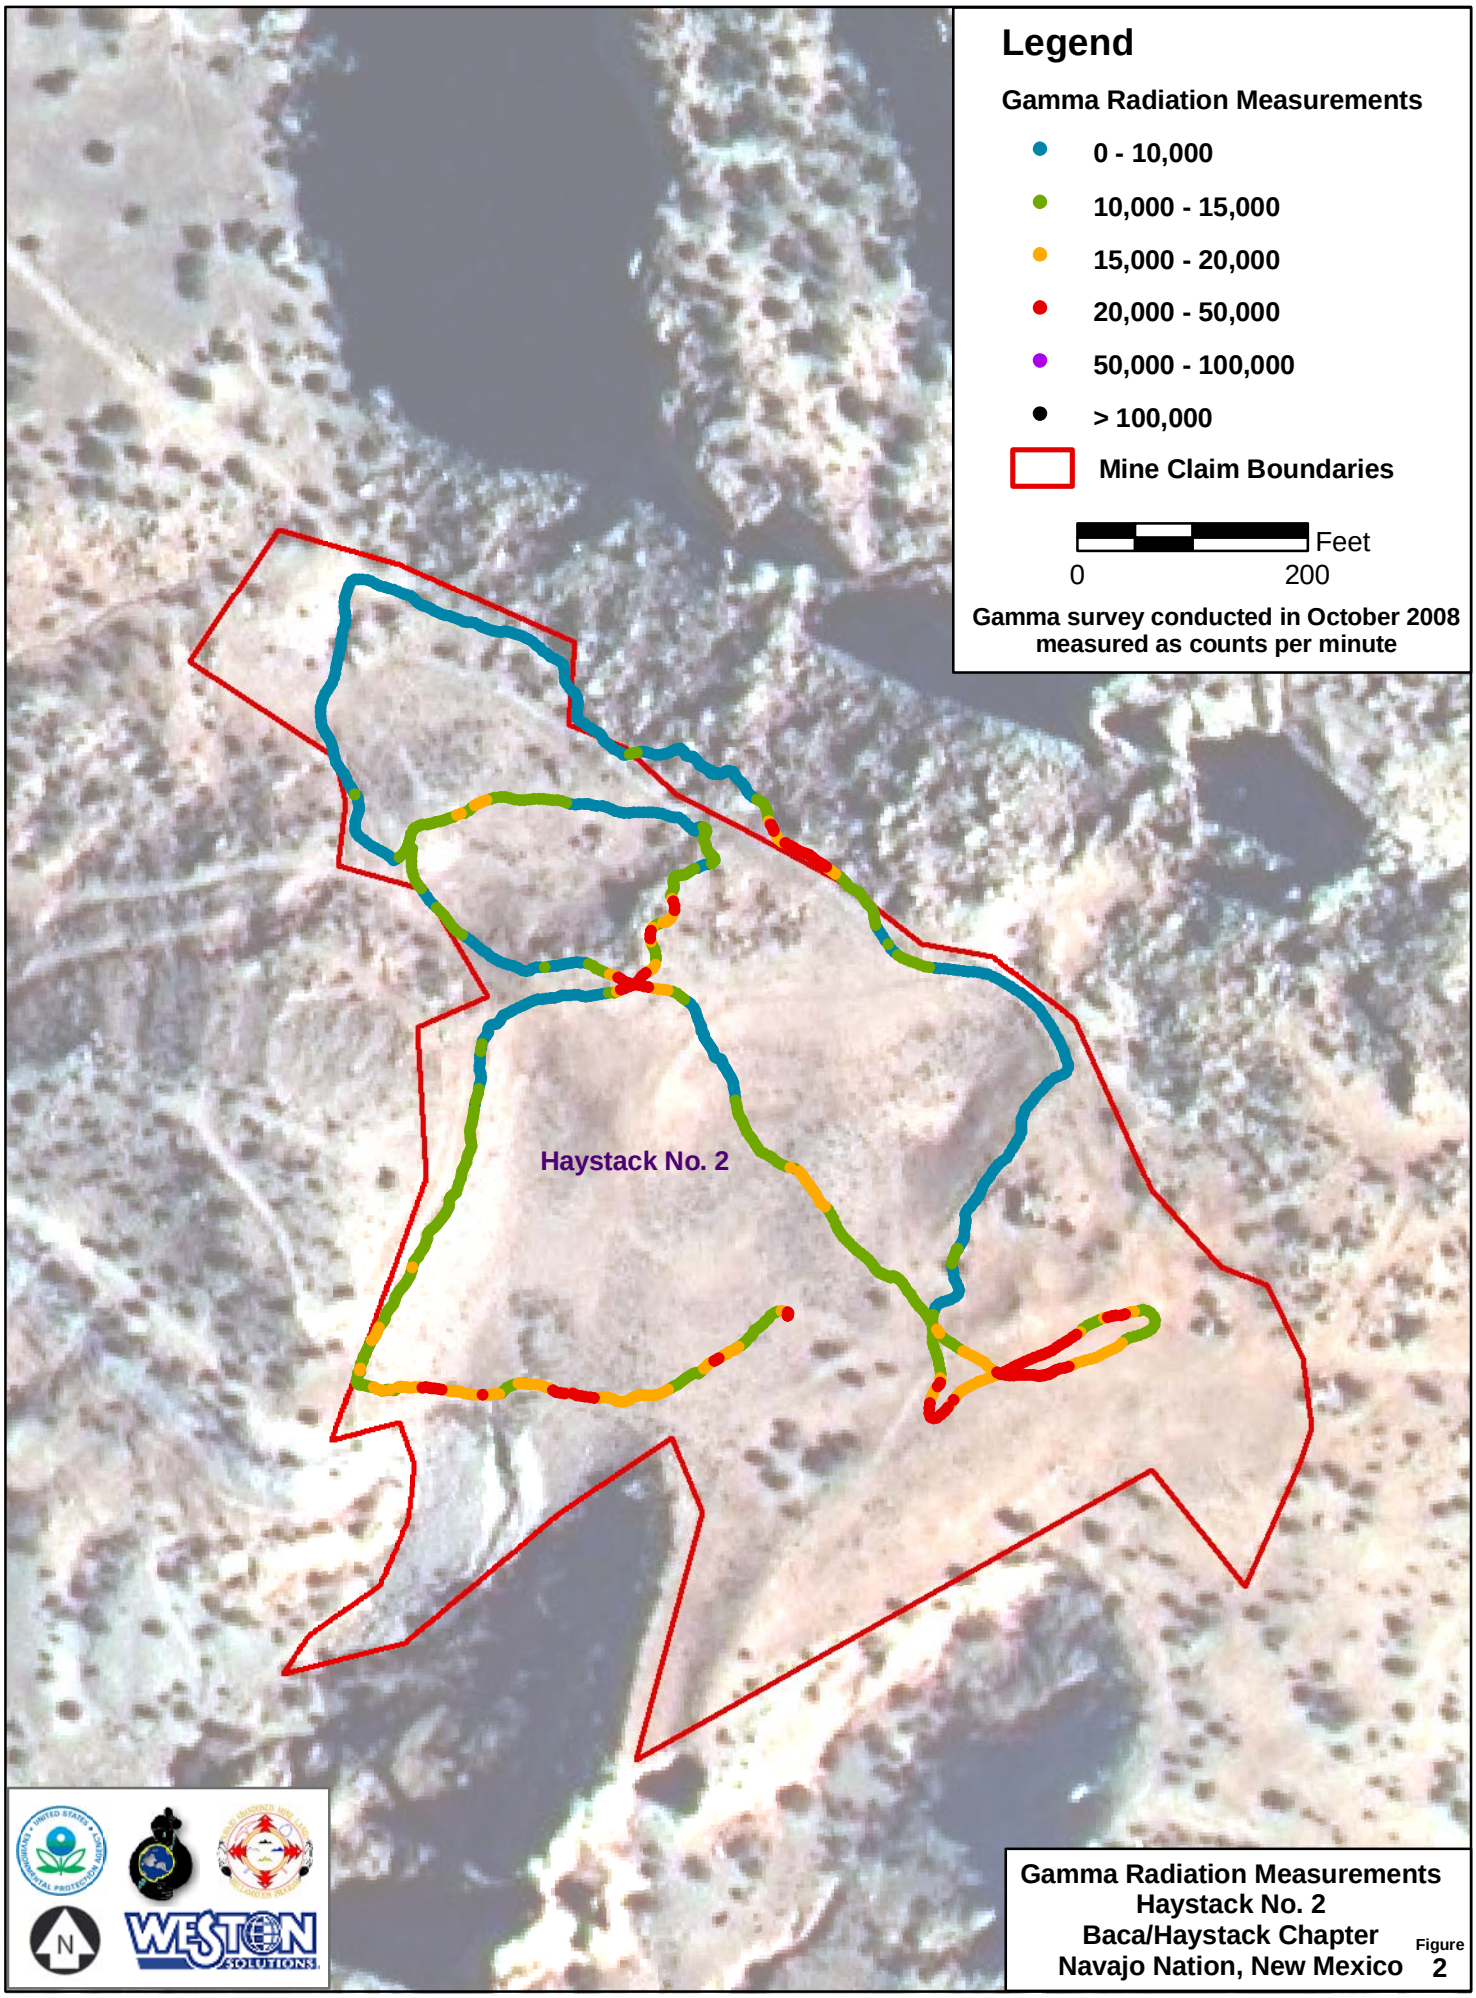
Figure 2

Gamma Radiation Measurements
Haystack No. 2
Baca/Haystack Chapter
Navajo Nation, New Mexico
