Project MUSICK MINE PA/SI

USEPA SF
1213742

SAMPLE/SCREENING SKETCH UPPER MINE, LOWER WASTE PILE

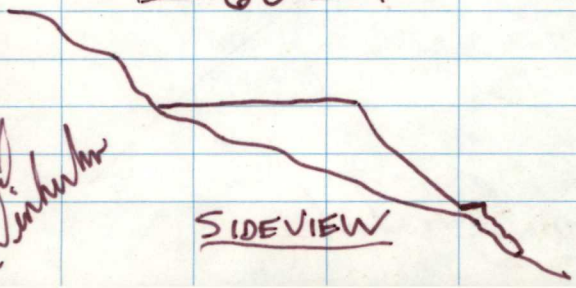
UPPER MINE UPPER ADIT SKETCHS

Loc.	RDG	As	Pb	Hg (PPM)
1	23	524	4,426	ND
2	24	511	6,472	ND
3	25	546	3,644	DLD ~~46~~ ND
4	26	919	6,360	DLD ~~56~~ 46
5	27	714	3,331	DLD ~~ND~~ 56
6	28	546	3,594	DLD ~~90~~ ND
7	29	827	673	DLD ~~52~~ 90
8	30	571	5,395	52
9	31	459	3,239	ND
10	33	594	3,327	ND
11	34	710	6,028	73
12	35	707 ~~583~~ DLD	6,750	184
13	36	583	4,379	ND
14	37	803	6,130	ND
15
